Project Number: 6-WCAP0.02 035GG

Omau Cliffs Subdivision Geotechnical Assessment Report

20 August 2021

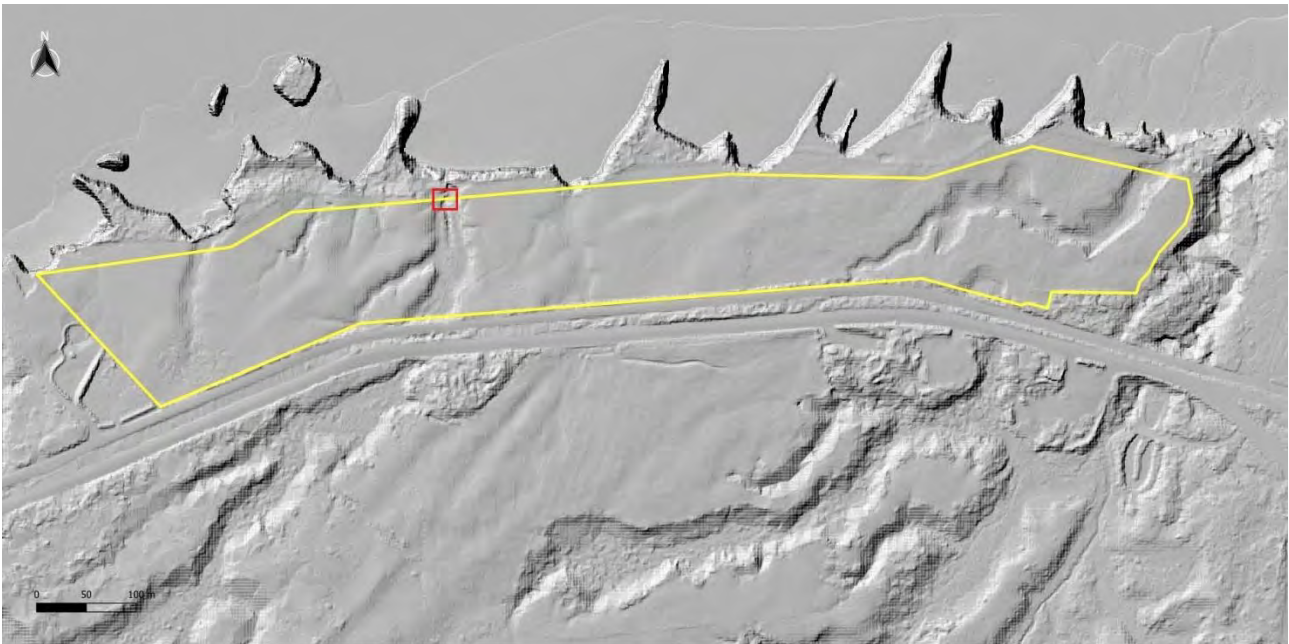
A review of available LIDAR data from the area found no signs of global instabilities developing across the terrace, refer to Figure 10. LIDAR data provides 3D information of the terrain with high accuracy and high spatial resolution and is commonly used for detection and characterisation slope instability features. Field observations (from a site walkover by WSP dated 2 August 2021) confirmed that only a few areas are affected by minor slumping, which are mostly associated with

Figure 10 LIDAR digital Elevation Model (DEM) of the Cape Foulwind area. The topography model inside the outline of the proposed 23 Lot subdivision (yellow outline) is very smooth and free of surface features typically associated with developing slope instability (surface depressions above slope crests, tension cracks). The LIDAR data clearly shows the positions of natural water courses draining the raised coastal terrace towards the northeast. The red outline indicates an area with cut slopes (ramp down to creek crossing).

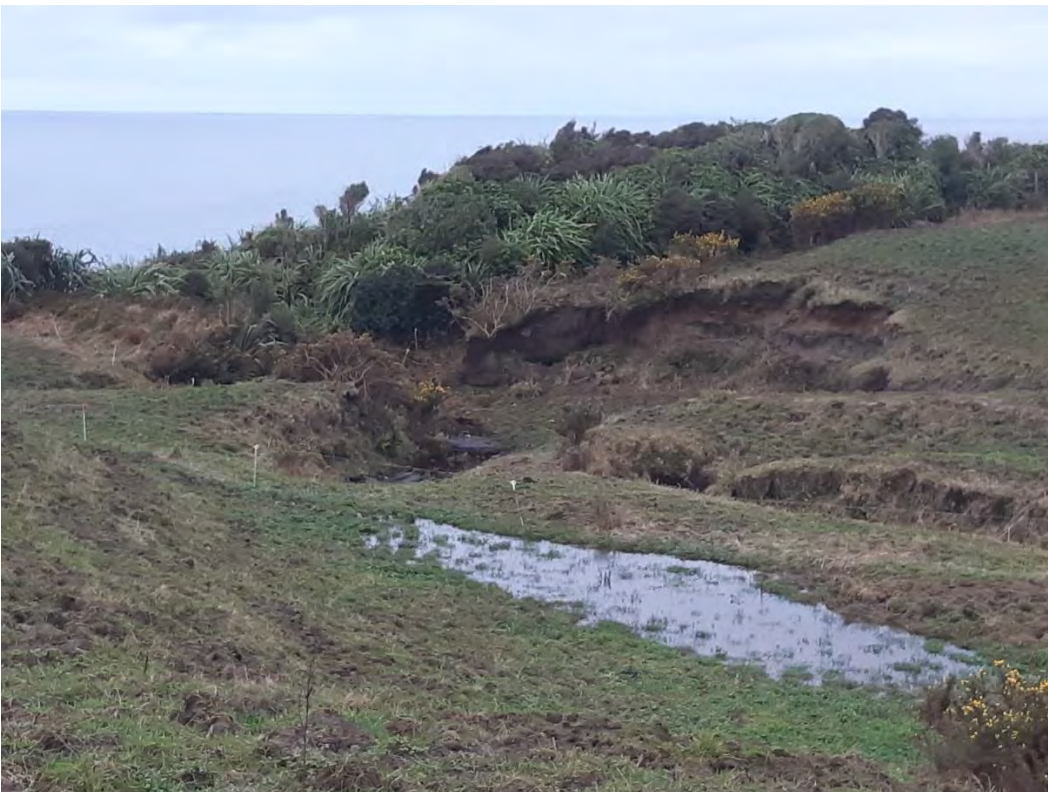
scour along a natural water course draining the site and cut slopes associated with an access ramp to a creek crossing, refer to Figure 10 and Site Photo 2 in Appendix B.

Site Photo 2 Minor slope instability associated cut slope along an access ramp to a creek crossing

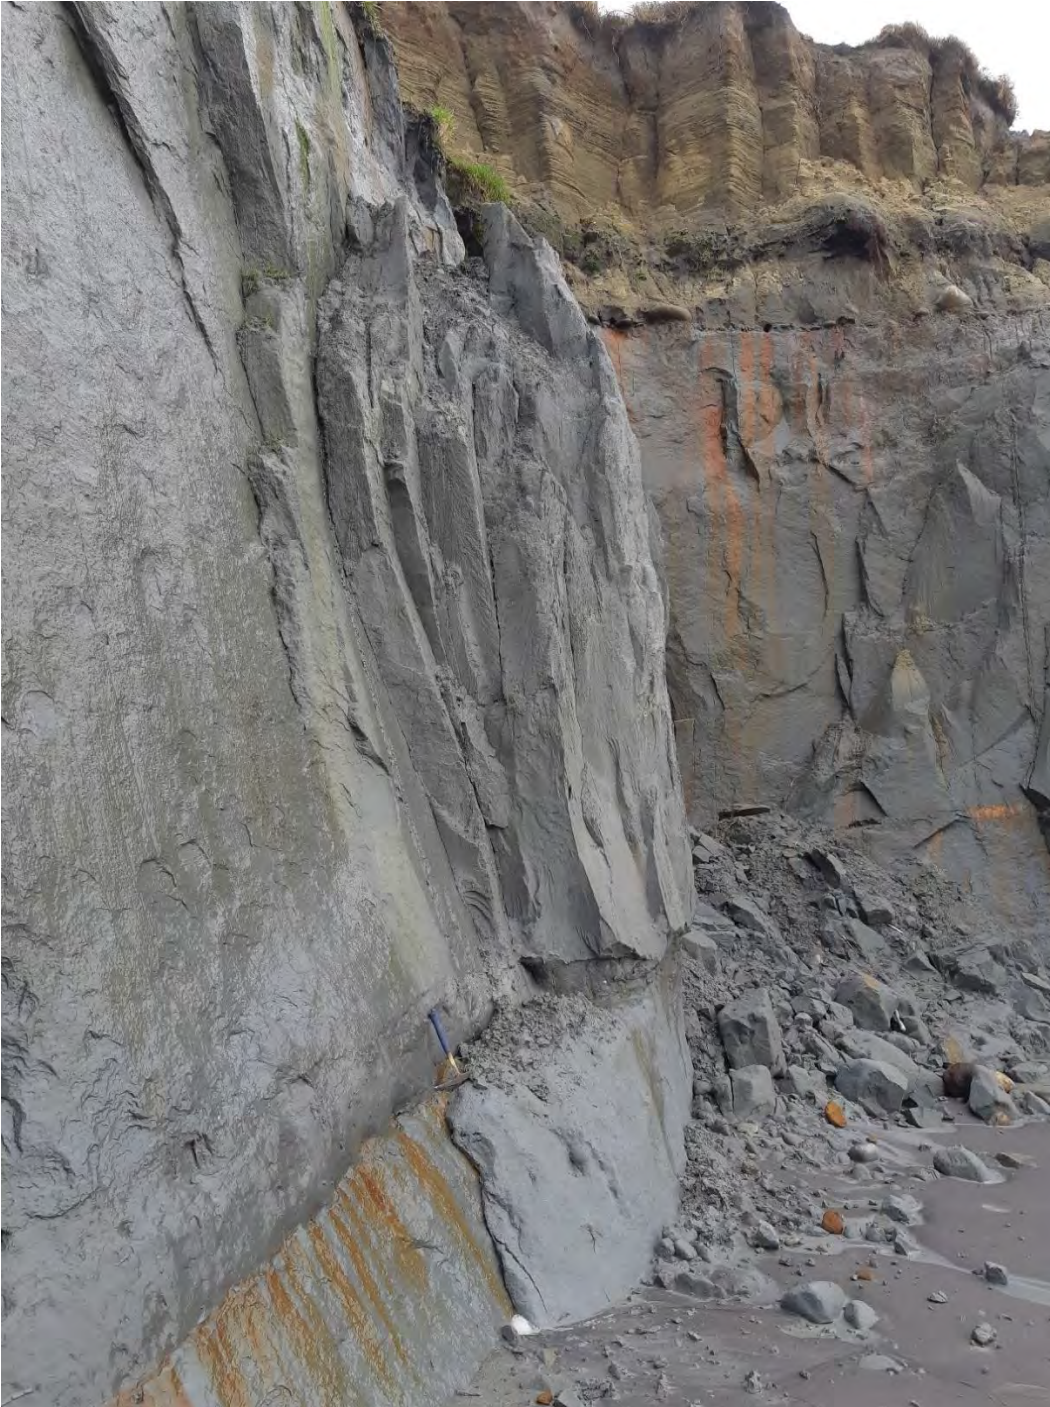
- Based on a site walkover undertaken by a WSP Engineering Geologist, the dominant failure mode in the mudstone along the beach below Omau Cliffs is confirmed to be slab failure along SW-NE and WNW-ESE orientated, very steeply inclined to subvertical, planar, moderately widely spaced (0.2-0.6m) persistent joints. The intact strength of the mudstone ranges from extremely weak to weak with moderately strong calcareous mudstone layers common. The potential for larger and more complex slope failures from undercutting and collapse of overhanging rock mass was also evident from recent rockfall.

Site photo 3 Typical slab failure along SW-NE and WNW-ESE orientated, very steeply inclined to subvertical, planar, moderately widely spaced (0.2-0.6m) persistent joints observed in the mudstone along the beach below Omau Cliffs. The intact strength of the mudstone ranges from *extremely weak to weak*.

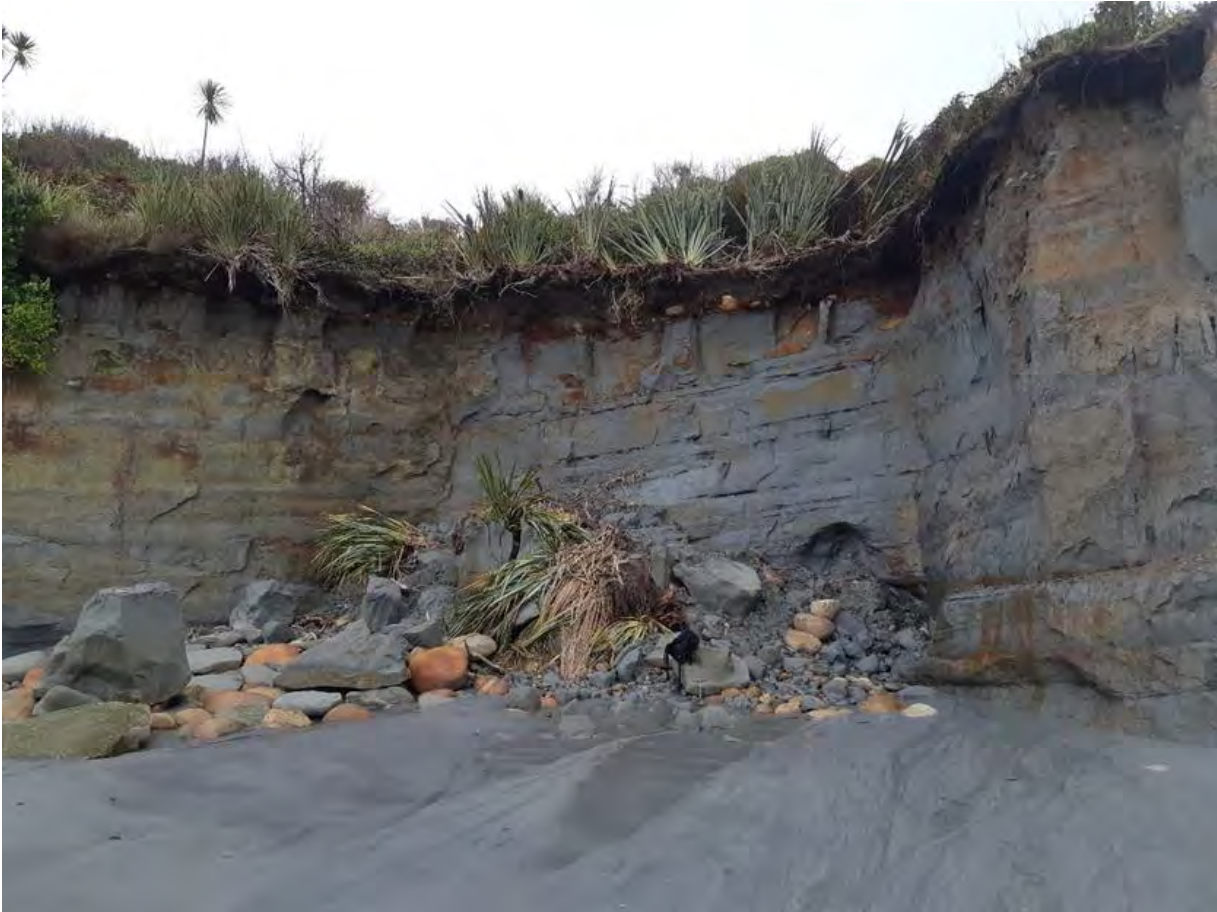
- Recent significant failures likely due to undercutting of the toe by wave action causing collapse of the overhanging rockmass, refer to Site Photo 4 in Appendix B.
- Structural complexity (low angle thrust fault with a small drag on the hanging wall block) was observed in the mudstone from the beach, which shows potential for a range of failure modes including larger complex failures, block slides, refer to Photo 4 in Appendix B.
- Groundwater seepage was commonly observed from the contact between the sand (Waites Formation) and the mudstone (O'keffe Formation). The mudstone is relatively impermeable and groundwater seepage becomes confined to depressions on top of the mudstone and contributes to erosion and weakening in areas where discharging onto the cliff face from the geological contact.

Site photo 4 Recent significant failure likely due to undercutting of the toe by wave action causing collapse of the overhanging rockmass. Daypack in the centre of the photo for scale. Note the typical step planar failure plane behind the spoil indicating

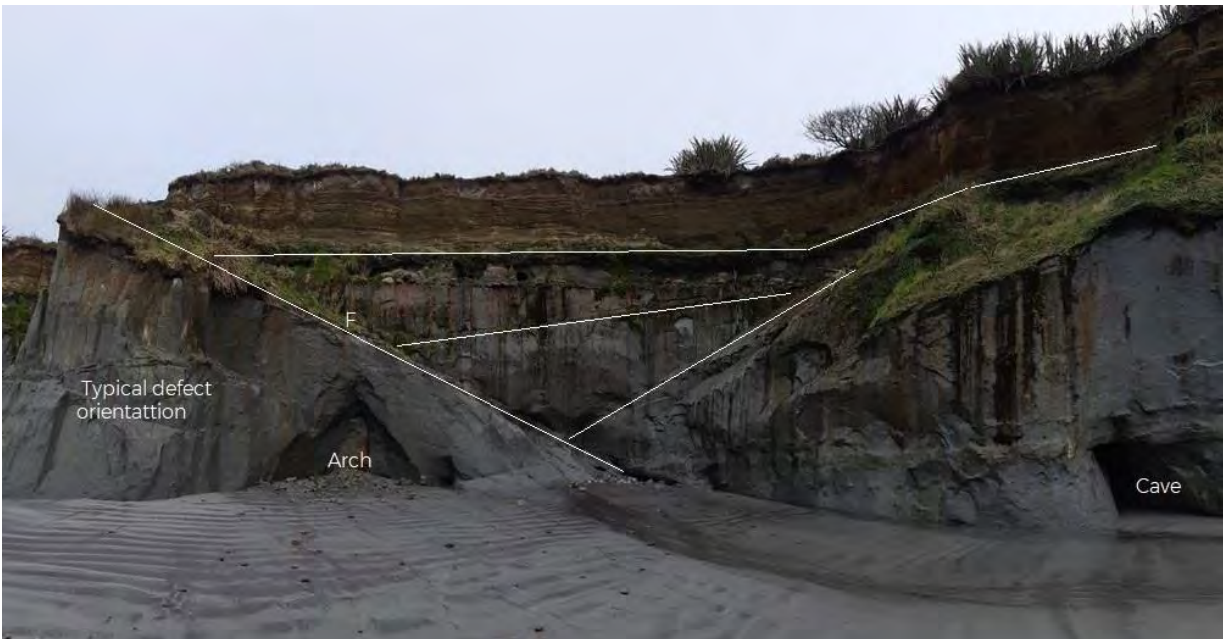
Site photo 5 Structural complexity observed in the mudstone from the beach. Likely low angle thrust fault (F) with a small drag on the hanging wall block (RHS of photo) truncated by erosional unconformity and overlain by Quaternary sands and gravels. Although the area appears relatively stable it shows potential for a range of failure modes including larger complex failures, block slides.

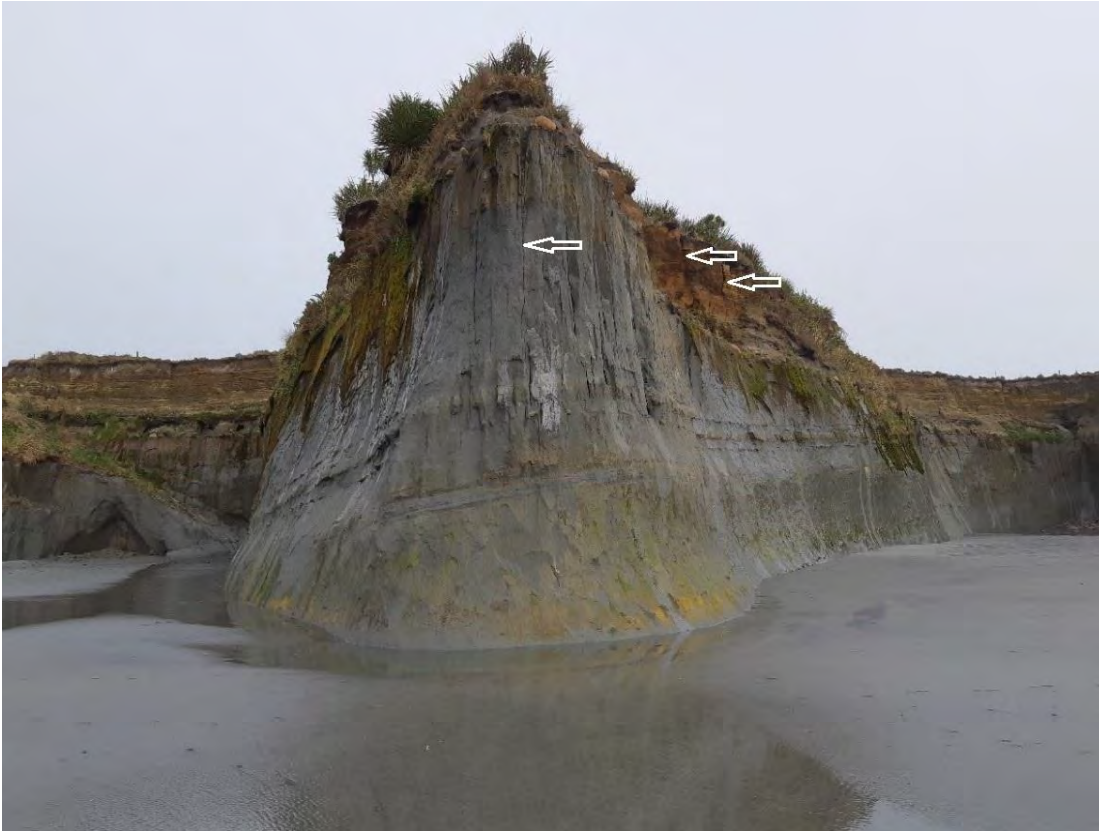
Site photo 6 Typical headland with relatively stronger mudstone (strength: weak). Note the subvertical joints in the upper section of the mudstone and overlying iron oxide cemented sandstone (visible open joints by white marker).

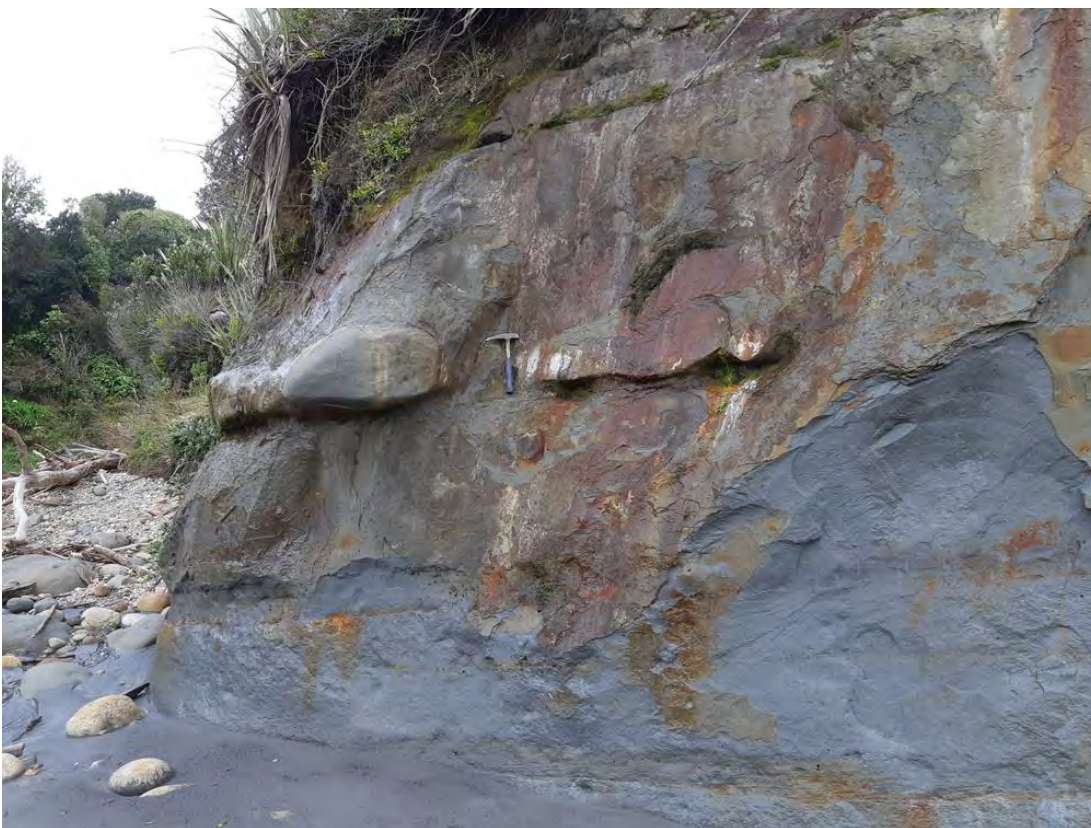
Site photo 7 Calcareous concretions (strength: moderately strong) observed in the mudstone on the beach by Gibsons Creek outlet.

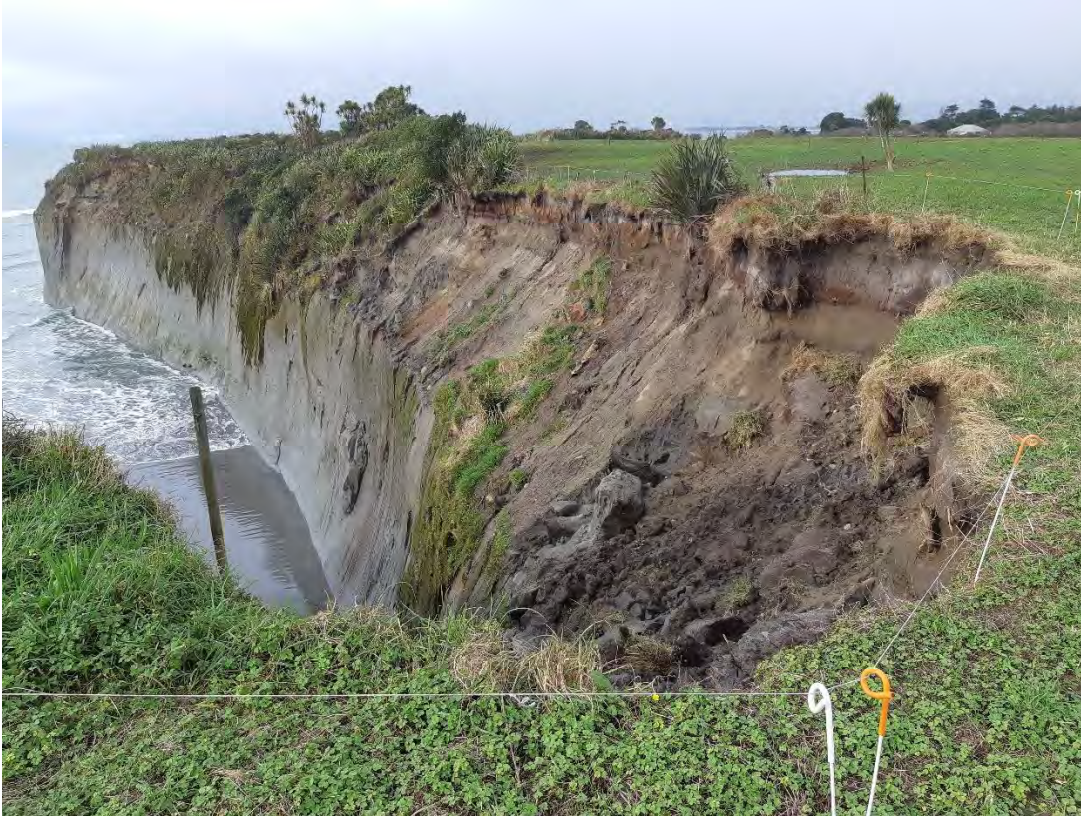
Site Photo 8 Recent failure in Quaternary unconsolidated sands along the crest of the Omau Cliffs. Lack of extensive iron cementation makes this section more prone slope failures

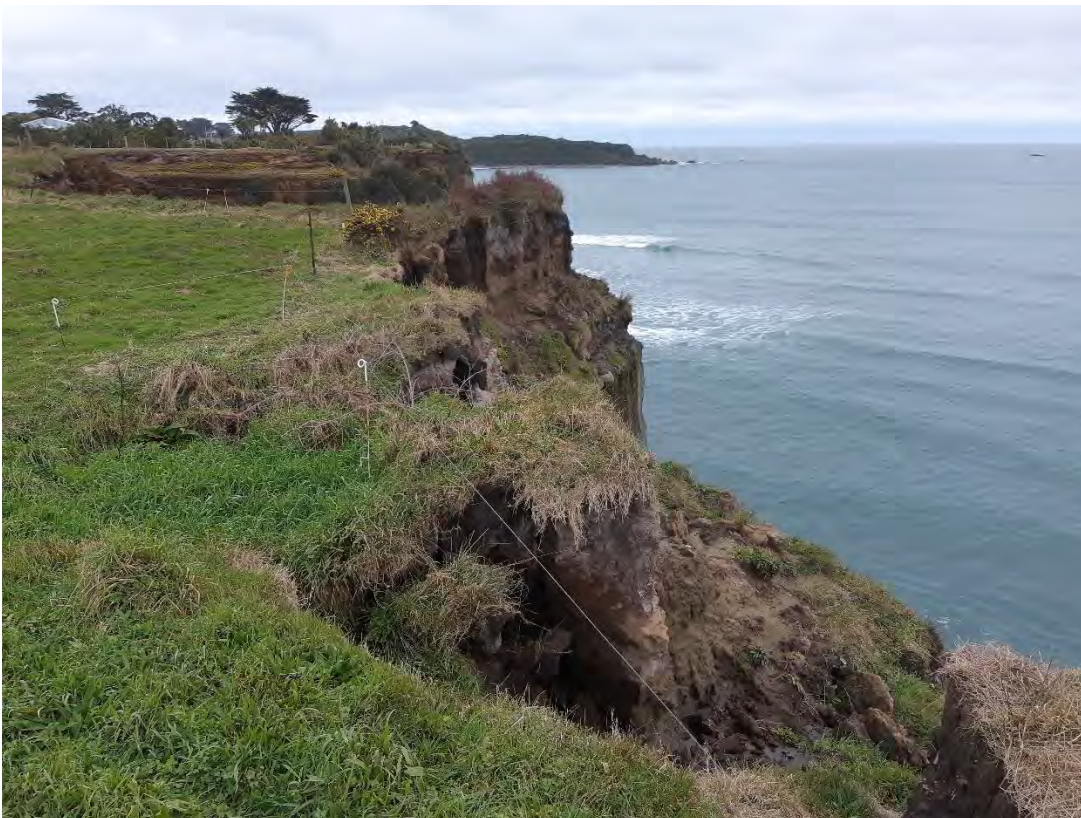
Site Photo 9 Recent slope failure along the cliff crest caused by water intrusion from natural drainage of the terrace. West end of the subdivision. Lack of extensive iron cementation makes this section more prone slope failures

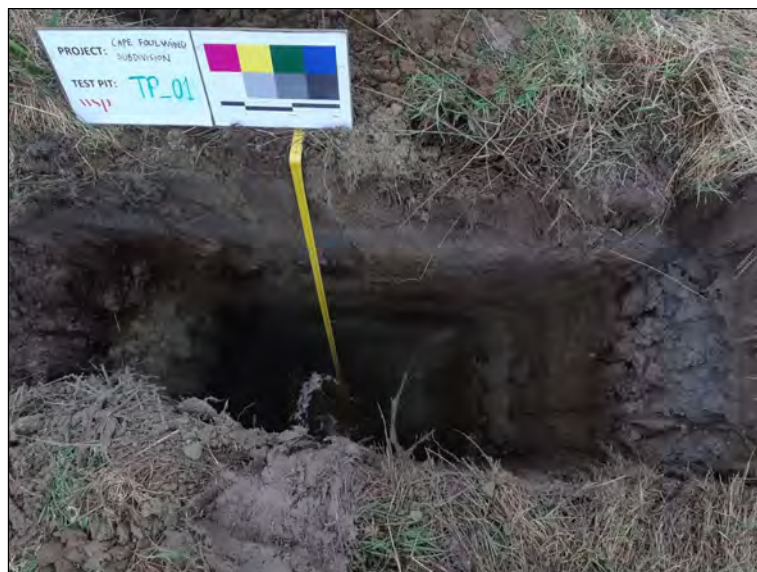
Testpit TP_01

Notes:
 Testpit positioning with handheld GPS.
 Slow groundwater seep at 1.40m.

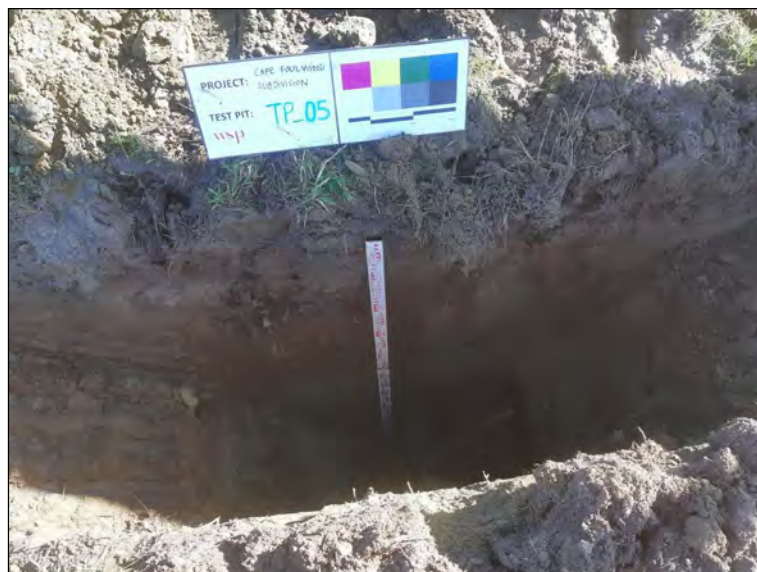
Testpit TP_05

Notes:
 Testpit positioning with handheld GPS.
 Groundwater seep at 0.30m.

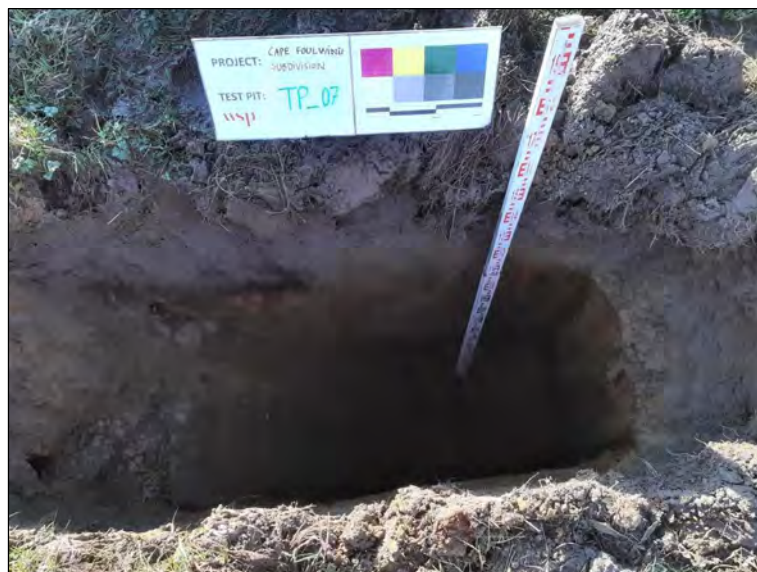
Testpit TP_07

Notes:
 Testpit positioning with handheld GPS.
 Groundwater seep at 0.60m.

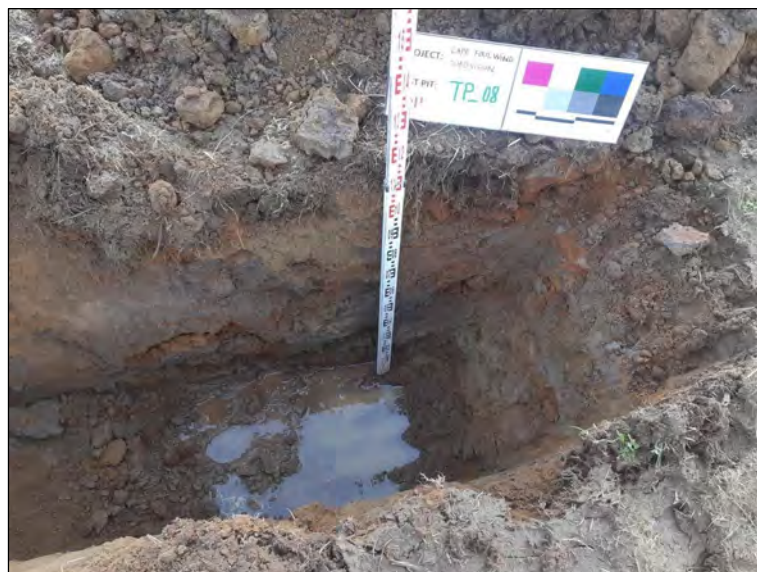
Testpit TP_08

Notes:
 Testpit positioning with handheld GPS.
 Groundwater seep at 1.15m.

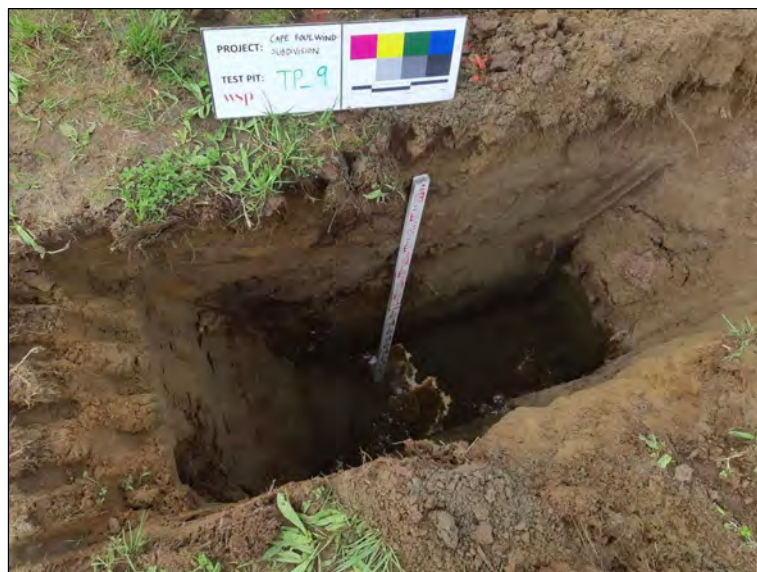
Testpit TP_09

Notes:
 Testpit positioning with handheld GPS.
 Groundwater seep at 1.50m.

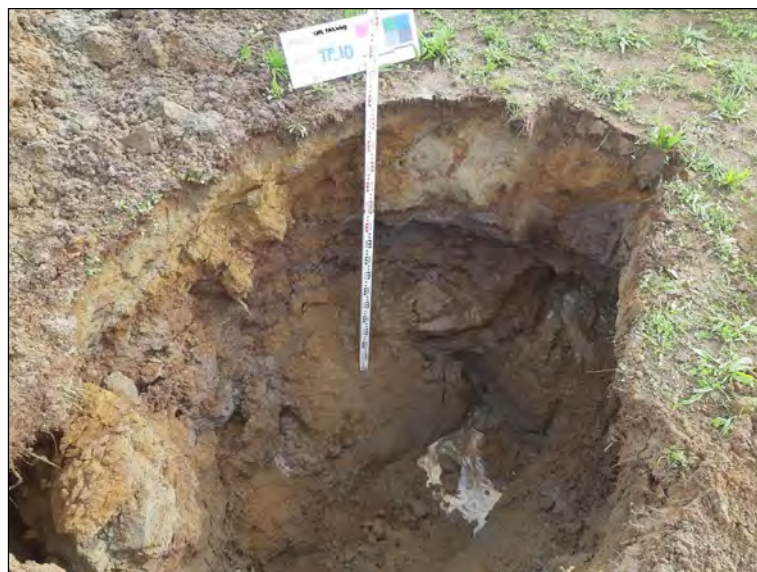
Testpit TP_10

The relatively lack of regional groundwater as well as the geological setting of the site suggests that the liquefaction potential of the soils encountered at this site is expected to be low. The only exception is TP_10 (near lots 19 and 18), where the test pit walls became unstable during excavation due to water ingress in loose ground conditions. We recommend further investigations (as part of foundation design) be undertaken at all lots, in particular lots 19 and 18, to assess the liquefaction susceptibility and effects.

Notes:
 Testpit positioning with handheld GPS.
 Groundwater at 1.55m after 20min.
