**GEOTECHNICAL SITE SUITABILITY
ASSESSMENT**

PROPOSED SUBDIVISION

**LAKE POERUA
WESTLAND**

R06812016-02-V2

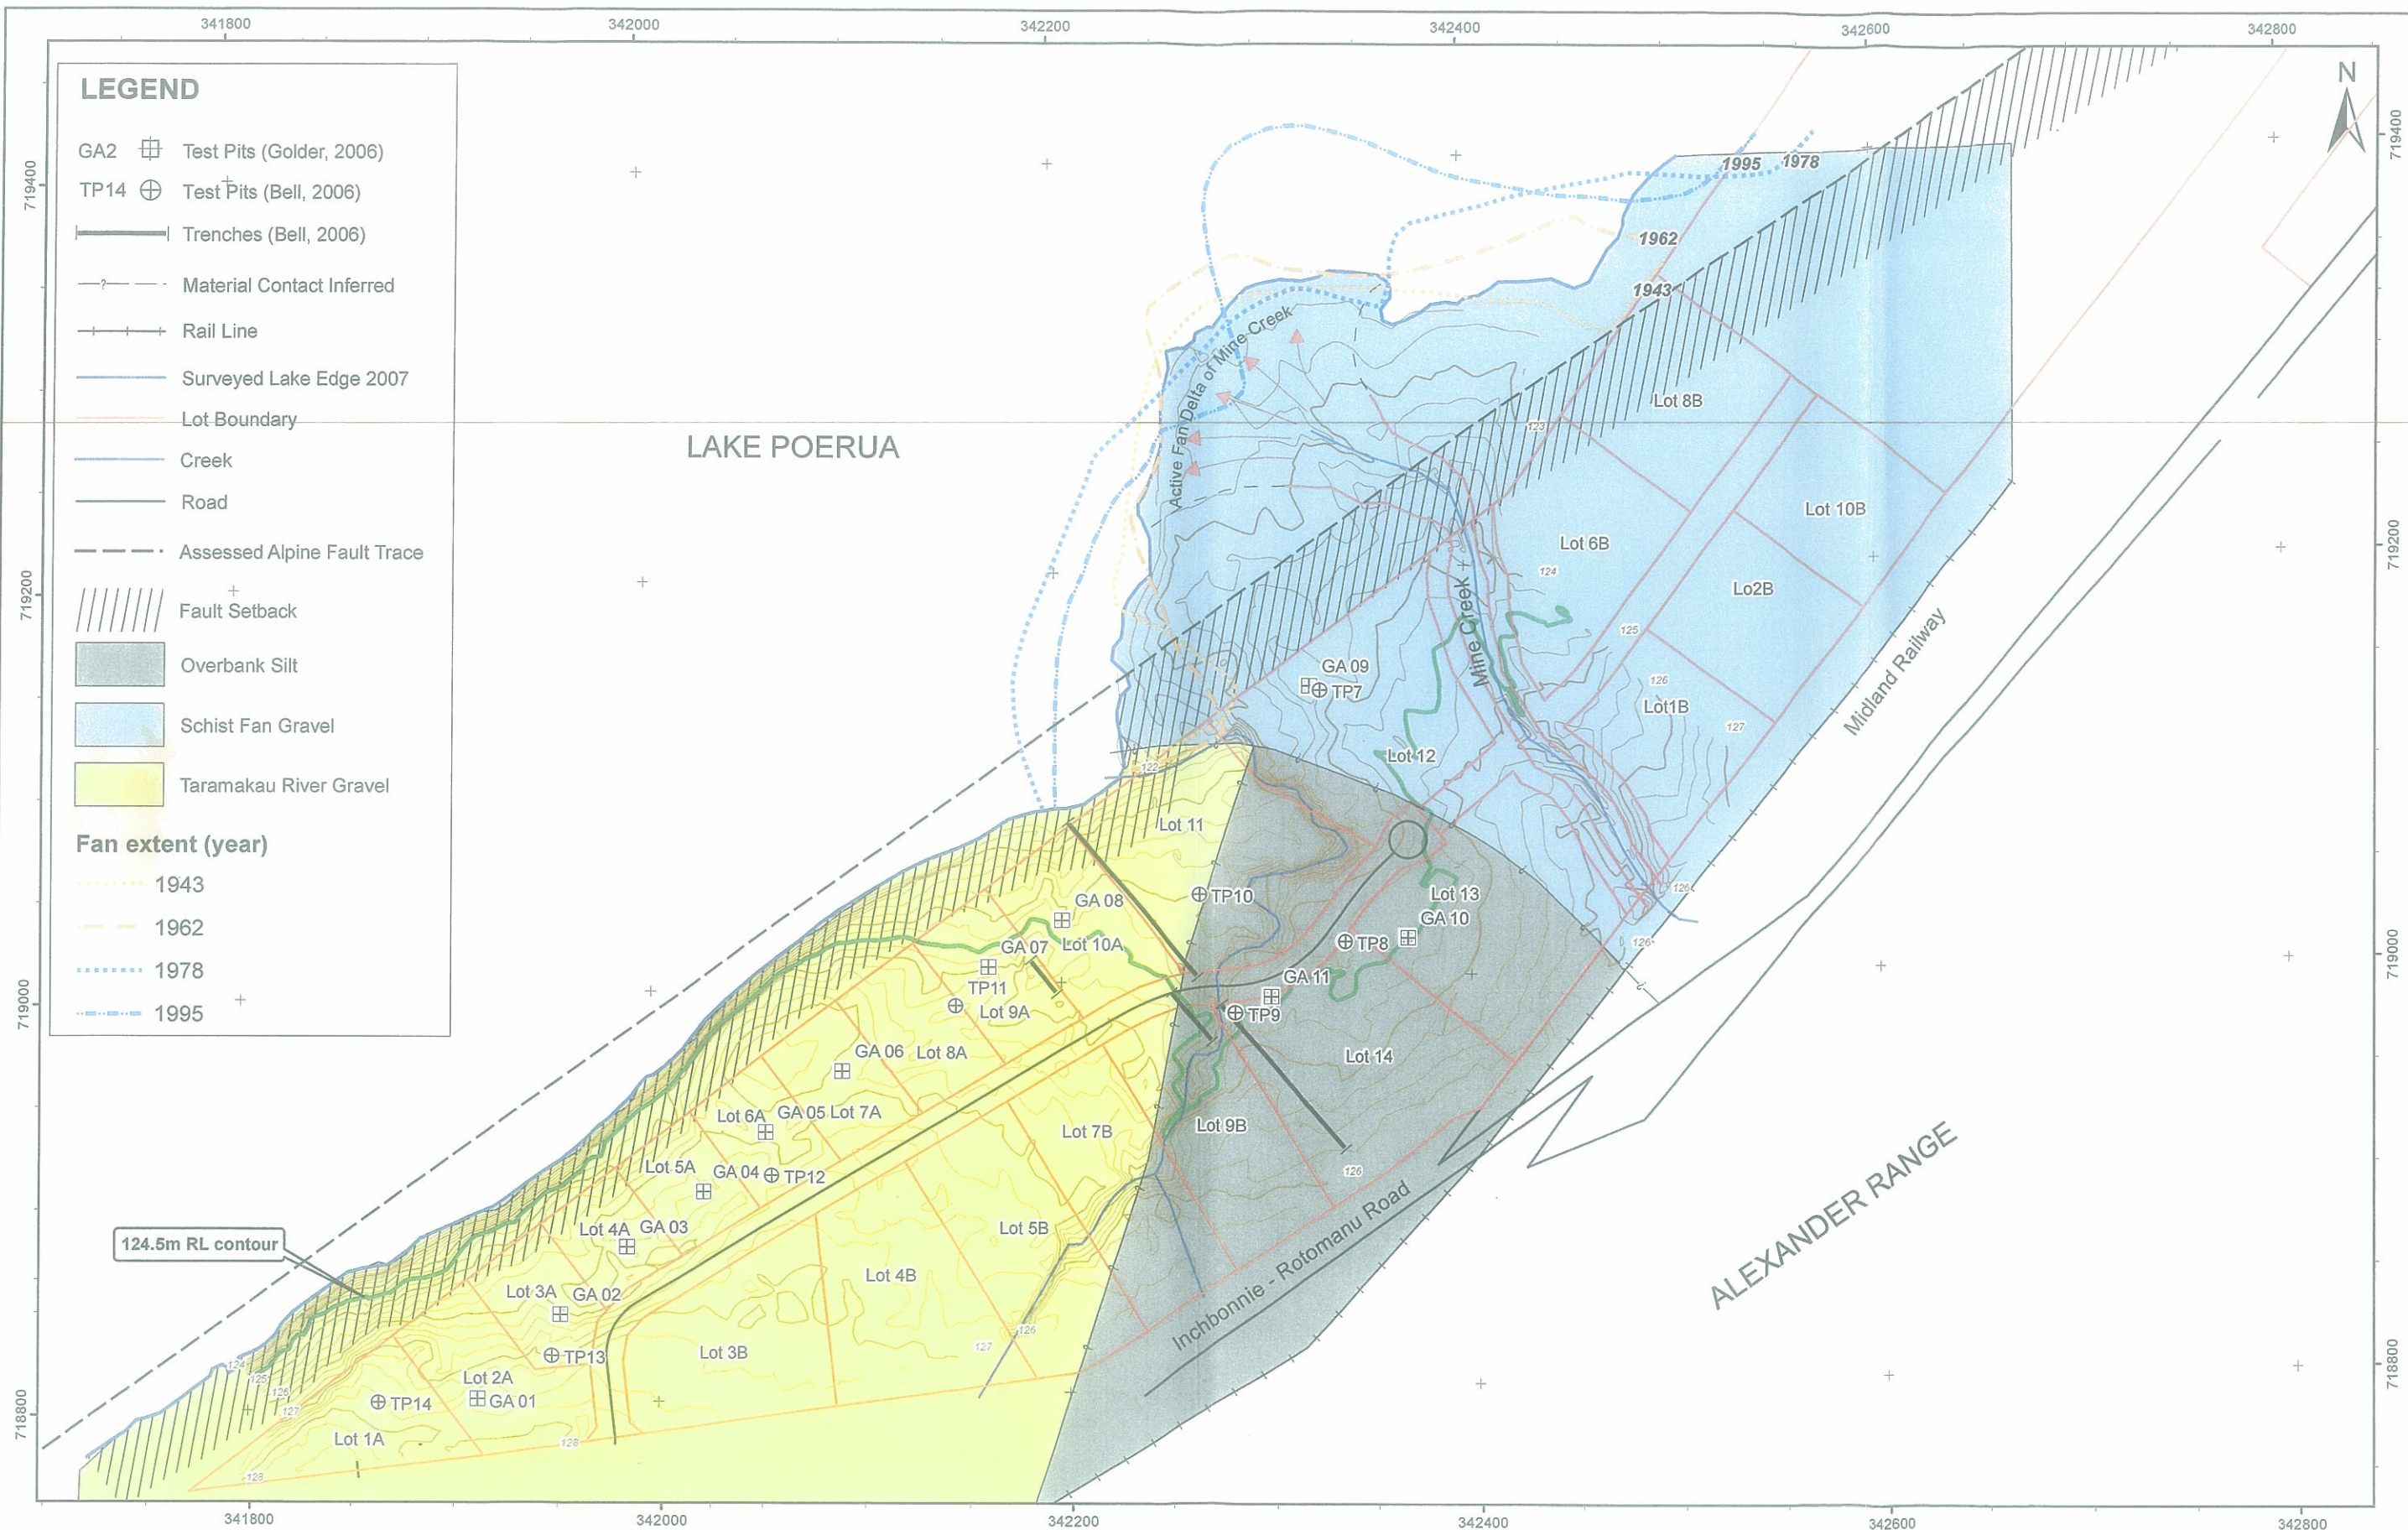
CLIENT Grant Marshall		PROJECT Geotechnical Assessment Proposed Subdivision, Lake Poerua, Westland			
DRAWN JVB	DATE July 2007	TITLE ENGINEERING GEOLOGICAL PLAN			
CHECKED LRC	DATE 24/9/07				
SCALE 1:3,000	A3	PROJECT No 06812016	REPORT No R06812016-02-v2	REV No 1	FIGURE No 5

The description of materials discussed below can be read in conjunction with the observed distribution of materials as shown in Figure 5.

The site is underlain by dense to very dense, sub to well rounded sandy gravel with maximum clast size generally 0.1 m with occasional boulders up to 0.6 m diameter. Occasional sand layers to 0.8 m thickness were observed near or at the top of the gravels. Iron pans were commonly observed within the sandy gravel.

An area of loose to very loose, sub-angular gravel with a maximum observed clast size of 0.1 m diameter occurs to the north east of the site. This material is assessed to be derived from Mine Creek, which flows out of one of the steep catchments draining the Alexander Range to the southeast. Schist fan gravel was encountered to 1.8 m depth in the test pit excavated on proposed Lot 12 (GA 09), which is considered representative of the likely thickness of this material across proposed Lots 12 and 13. It is possible that thicker deposits may occur in other abandoned and infilled channels particularly more in the centre of this fan towards the northwest of these proposed lots.

In parts of the proposed subdivision, soft to firm, moist to saturated silt beds up to 1.5 m thick overlie the Taramakau River Gravel. Silt overbank deposits may be locally present in other

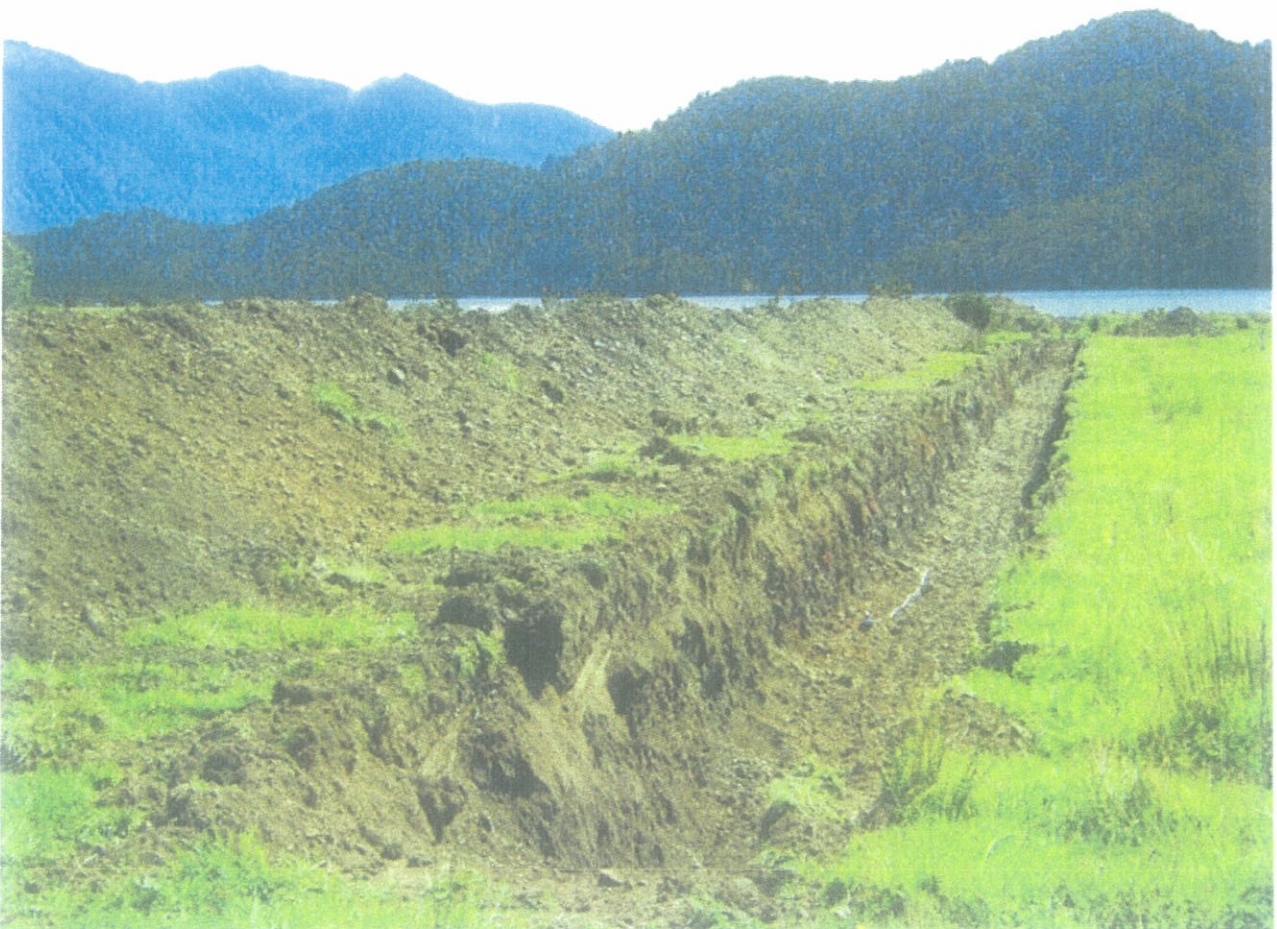
Figure A2: View along Trench C looking north-west towards Lake Poerua, with excavation to typical depth of 2m over distance of ~100m. Note absence of groundwater in trench.

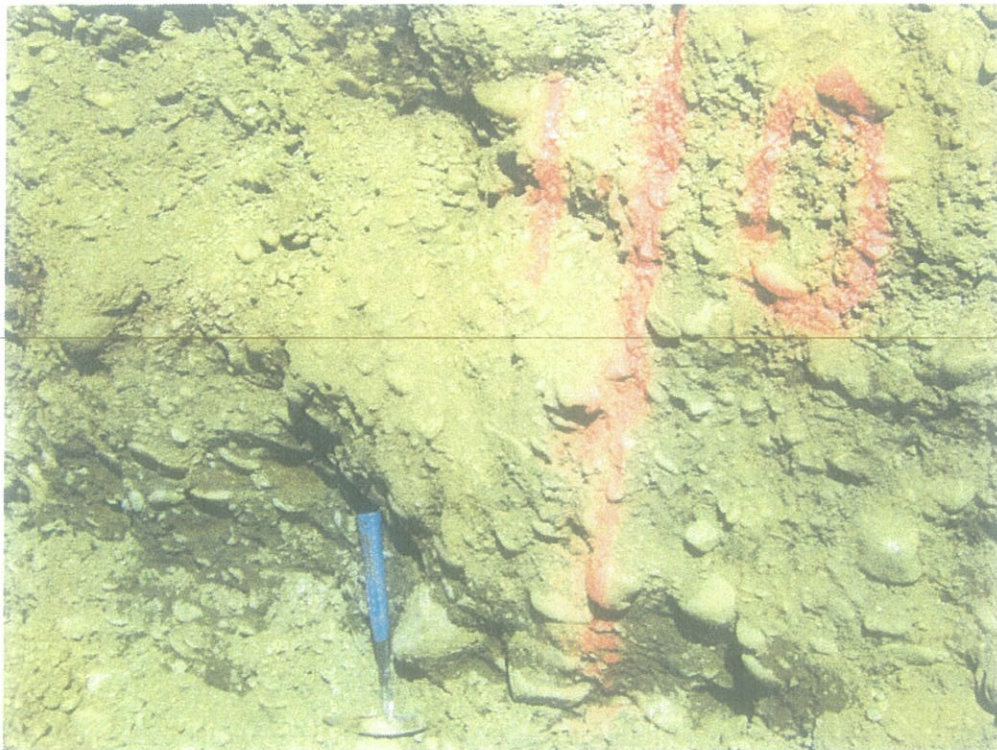
Figure A3: Compact Taramakau-derived sandy gravels at 10m in Trench A. Upper part of exposure in photo shows lense of loose gravel to about 400mm in thickness.

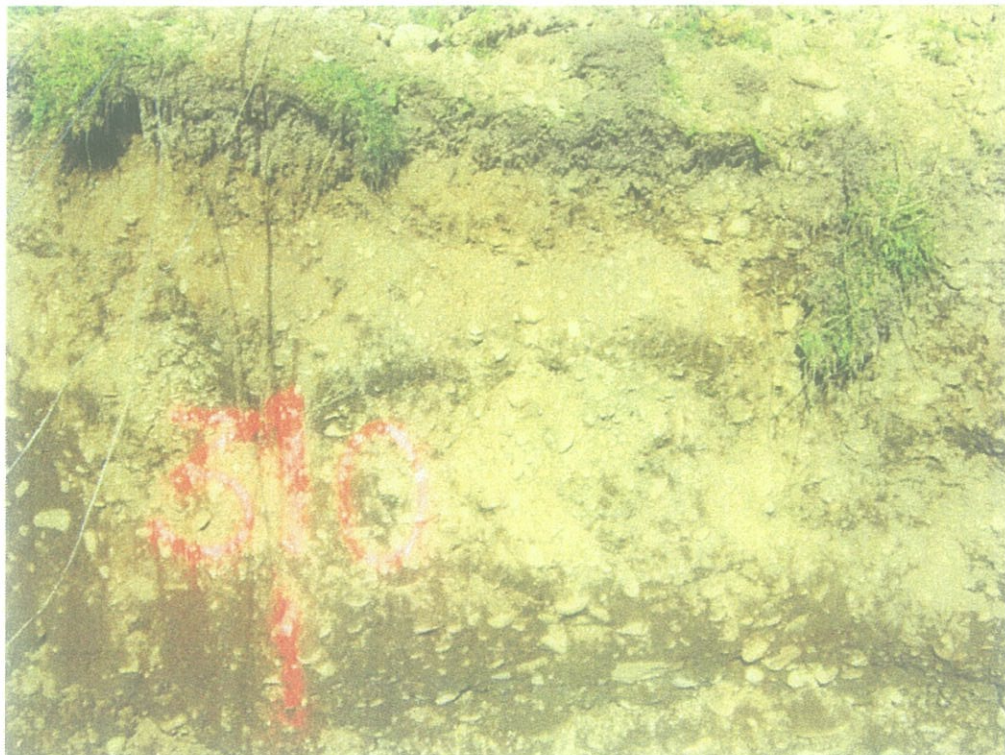
Figure A4: Compact brown slightly weathered sandy gravels at 30m in Trench A. Sediments locally bedded at this location, with suggestion of deposition as delta into body of water.

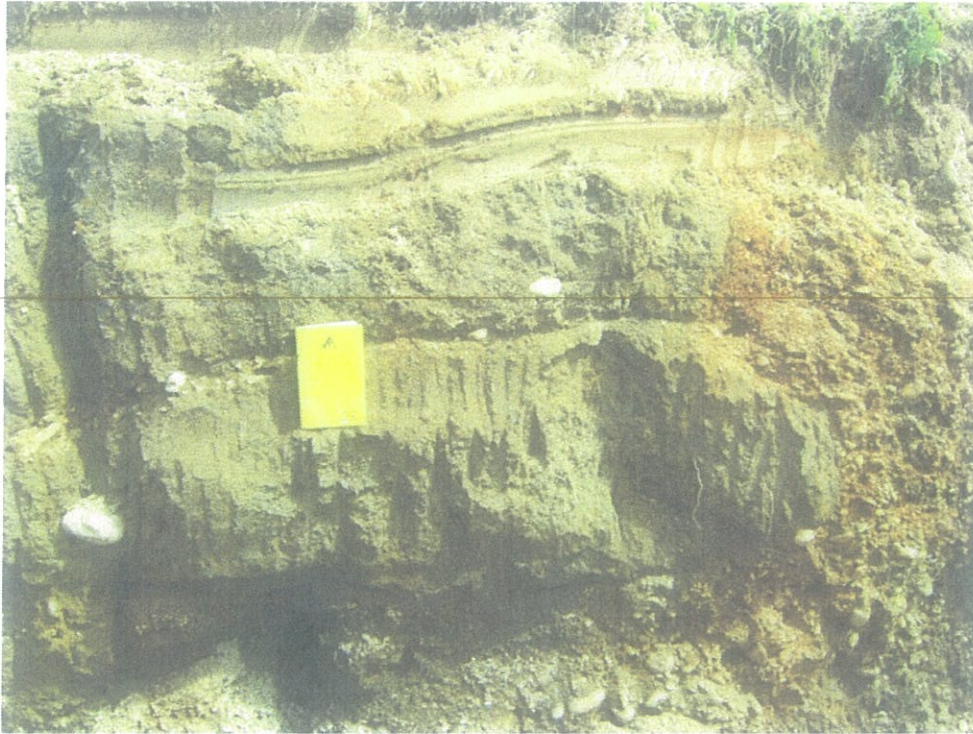
Figure A5: Western swamp margin at about 60m in Trench A, showing clayey silt lenses partially enveloped by gravels. Contacts definitely sedimentary and erosional/depositional.

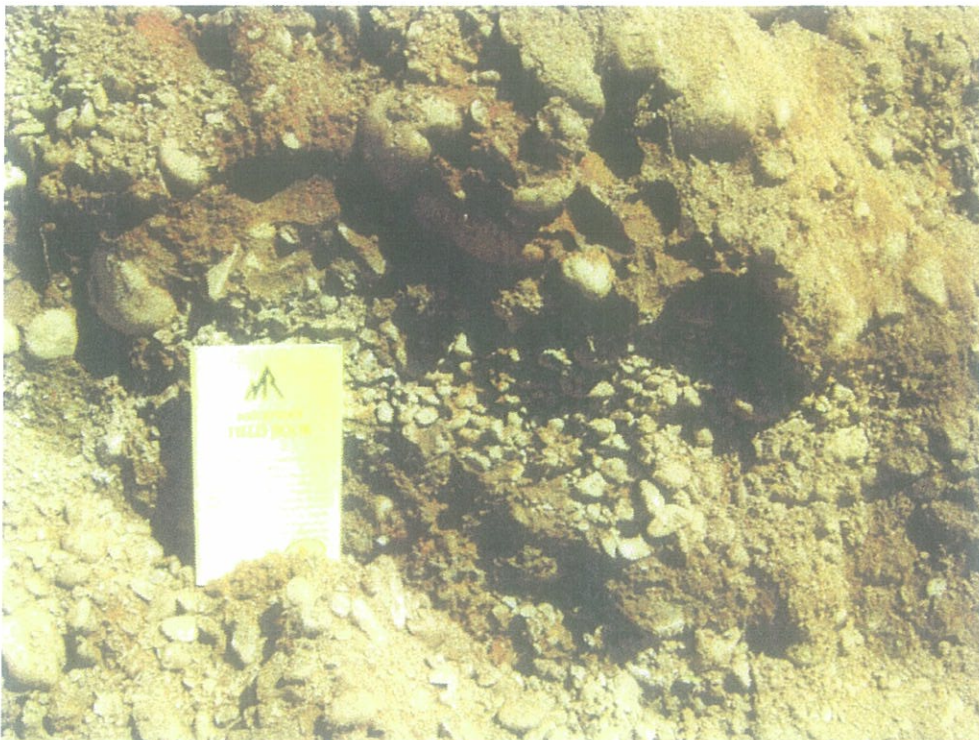
Figure A6: Compact brown gravels at about 60m in Trench A, adjacent to western swamp margin. Iron oxides attributed to permeability barrier formed by adjacent clayey silts.

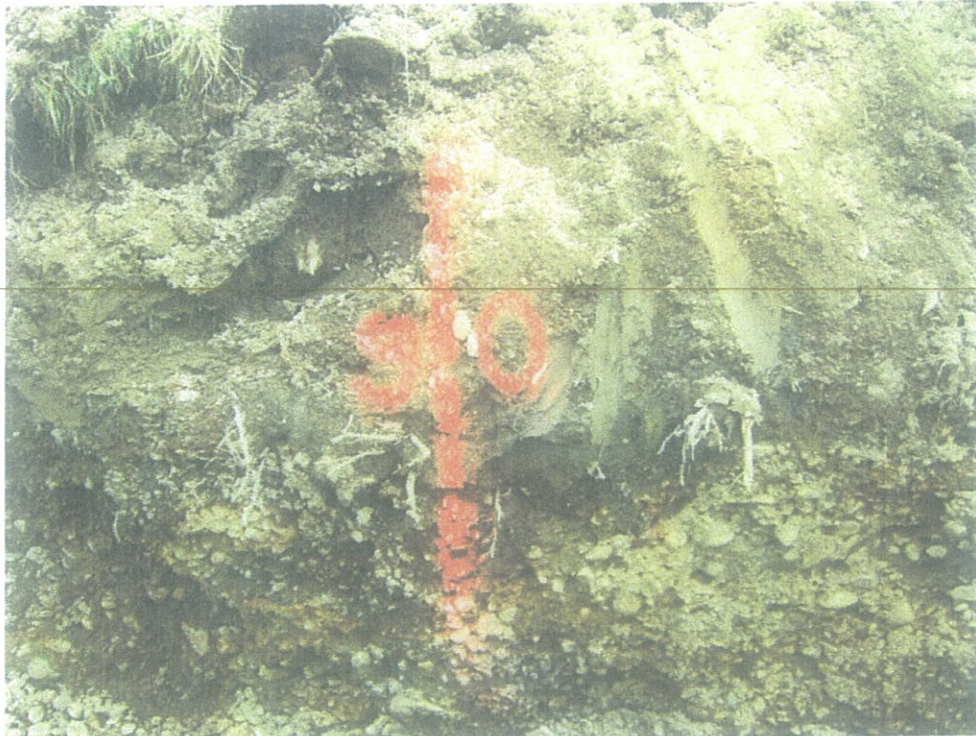
Figure A7: Organic-rich grey clayey silts at 90m in Trench A showing numerous rootlets. Interpreted as overbank swamp deposits overlying Taramakau-derived sandy gravels.

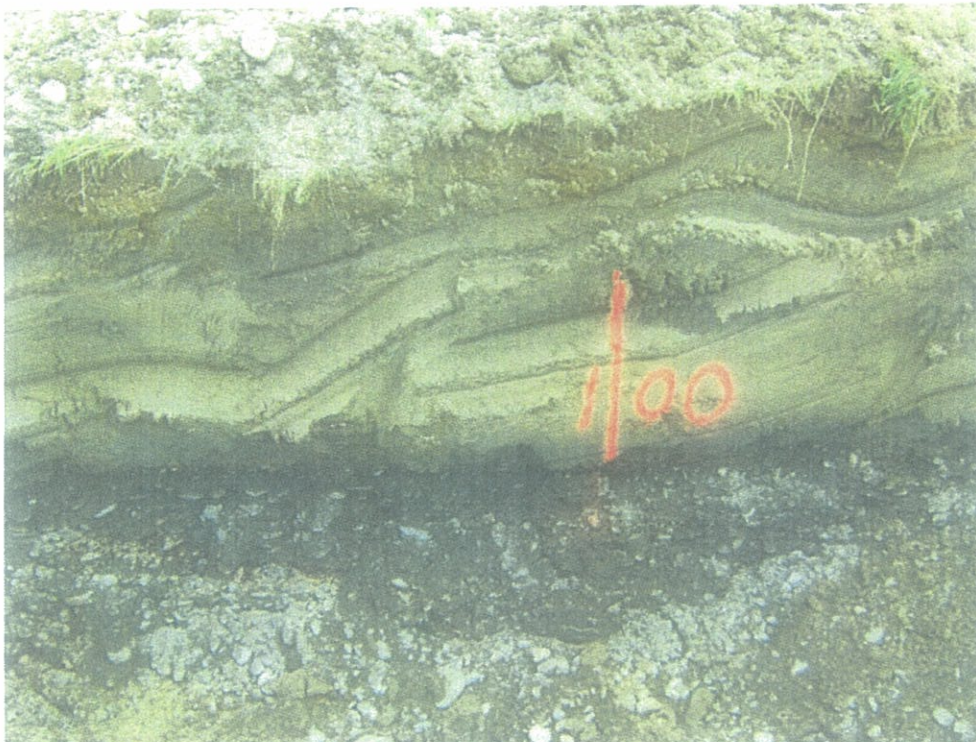
Figure A8: Soft grey clayey silts overlying loose sandy gravels at 100m in Trench B.

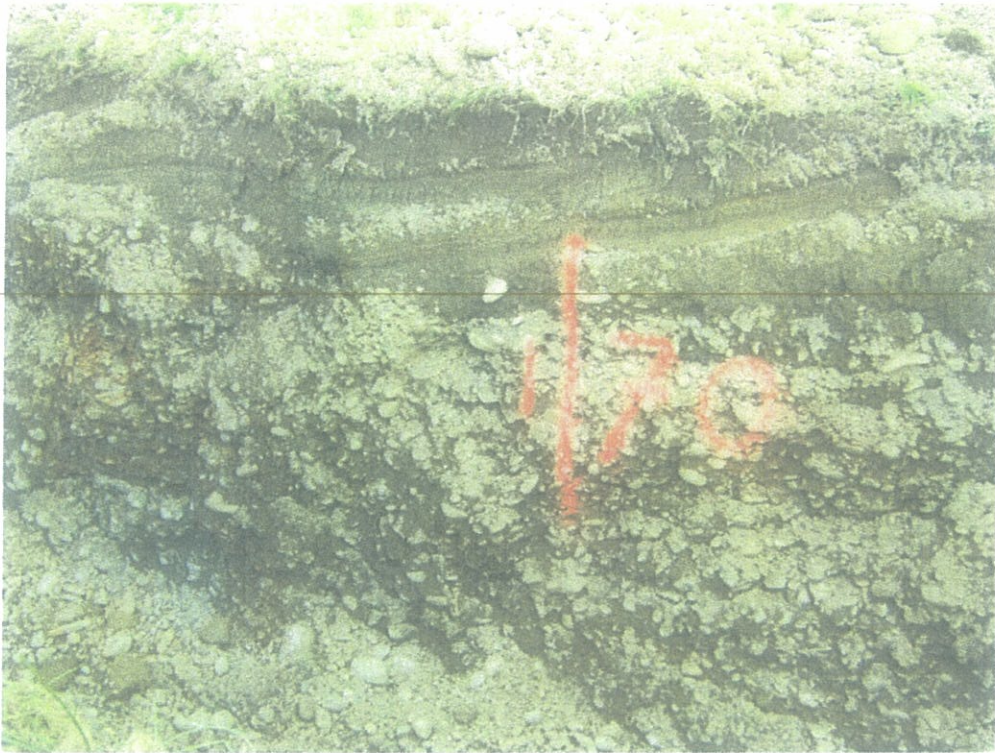
Figure A9: Grey clayey silt "overbank swamp" deposits overlying compact sandy gravels at 170m in Trench C. Eastern margin of "swamp" deposits is located at 178m.

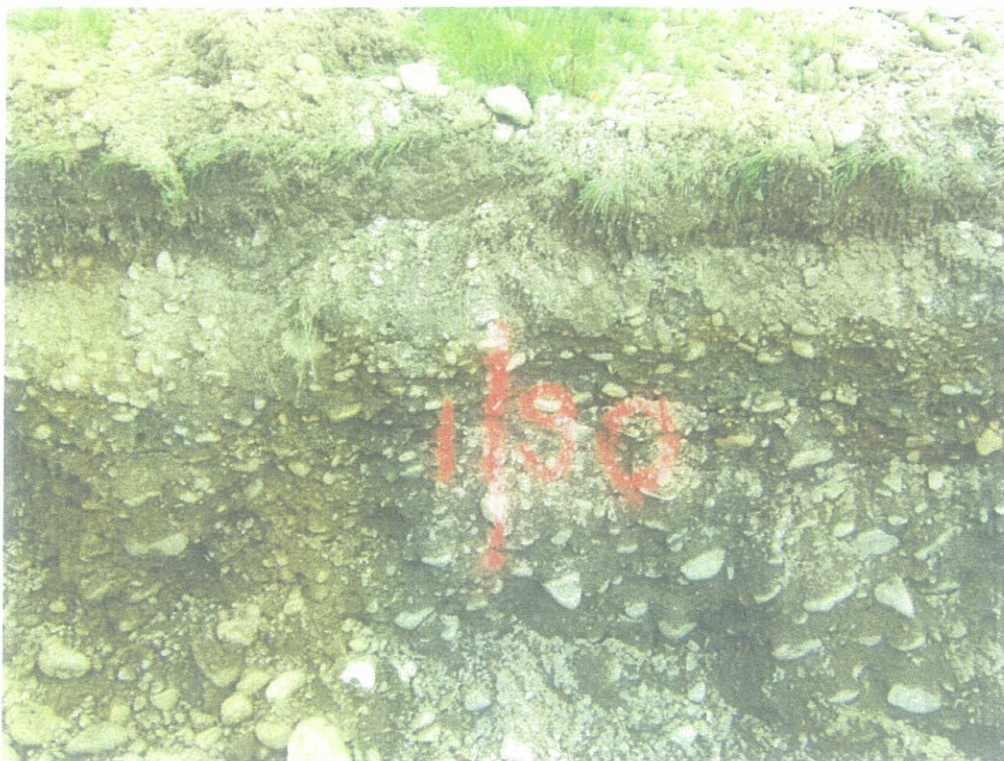
Figure A10: Compact grey Taramakau-derived sandy gravels at 190m in Trench C.

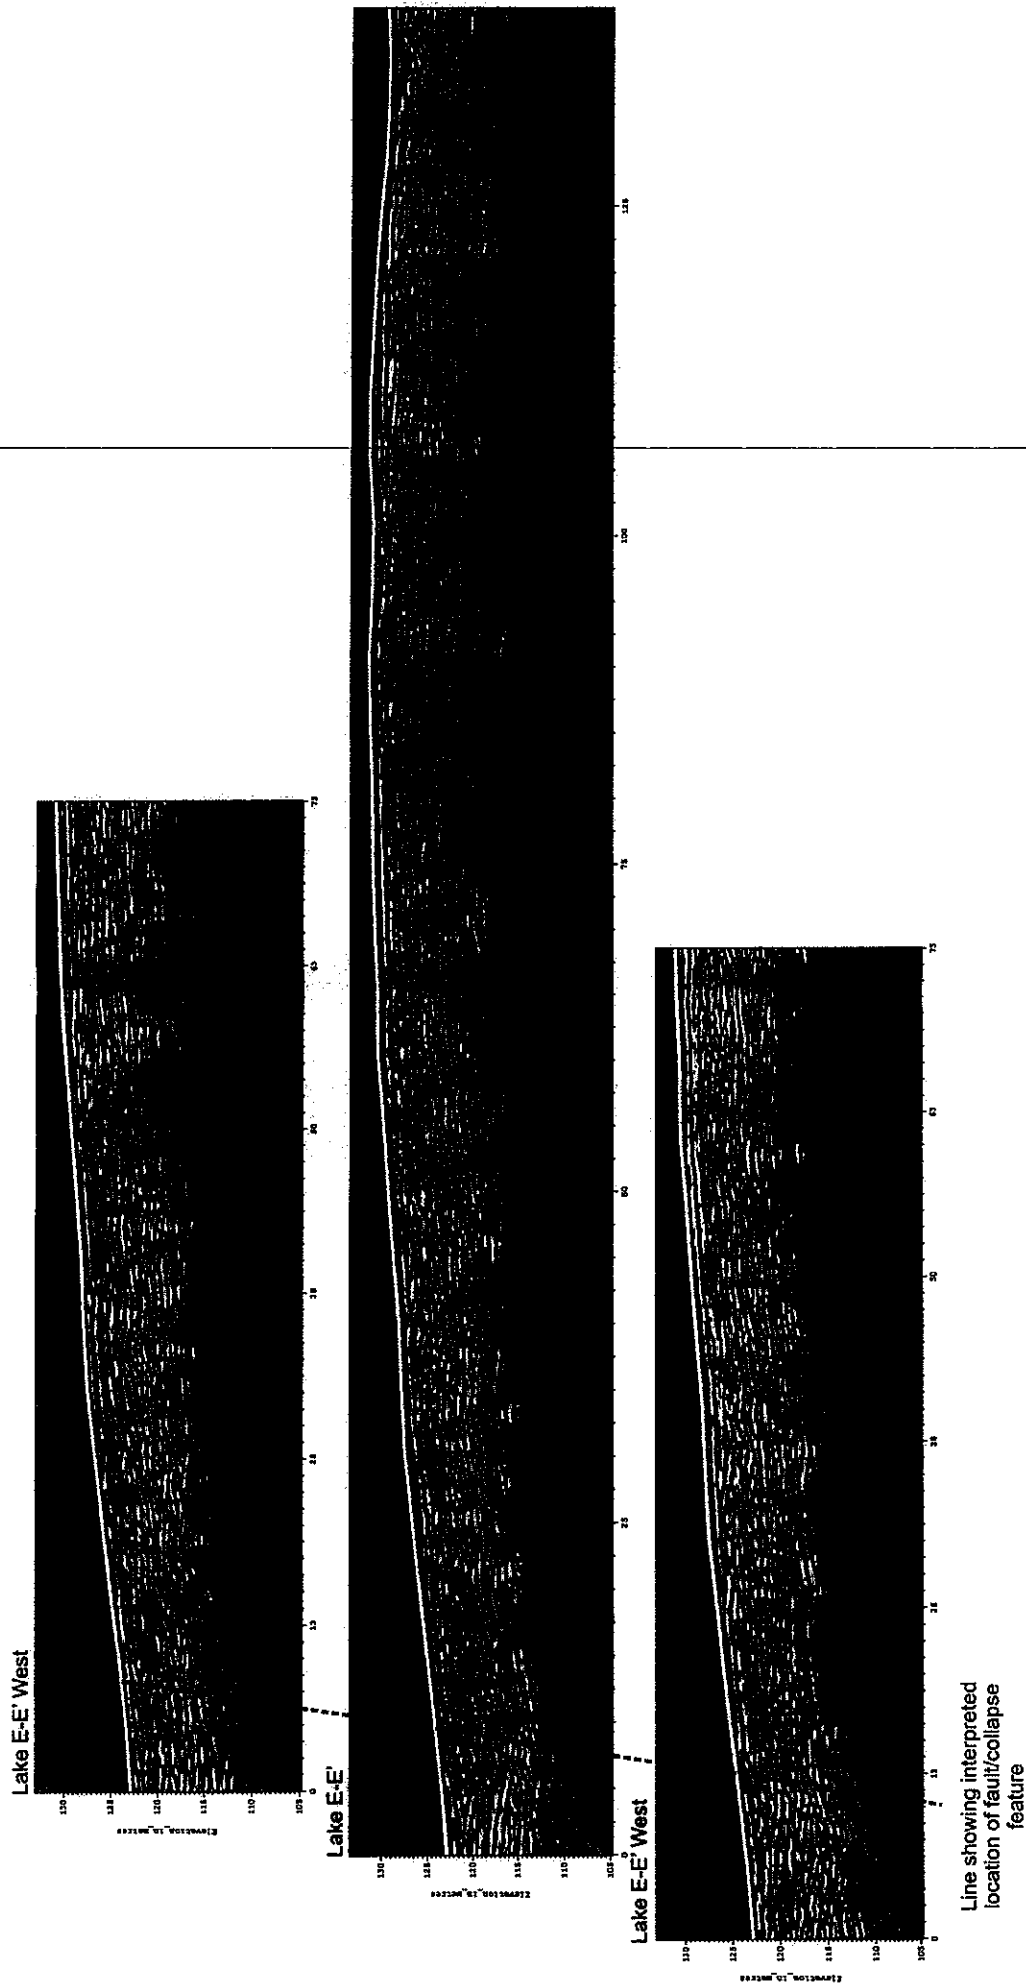
Line showing interpreted location of fault/collapse feature
