**Review of Proposed Lake Poerua Subdivision,
Grey District**

**GNS Science Consultancy Report 2006/221
6 December 2006**

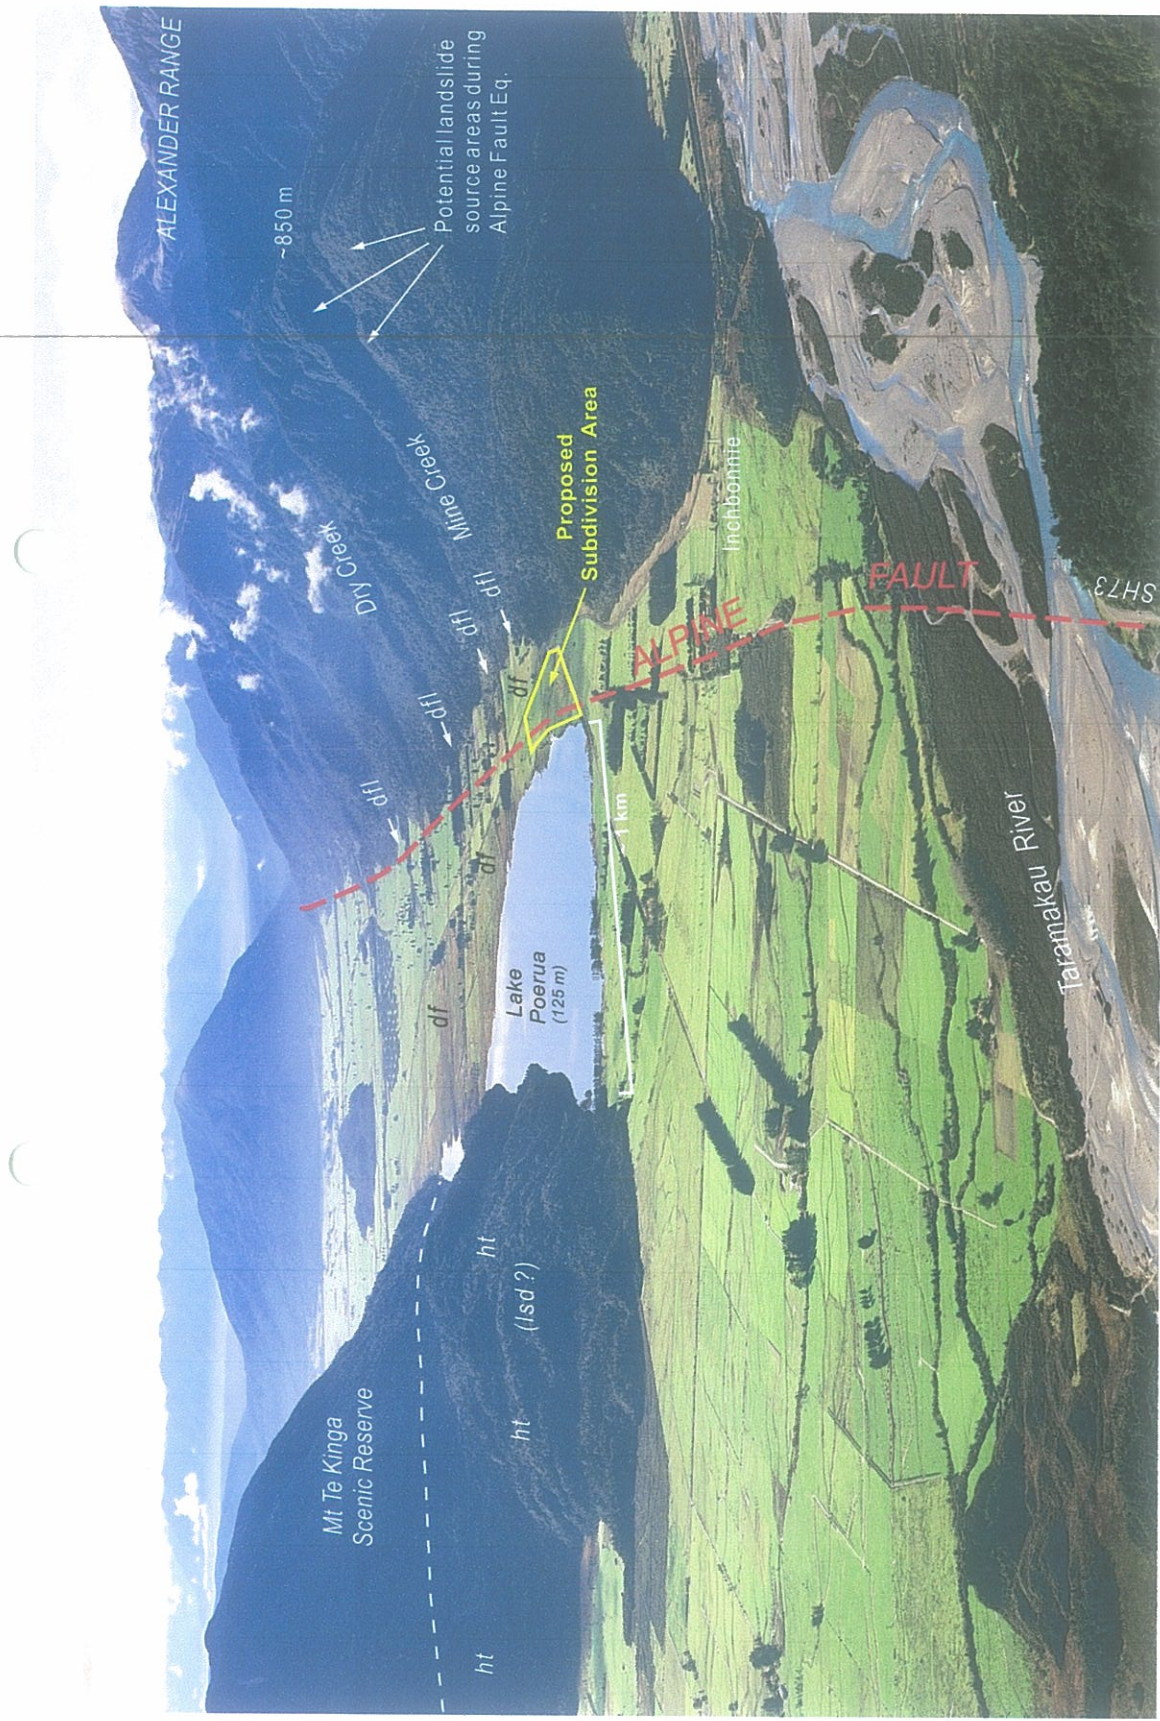
Figure 1 Aerial view looking northeast showing the proposed Lake Poerua subdivision area, and the generalised location of the Alpine Fault where it cuts across the Taramakau Valley and heads northeast past Lake Poerua and along the foot of the Alexander Range (Nathan et al. 2002), where it is largely obscured by debris fans (df) deposited since the last Alpine Fault earthquake about 300 years ago. Possible source areas of large landslides at the head of Mine Creek, and possible and debris flow paths (dff) are also shown. The hummocky terrain (ht) to the north of Lake Poerua could be ice smoothed granite, but may also be the debris of a very large (c.5 km²) prehistoric landslide collapse feature on the southwest side of Mt Te Kinga (the Nathan et al. 2002 geological map shows a large landslide feature in this area out of picture to the left).

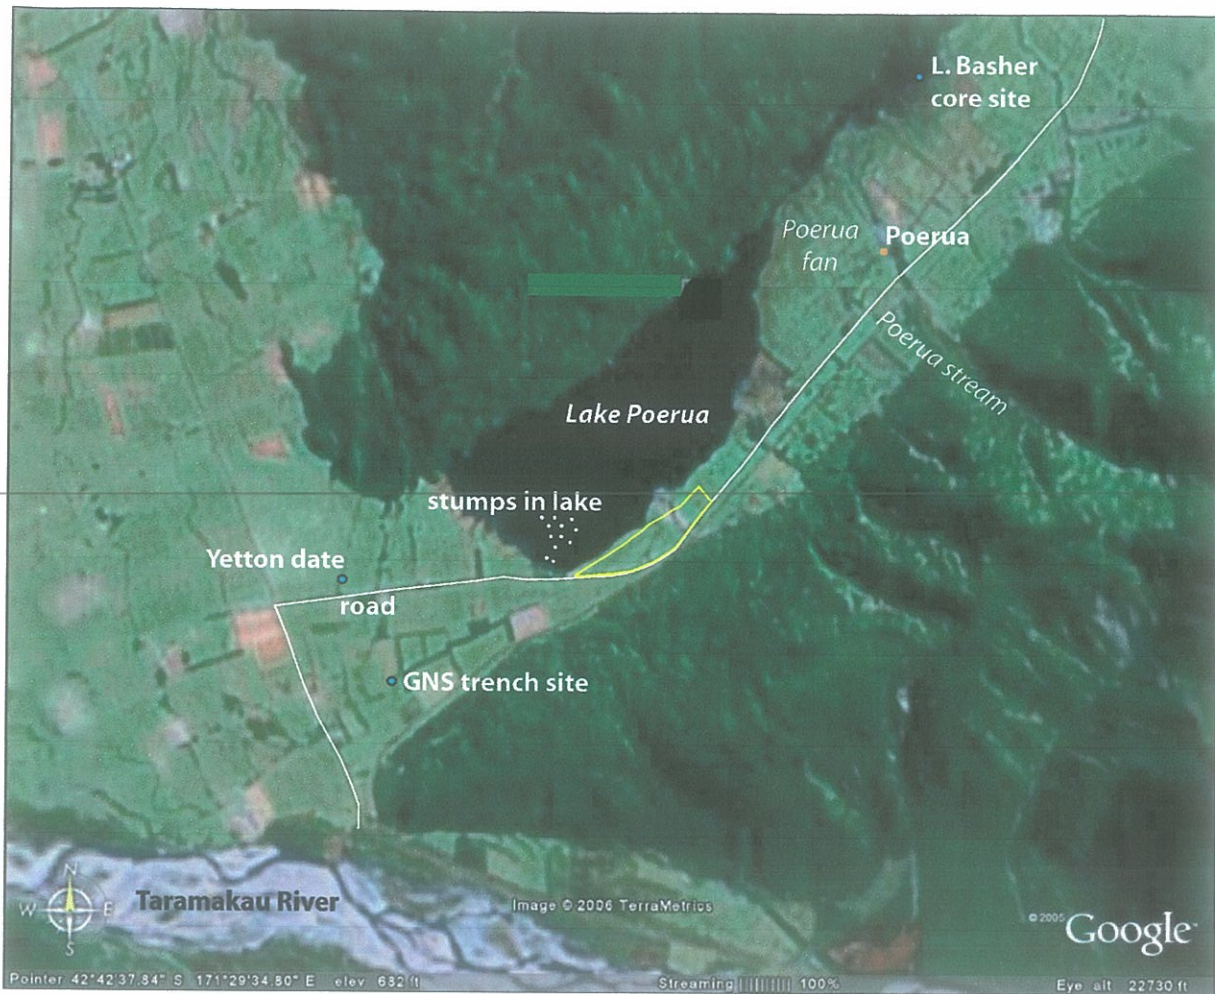
Figure 2 Satellite image view of the Inchbonnie-Lake Poerua area with key sites used for geomorphic interpretation of fault activity described in text. The area of the proposed subdivision shown in yellow. The Alpine Fault is not mapped on this image, but was trenched at the GNS site at Harris farm. Field boundaries W and NE of this site mark the approximate location of the fault.

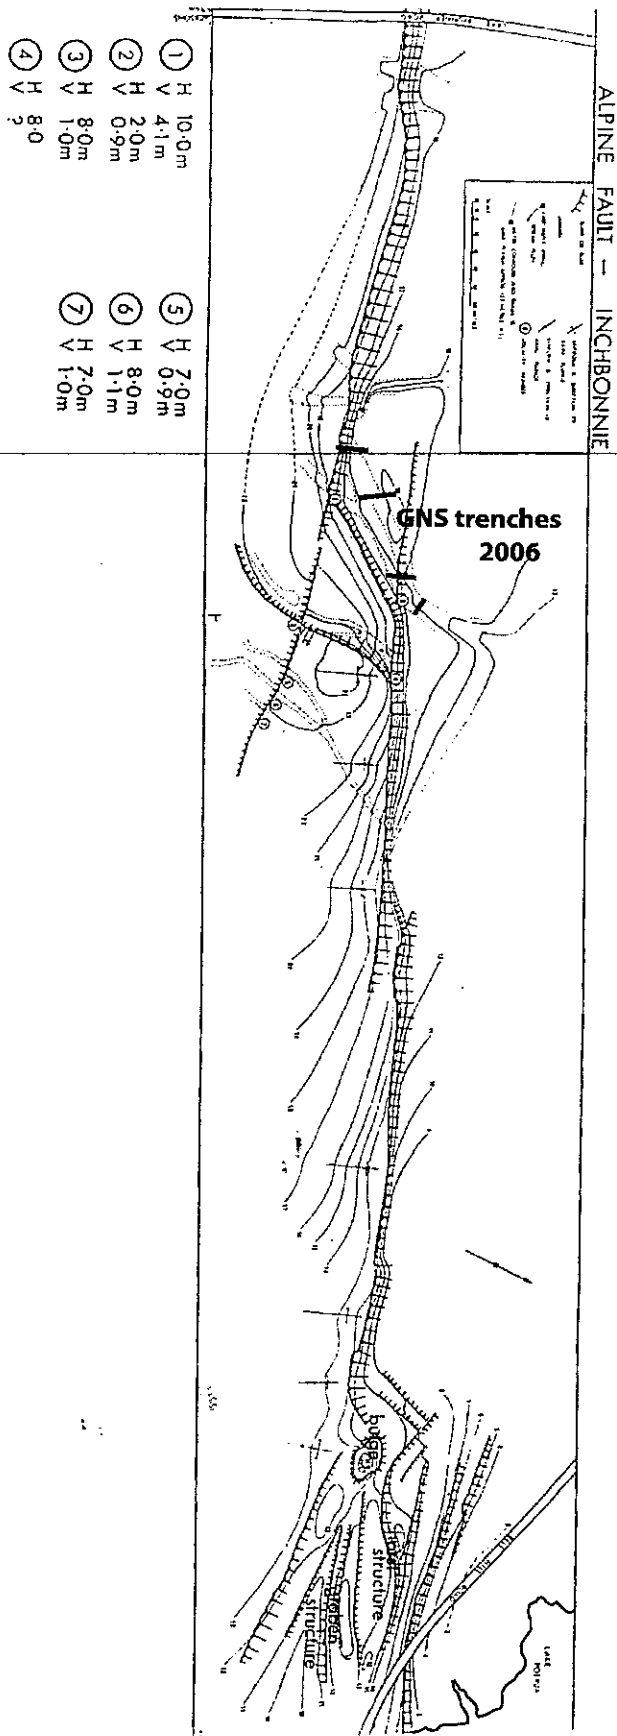
Figure 3 Scan of Berryman (1975) active trace map of the Alpine Fault at Inchbonnie. Figure has been reduced in size and rotated from original view. North, and Lake Poerua, are toward lower right corner. Note the detail of active fault traces mapped at the GNS trench site and near the SE corner of Lake Poerua.
