In the matter of a hearing on submissions on the proposed Te Tai Poutini Plan

Tauranga Bay Holdings Limited

Evidence of Philippe Dumont – Environmental Engineer

Preliminary Site Investigation (PSI)

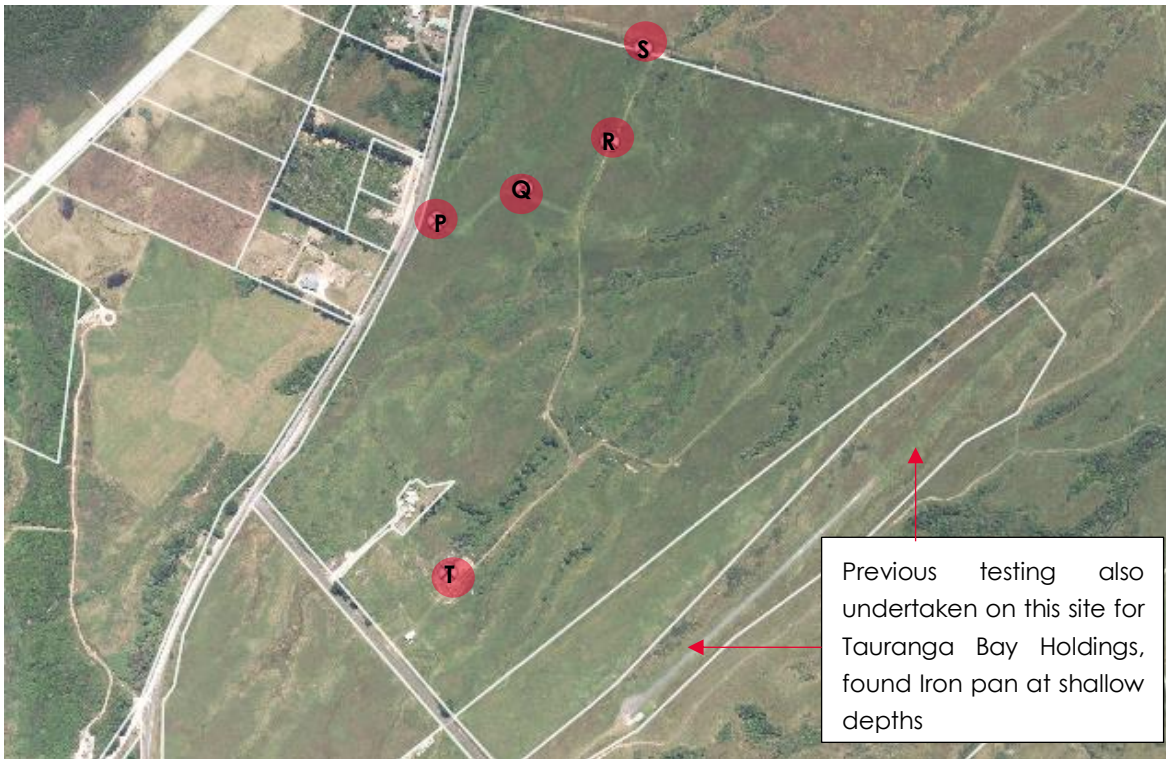
Figure 10. Additional test pits undertaken on 8th August 2022

On the 8th August 2022 a geotechnical site investigation was undertaken to support the application for a zone change, this investigation included a site walkover, five machine dug test pits and measurement of percolation rates in two of the test pits. Due to the nature of the previous investigation on Sec 41 SO 13711 and another investigation on Sec 39 SO 13711 also undertaken for Tauranga Bay Holdings, this broader investigation allowed us to make informed recommendations on the site for future rural residential use. The location of our test pits can be found in Figure 10, labelled P – T.

From our geotechnical investigation we confirm the presence of shallow iron pan underlies the site which was encountered at each of the fifteen locations investigated on Sec 41. Iron pan was also found at shallow depths for all 5 additional Test Pits. (P – T) The iron pan was encountered at depths ranging between 0.2m – 1.55m below the existing ground level. Under the iron pan layer was dense sand which can provide strong bearing capacity greater than “Good Ground” requirements as defined in NZS3604: 2011.

For each of the twenty areas we investigated; A – T, we recommend That foundations in accordance with NZS3604: 2011 be used. We do not recommend the use of driven timber piles because of the iron pan layer, which may stop the piles reaching the required minimum depth, plus Area J (test 12) did not meet the requirements for driven timber piles.

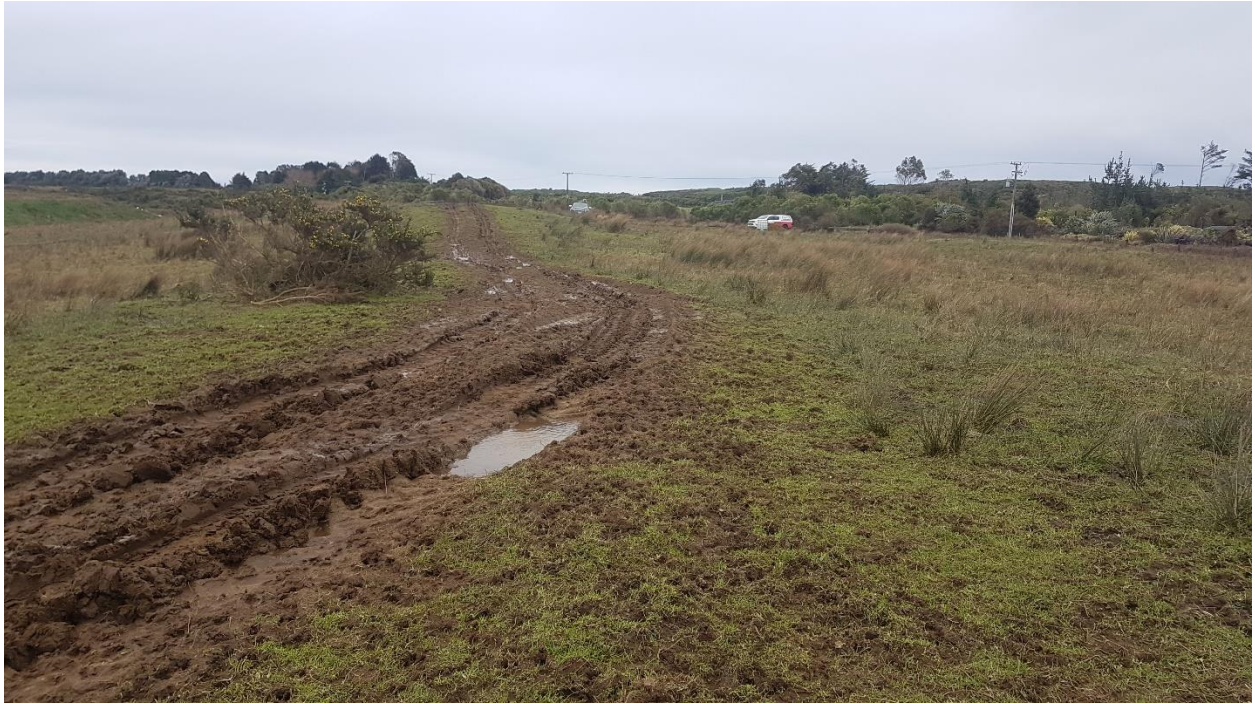
Figure 3. Photo showing typical ground conditions on site, these surface conditions are expected where shallow iron pan limits surface water from draining away

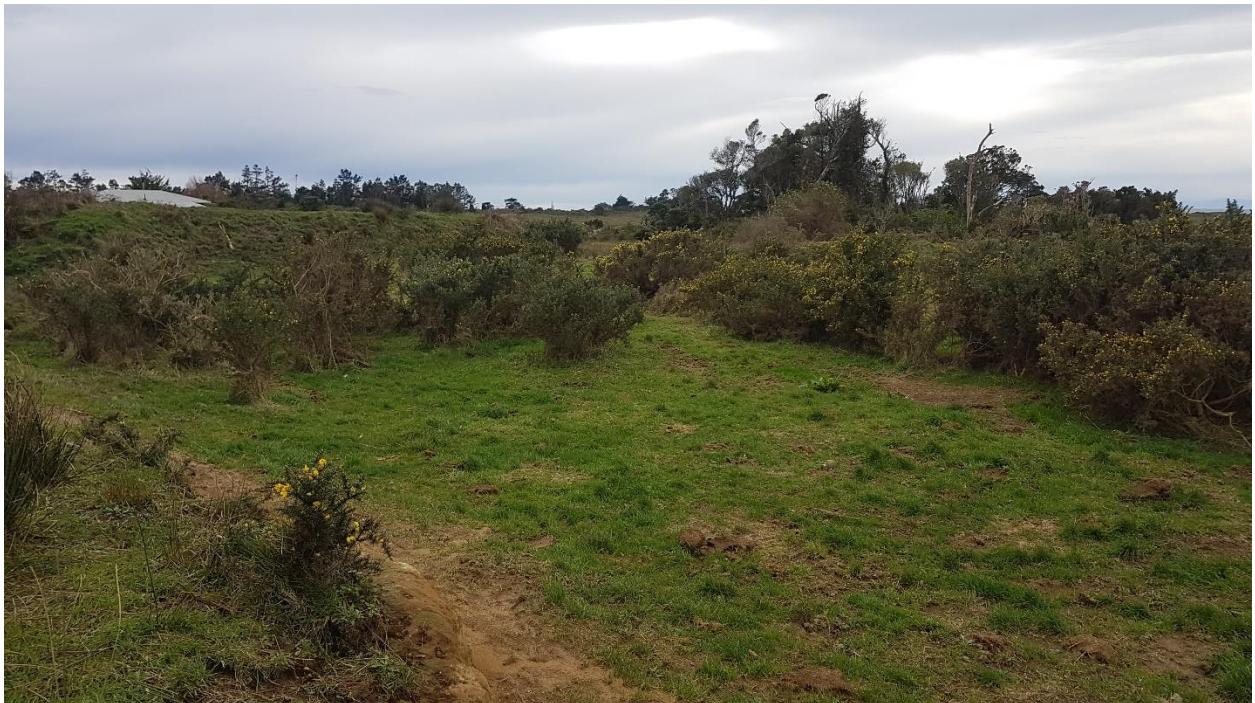
Figure 4. Photo showing surface conditions if topsoil and iron pan is removed, creating dry land suitable for residential use

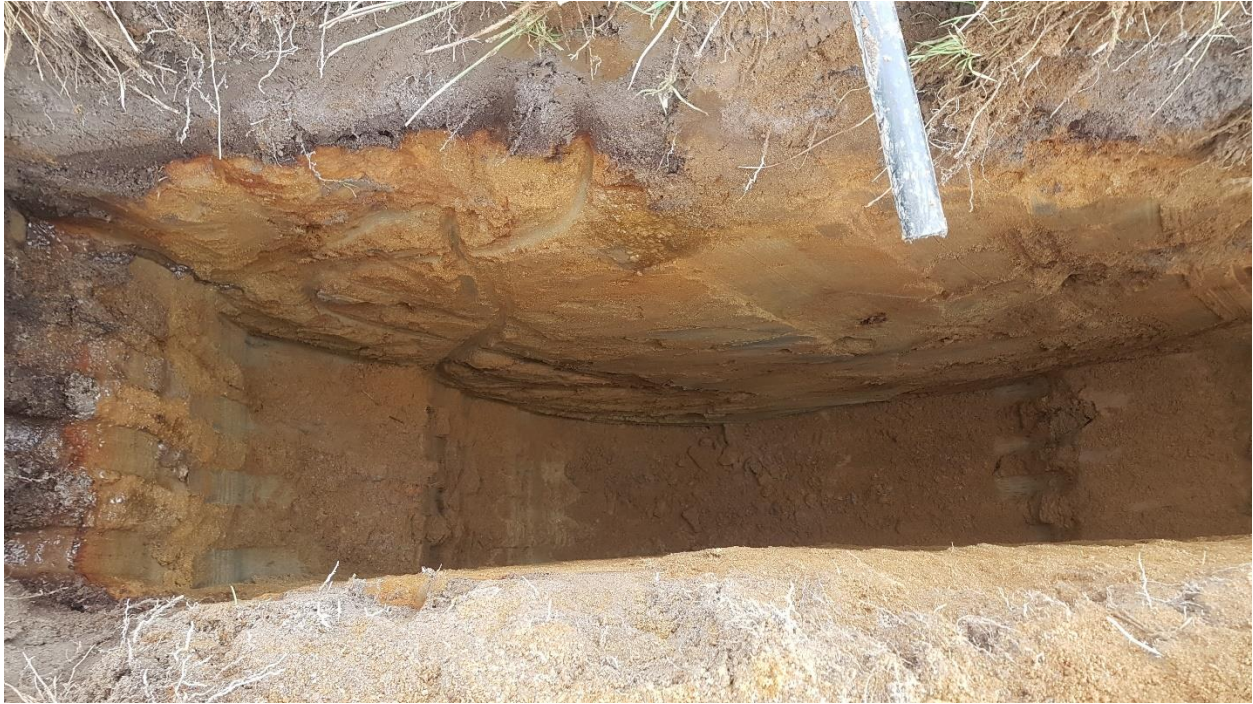
Figure 5. Photo of test pit at location P, underlying iron pan can be seen overlying sand

Where the iron pan was encountered within the top 600mm from the surface, we consider foundations which extend into the Good Ground we consider the iron pan layer be used. We anticipate this to be the case for areas B, C, D, F, G, H, I, L, M, N, O, P, Q and T.
