ENVIRONMENTAL MONITORING

RIVERBED AND COASTAL BEACH PROFILES

*Prepared by R Stocker
for the West Coast Regional Council*

WEST COAST REGIONAL COUNCIL

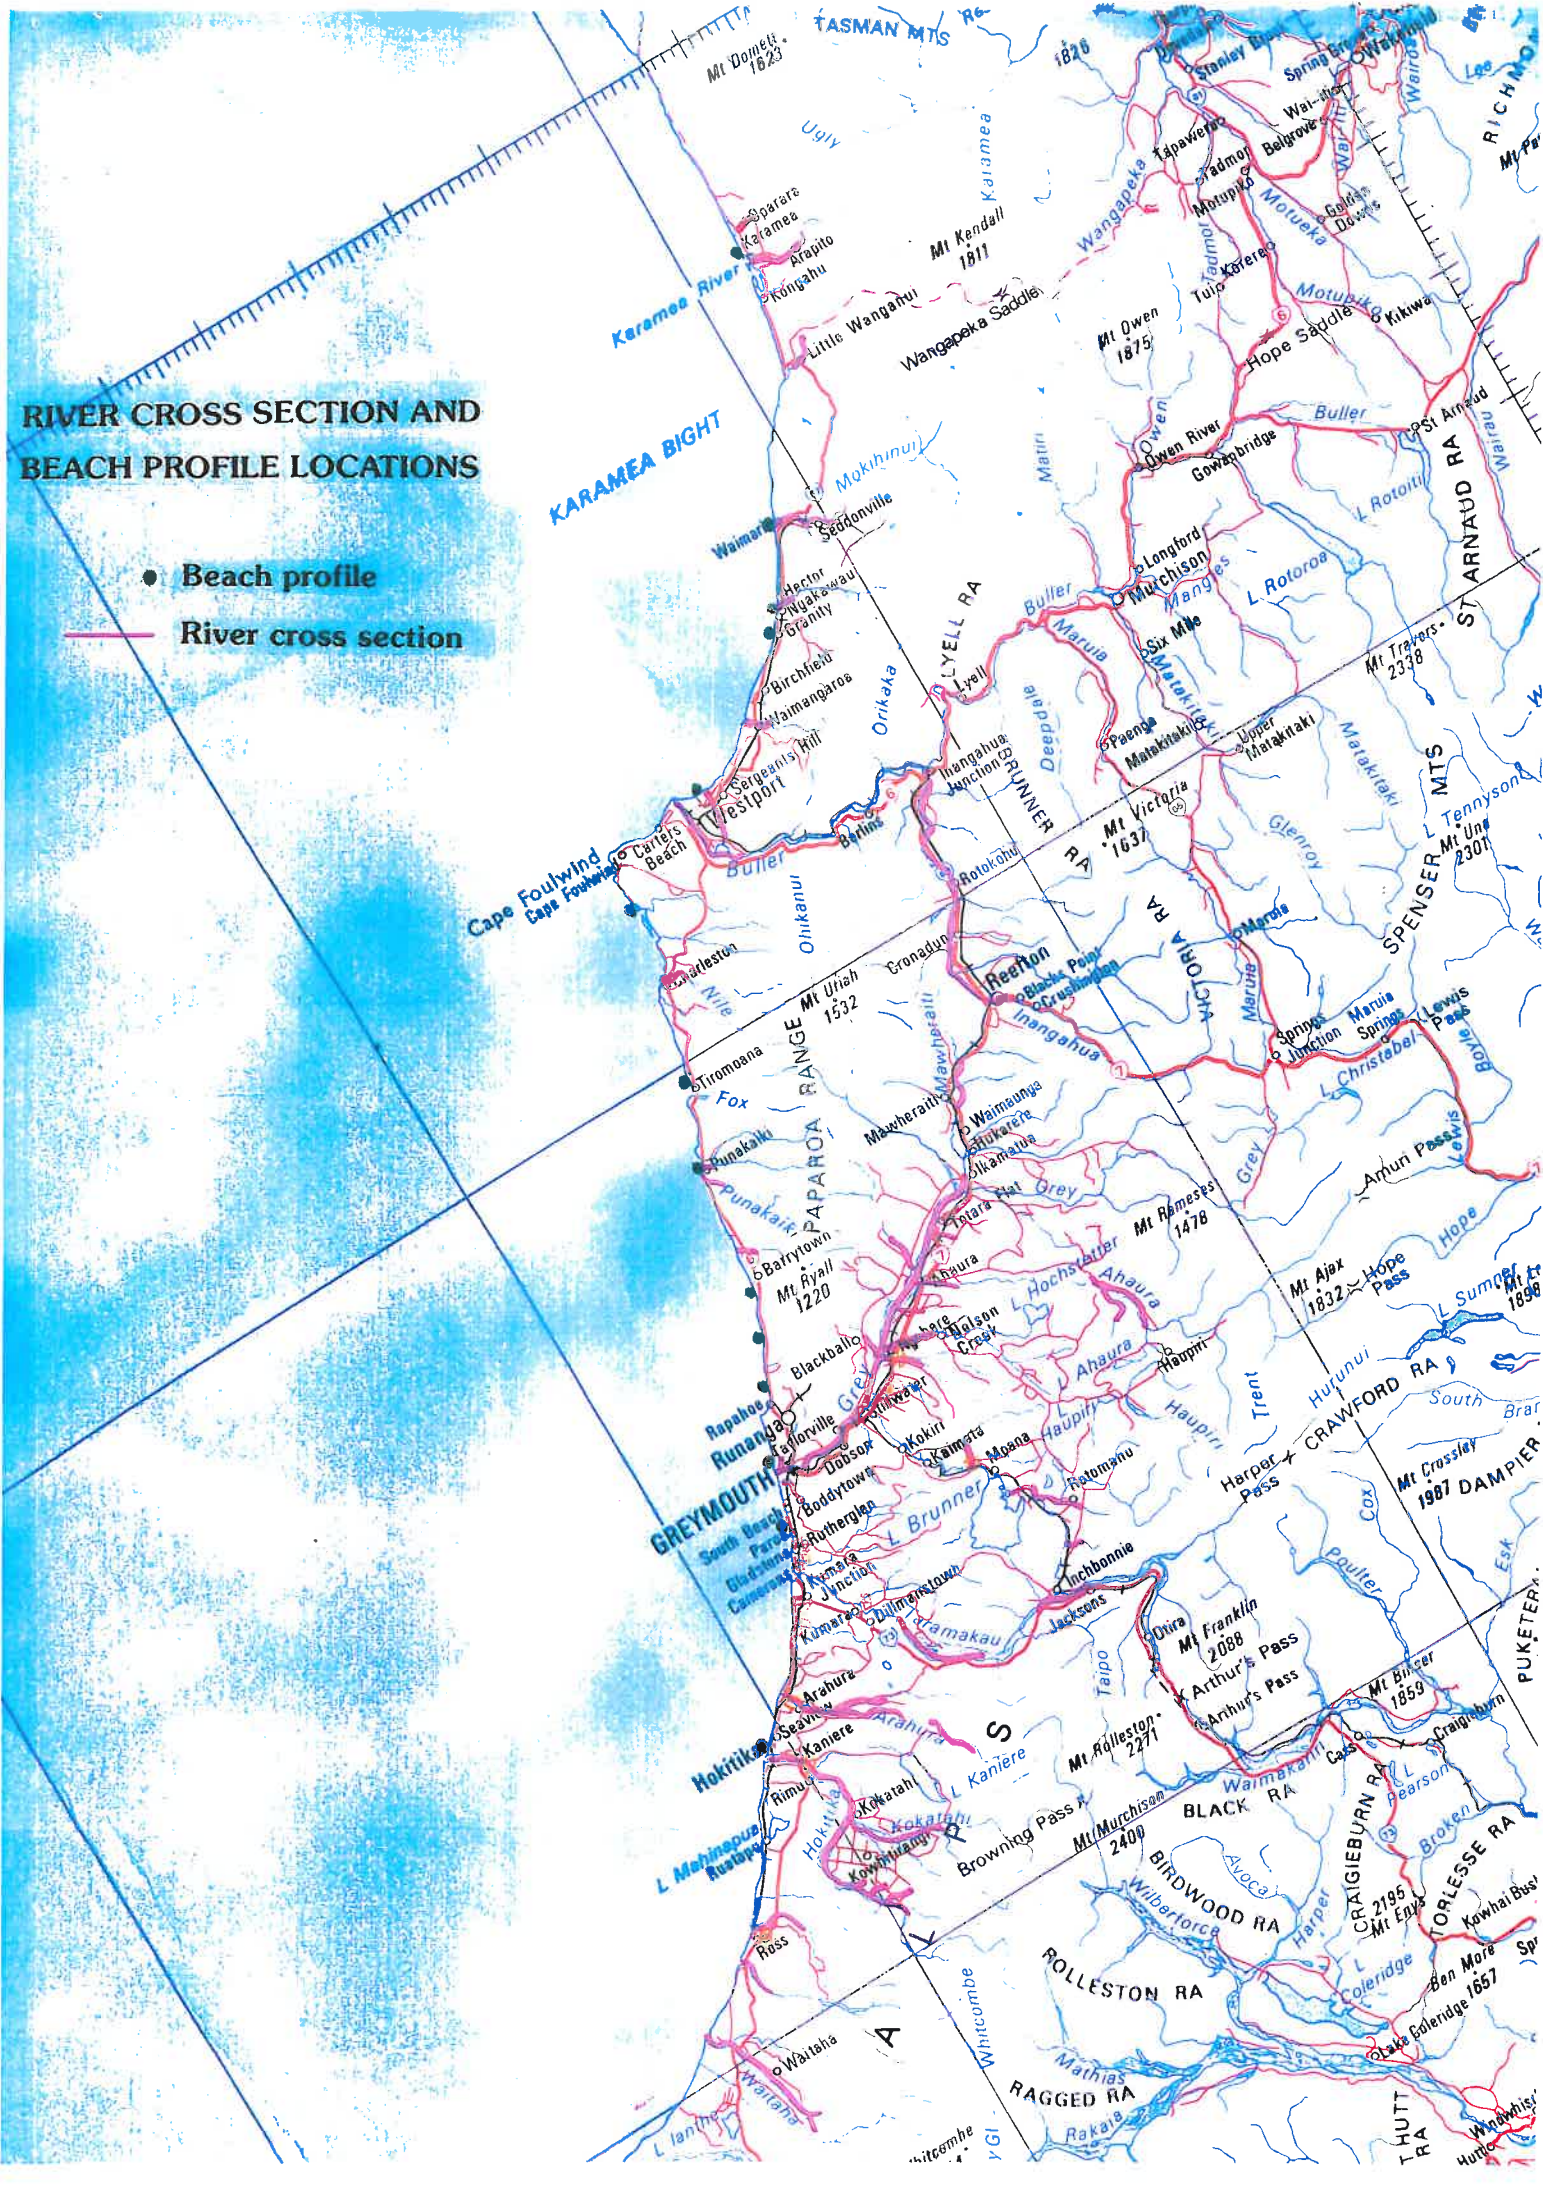
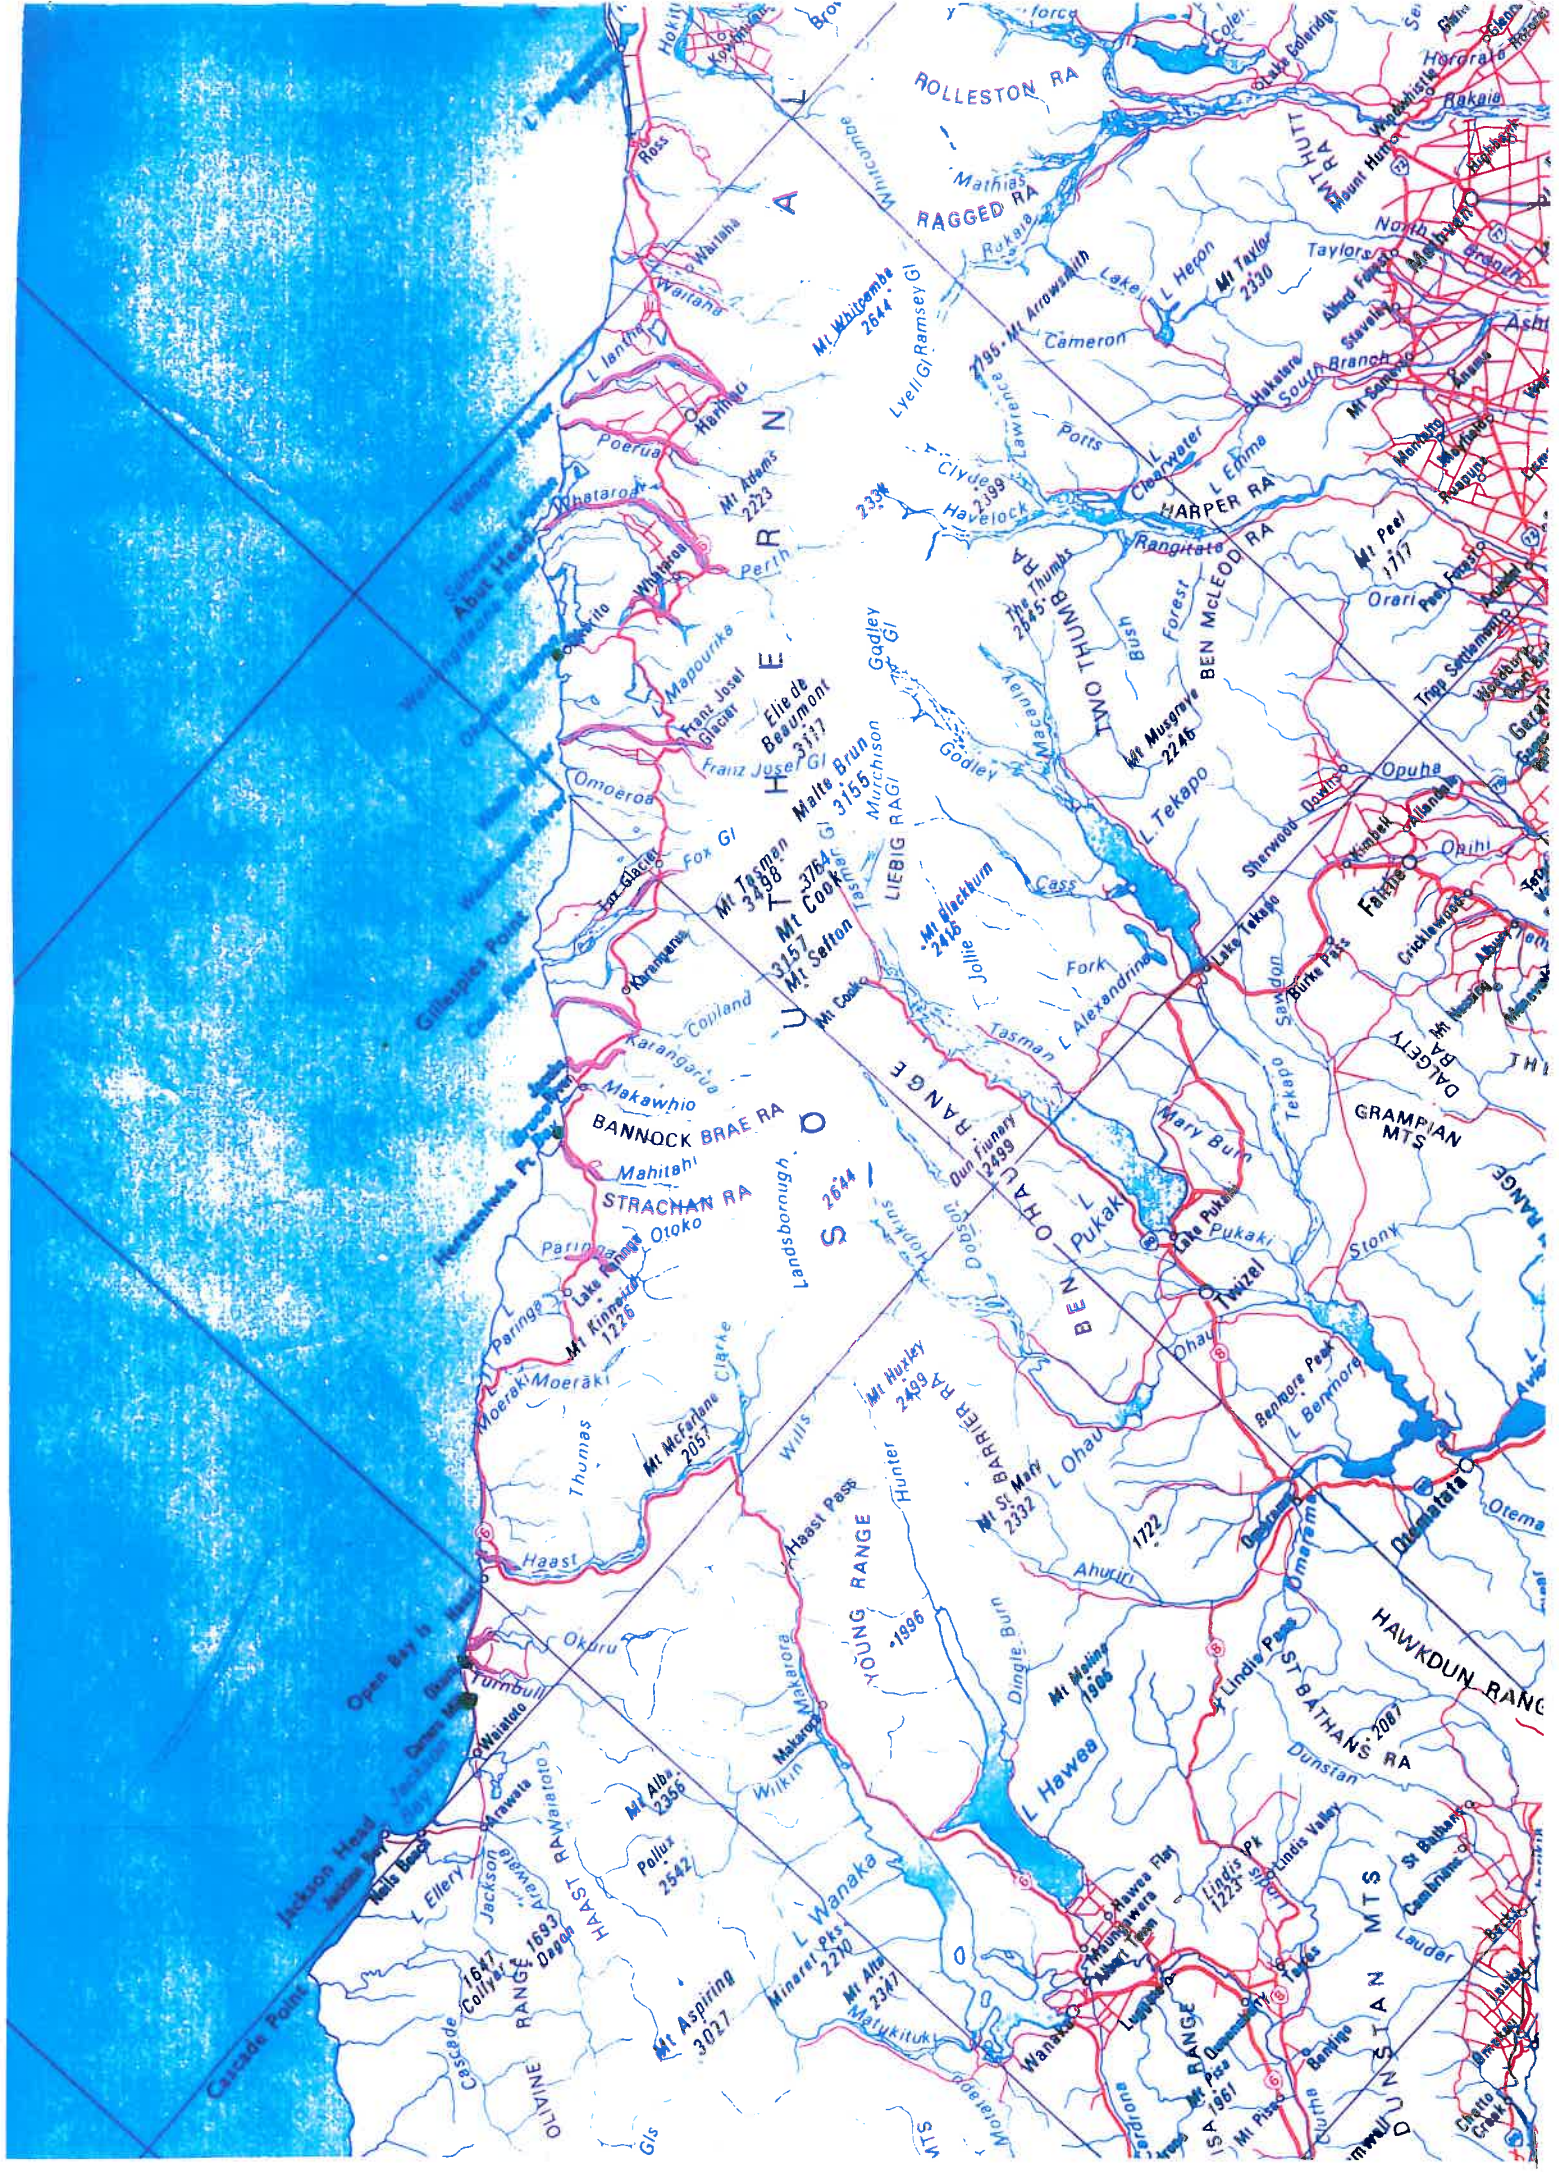
RIVER CROSS SECTION AND BEACH PROFILE LOCATIONS

- Beach profile
- River cross section
