# Review of West Coast Region Coastal Hazard Areas

*Prepared for West Coast Regional Council*

*February 2022*

NIWA CLIENT REPORT No: CHC2012-081  
Report date: February 2022  
NIWA Project: ELF12226, ELF16502, ELF21504

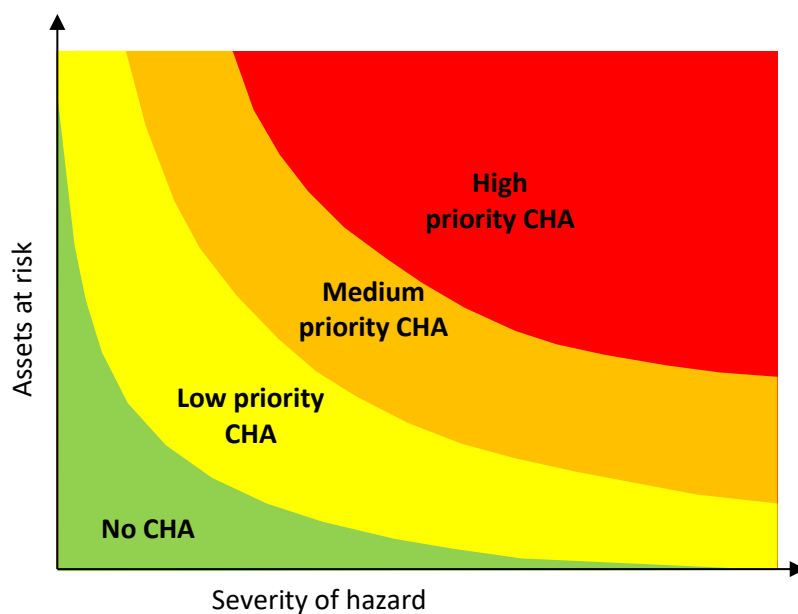
Figure 2-2: Schematic representing prioritisation process used in this report.

After mapping and recording the 'new' recommended CHAs, we applied a simple qualitative prioritisation of the hazard risk that they present (see Figure 2-1). This used 'expert opinion' to implement the simple definition that Hazard Process x Assets = Risk, or, in other words, the severity of hazard (likelihood) and the assets at risk (consequences) equal the risk. This prioritisation should be considered a 'first-pass' at identifying high, medium and low priority CHAs. The focus is on identifying high risk areas (NZCPS Policy 24) to allow for appropriate management of high risk areas and communities.

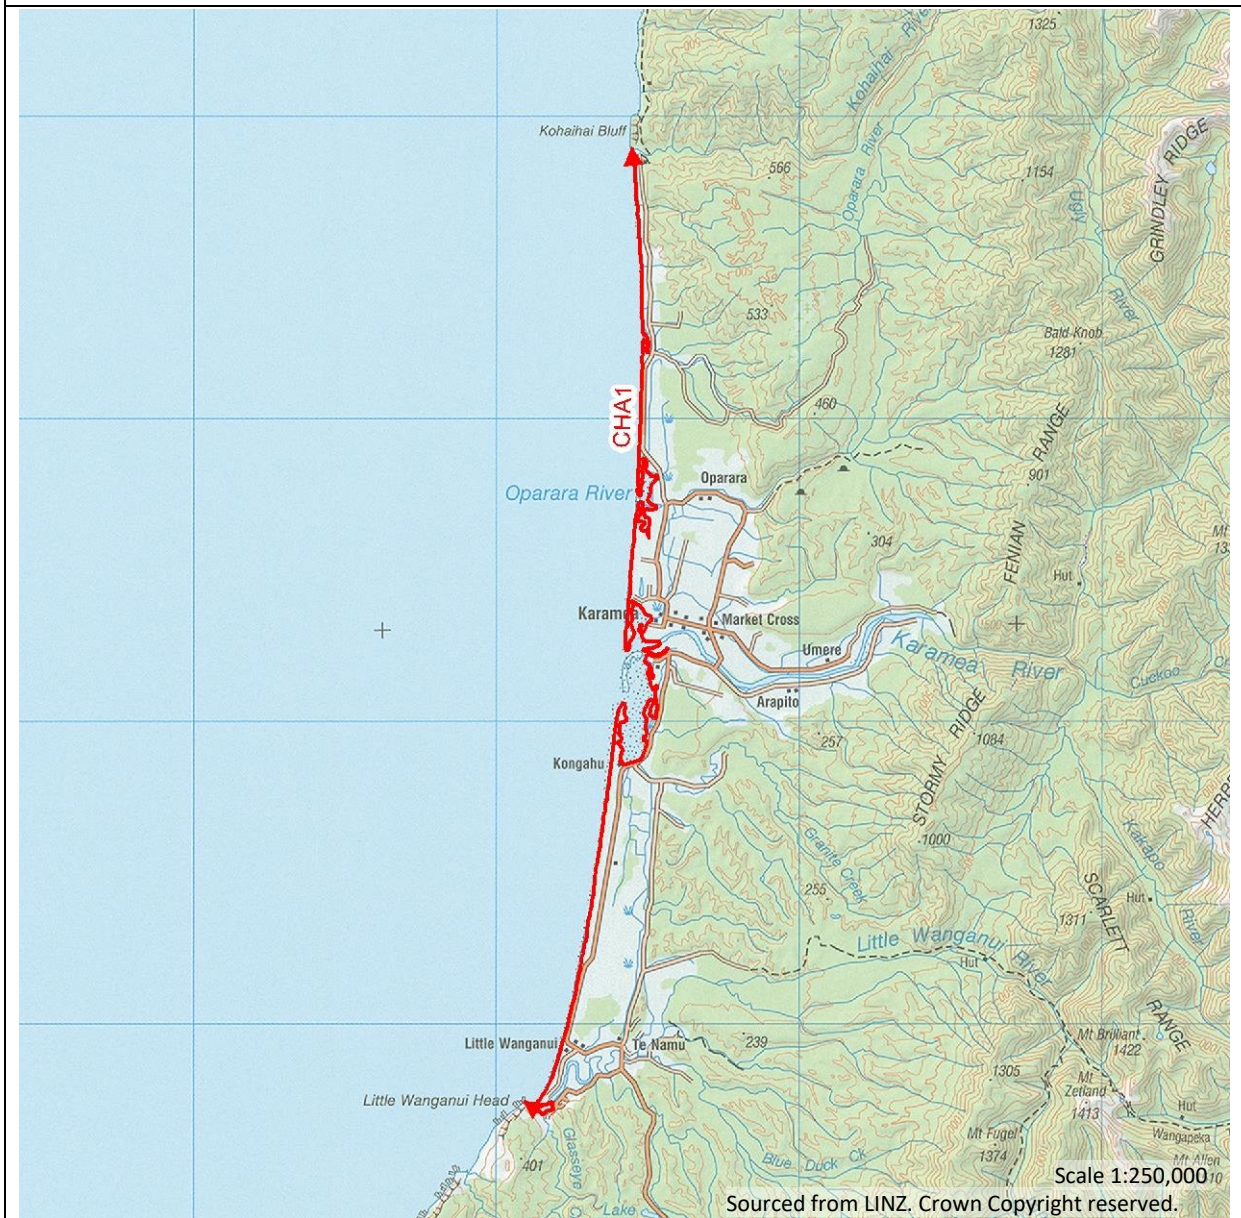
CHA1 extends from Kohaihai Bluff (**BP22 244 489**, 1524460mE, 5448930mN) to Little Wanganui Head (**BQ22 208 174**, 1520890mE 5417460mN). It includes the Break Creek mouth, Oparara River mouth and Estuary, the Karamea River mouth and the Karamea/Otumahana Estuary, and the Little Wanganui River.

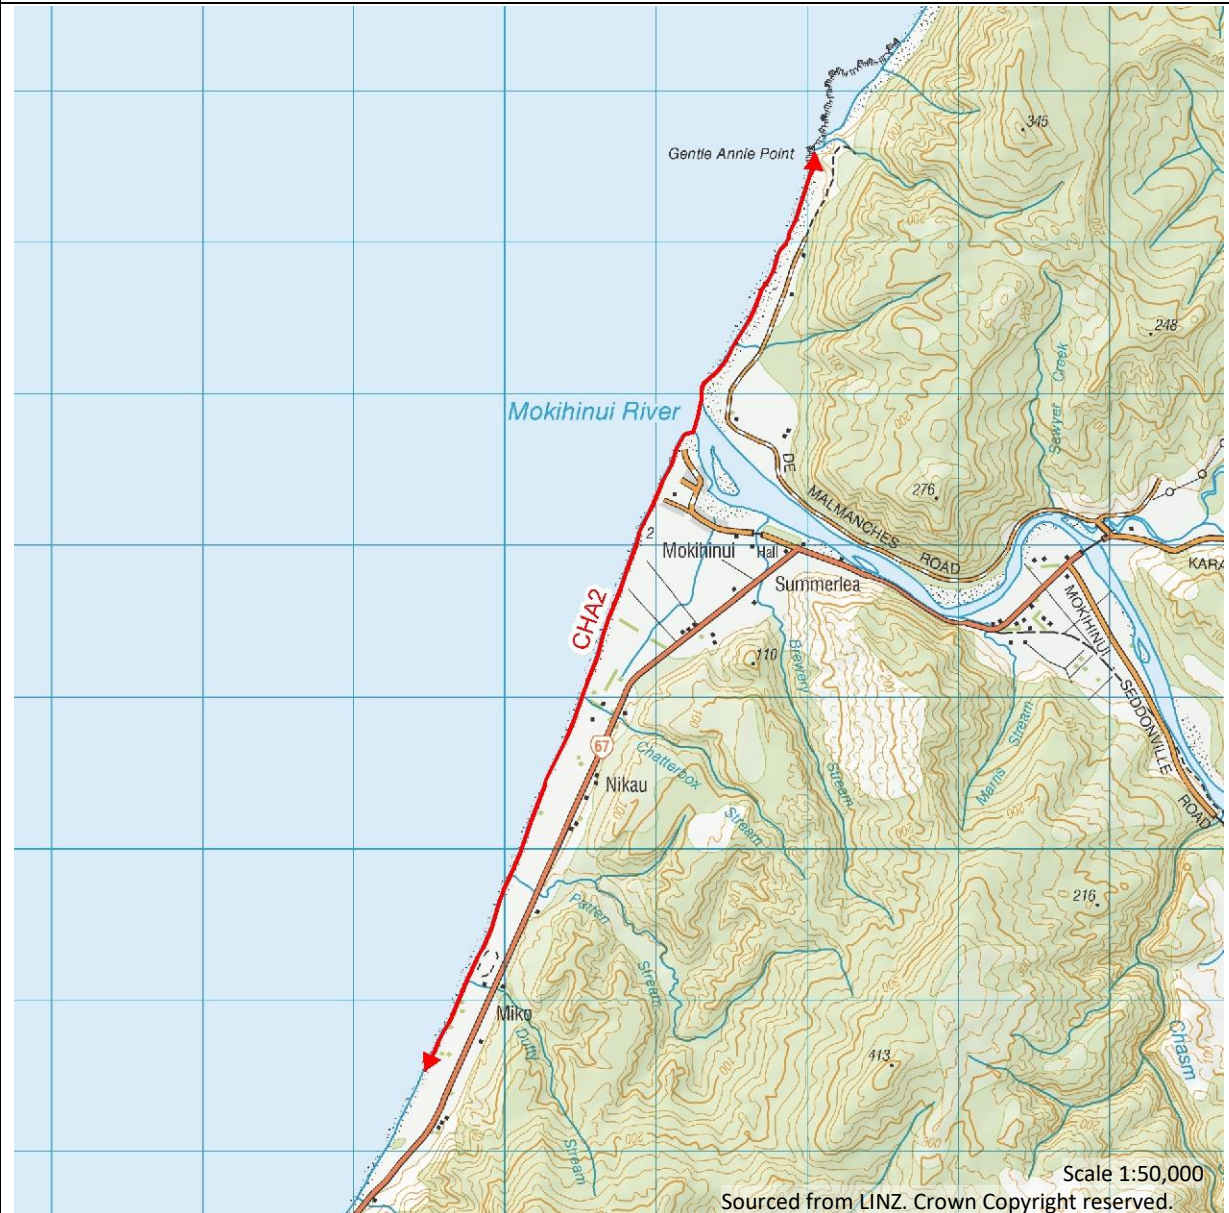
CHA2 extends from Gentle Annie Point (**BR21 120 046**, 1512040mE 5404600mN) to the south of Miko (**BR21 094 985**, 1509460mE 5398530mN)

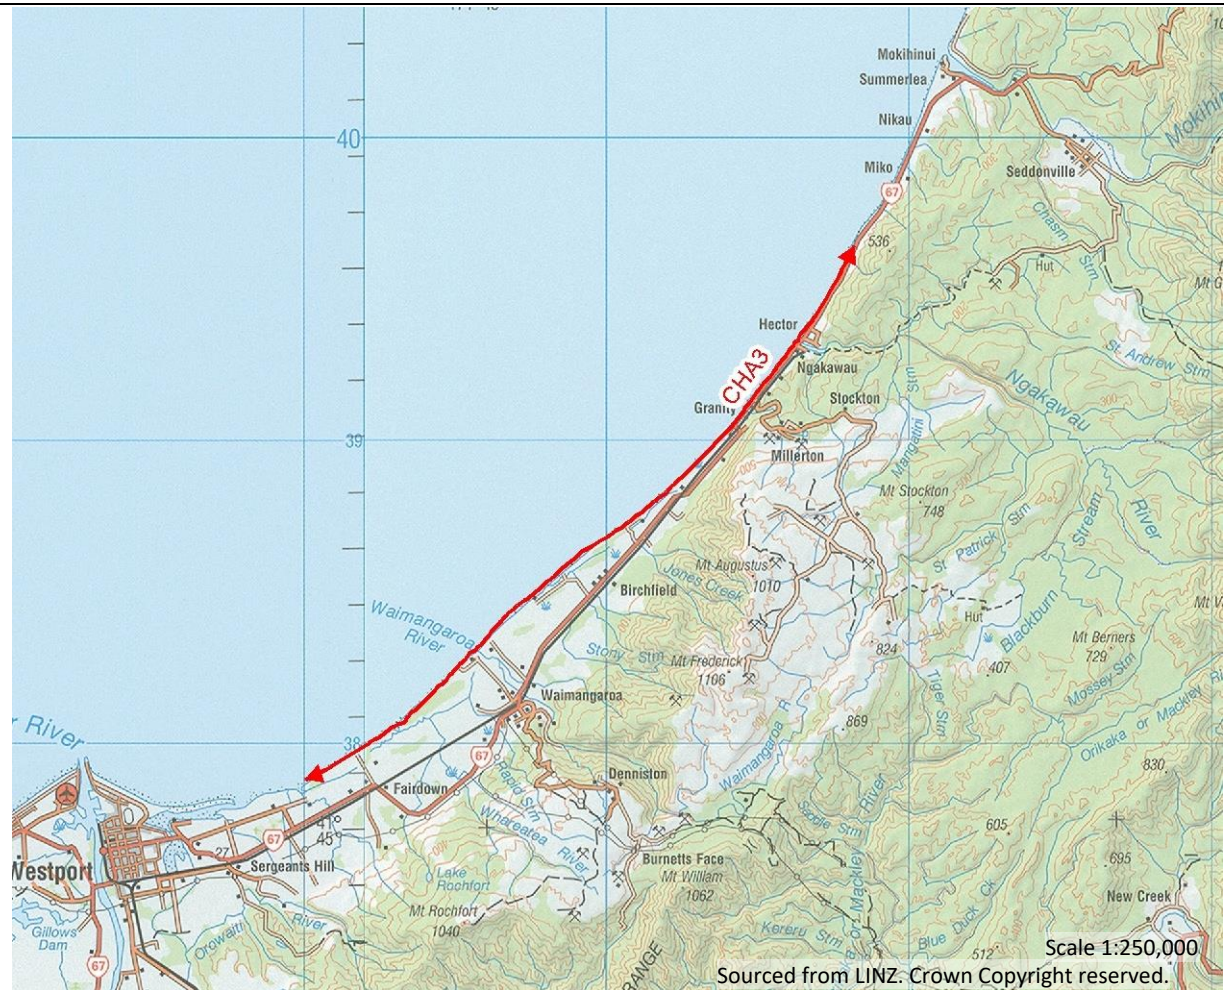
CHA3 extends from 400m north of Lamplough Stream (**BR21 081 964**, 1508180mE 5396440mN) to the mouth of the Orowaiti Lagoon (**BR20 900 788**, 1490040mE 5378800mN). The CHA includes Hector, Ngakawau and Granity as well as the Ngakawau and Waimangaroa Rivers and several smaller creeks.

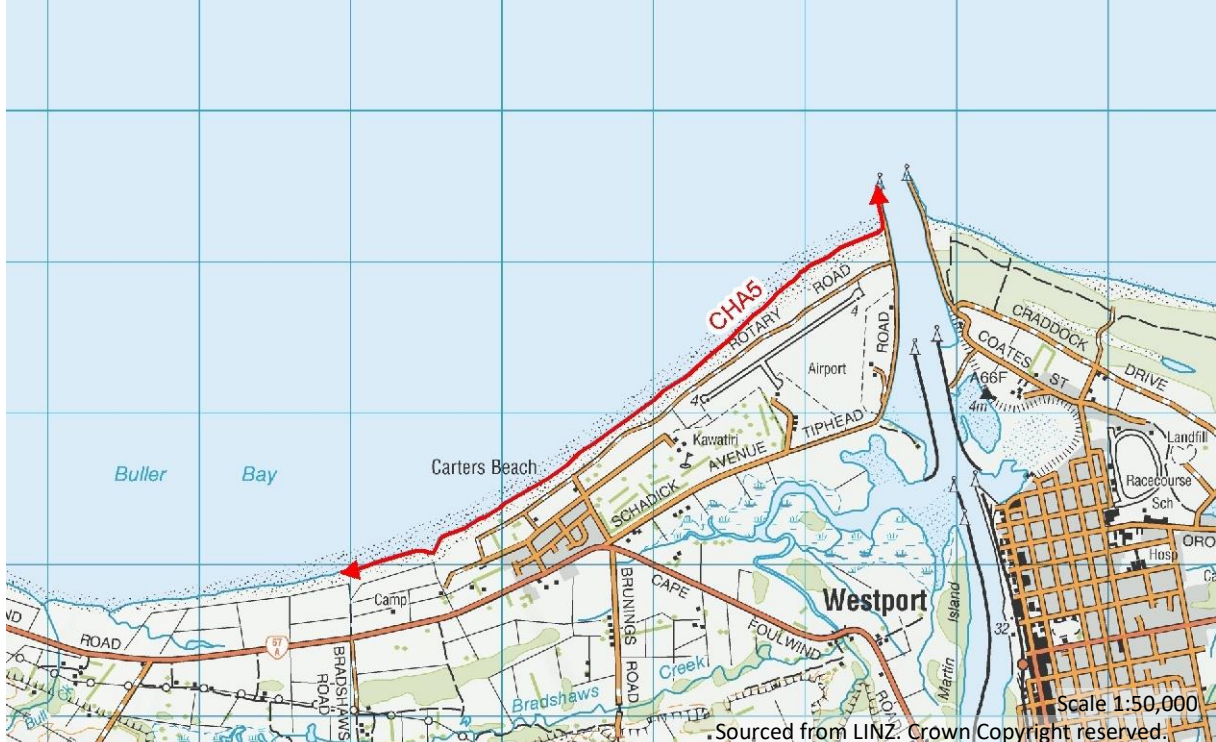
CHA5	Carters Beach
<p>This CHA extends from the Buller River mouth (<b>BR20 824 795</b>, 1482470mE 5379510mN) to a point level with Bradshaws Road, west of Carters Beach (<b>BR20 789 769</b>, 1478930mE 5376950mN).</p>

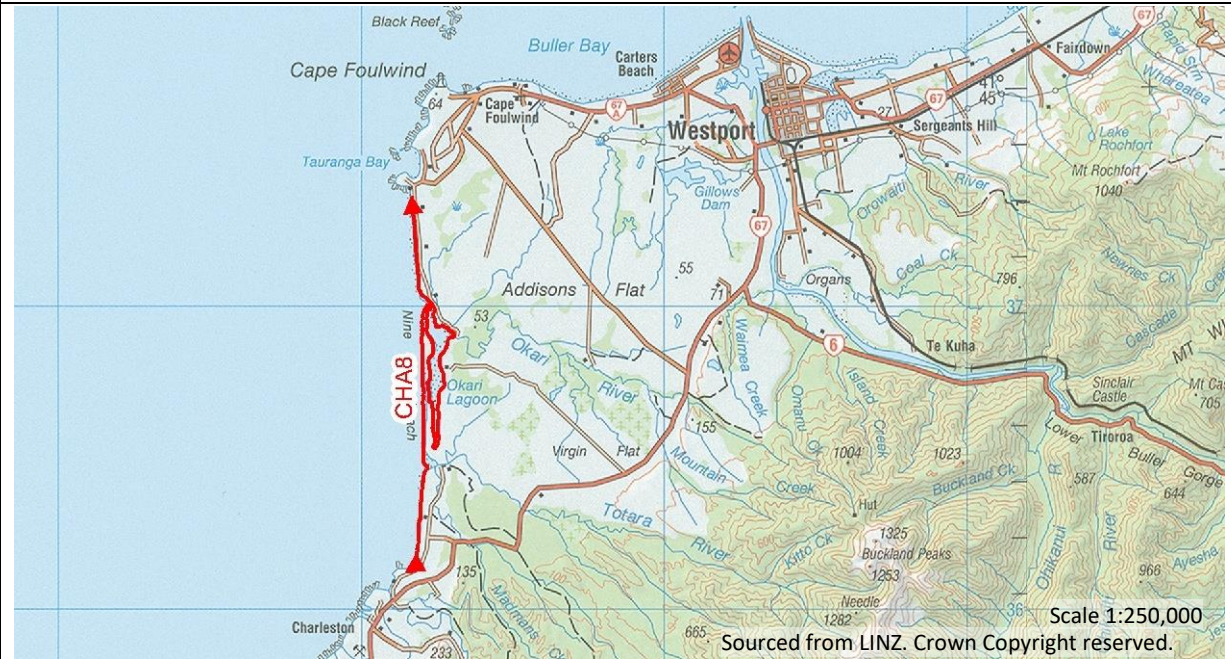
The Nine Mile Beach CHA stretches from near the north end of the beach (**BR20 716 736**, 1471680mE 5373610mN) to Parsons Hill at the south end of the beach (**BS20 715 612**, 1471550mE 5361270mN). The CHA includes the Okari Lagoon and the mouth of the Totara River.

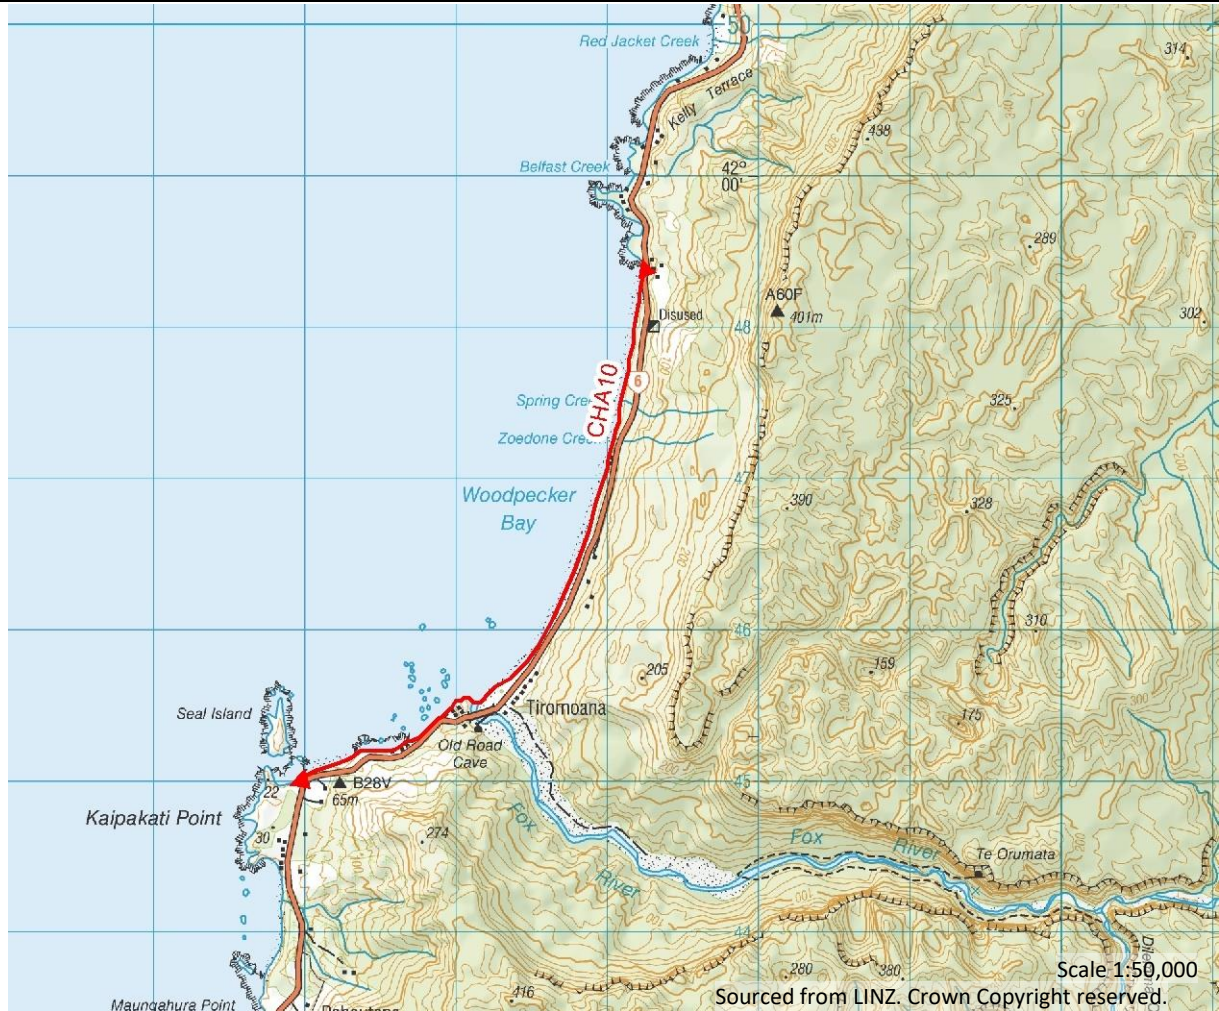
The Woodpecker Bay CHA extends from **BS19 672 484** (1467220mE 5348440mN) to **BS19 649 449** (1464910mE 5344980mN). This CHA includes Tiromoana and the mouth of the Fox River.

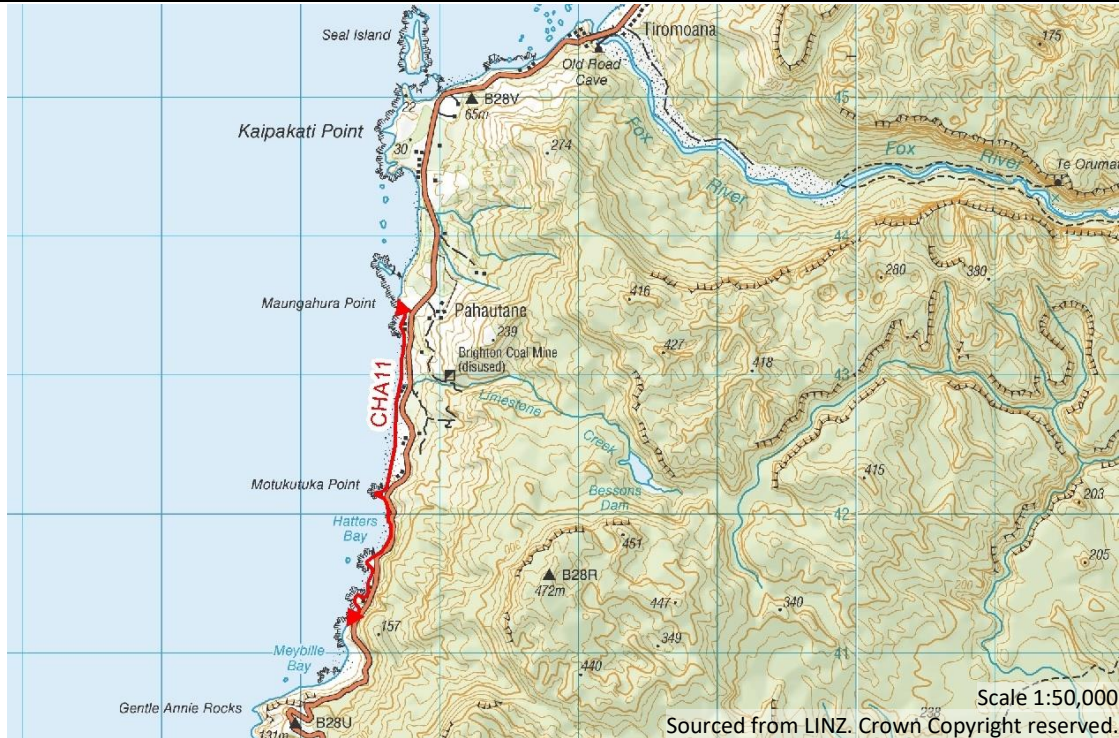
CHA11 encompasses an exposed section of coast consisting of narrow beaches between small rocky outcrops. This CHA extends from Maungahura Point (**BS19 647 435**, 1464700mE 5343550mN) to the rocky outcrop at the north end of Meyville Bay (**BS19 643 412**, 1464330mE 5341200mN)

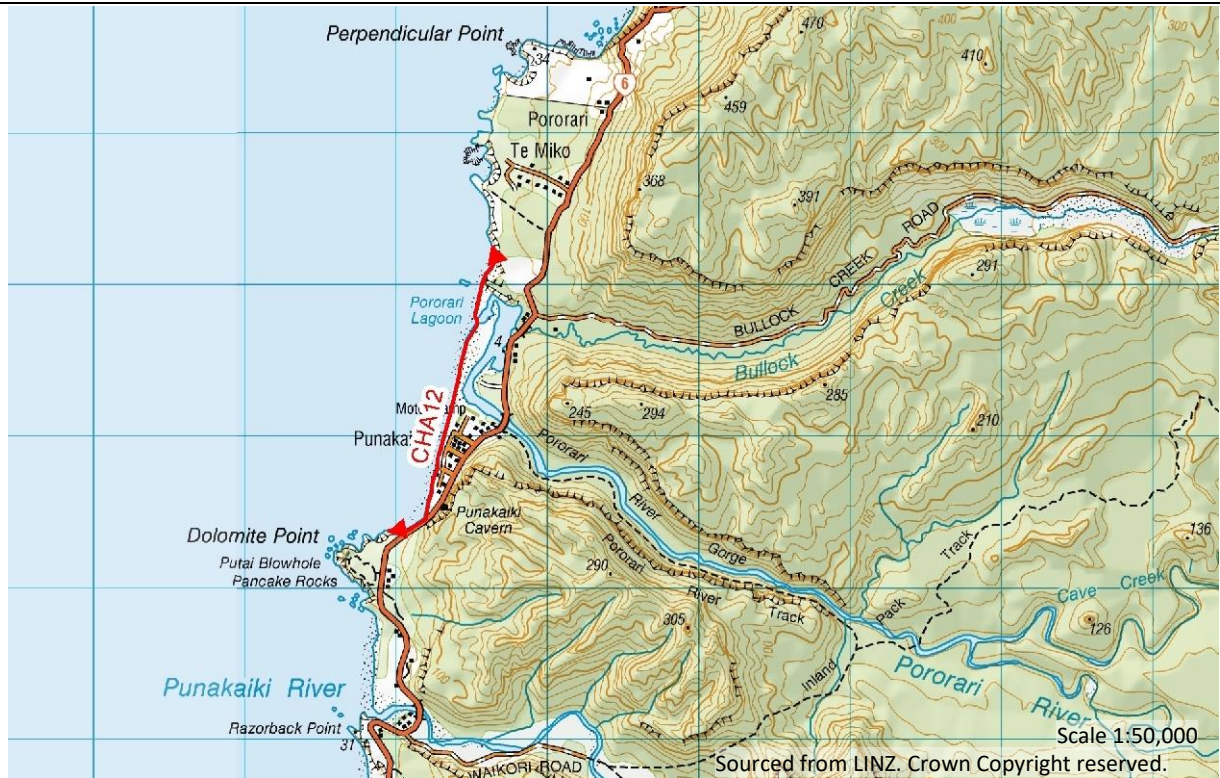
This CHA covers the length of beach in front of Punakaiki Village including the Pororari River mouth and lagoon. The CHA stretches from **BS19 626 382** (1462630mE 5338260mN) to **BS19 619 363**(1461940mE 5336380mN).

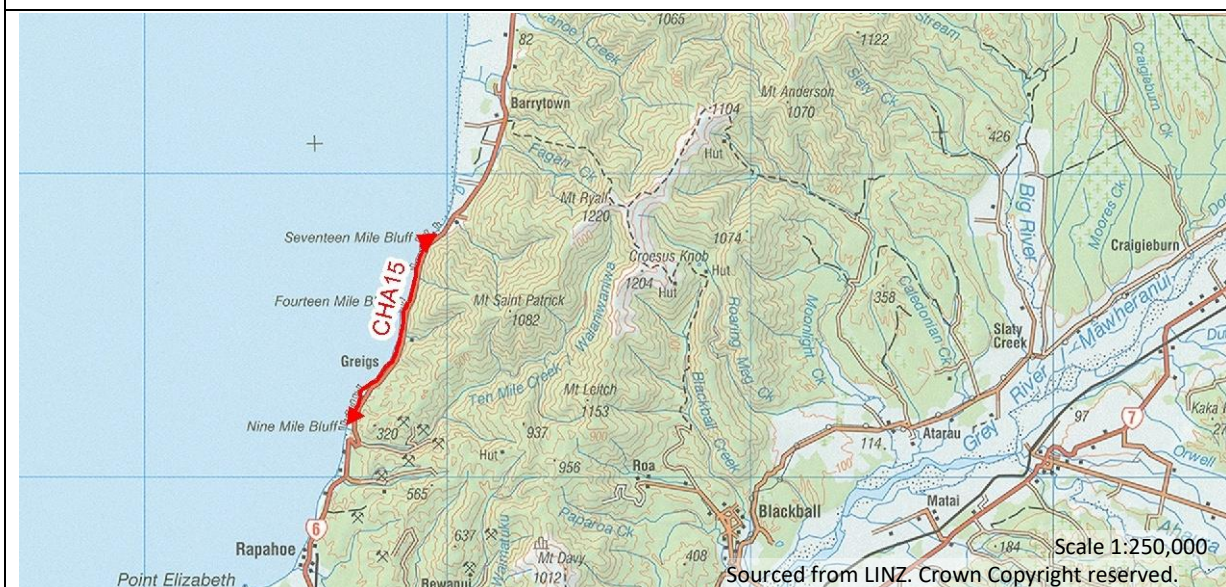
CHA 15 stretches from the end of CHA 14 at 17 Mile Bluff (**BT19 596 180**, 1459640mE 5318010mN) to 10 Mile Creek (**BT19 567 117**, 1456720mE 5311720mN). The CHA includes the small settlement of Greigs.

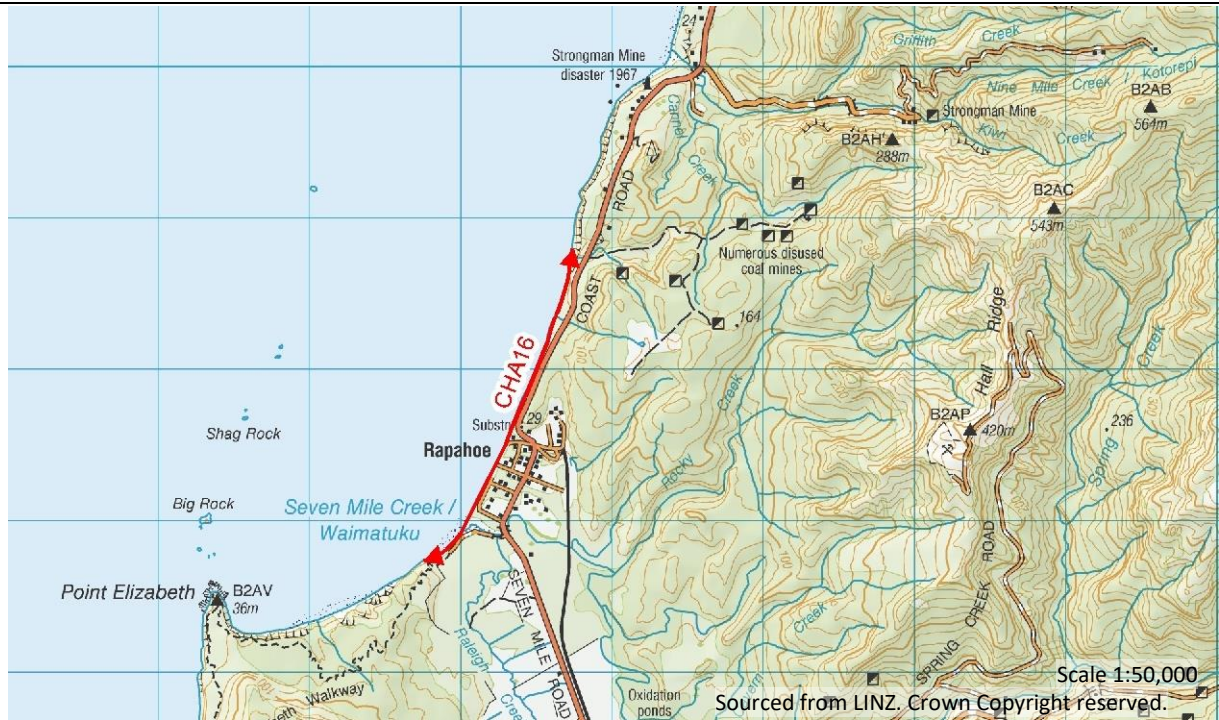
The Rapahoe CHA stretches from about 1.5km north of Rapahoe (**BT19 557 088**, 1455740mE 5308810mN) to south of Seven Mile Creek (**BT19 547 067**, 1454750mE 5306740mN).

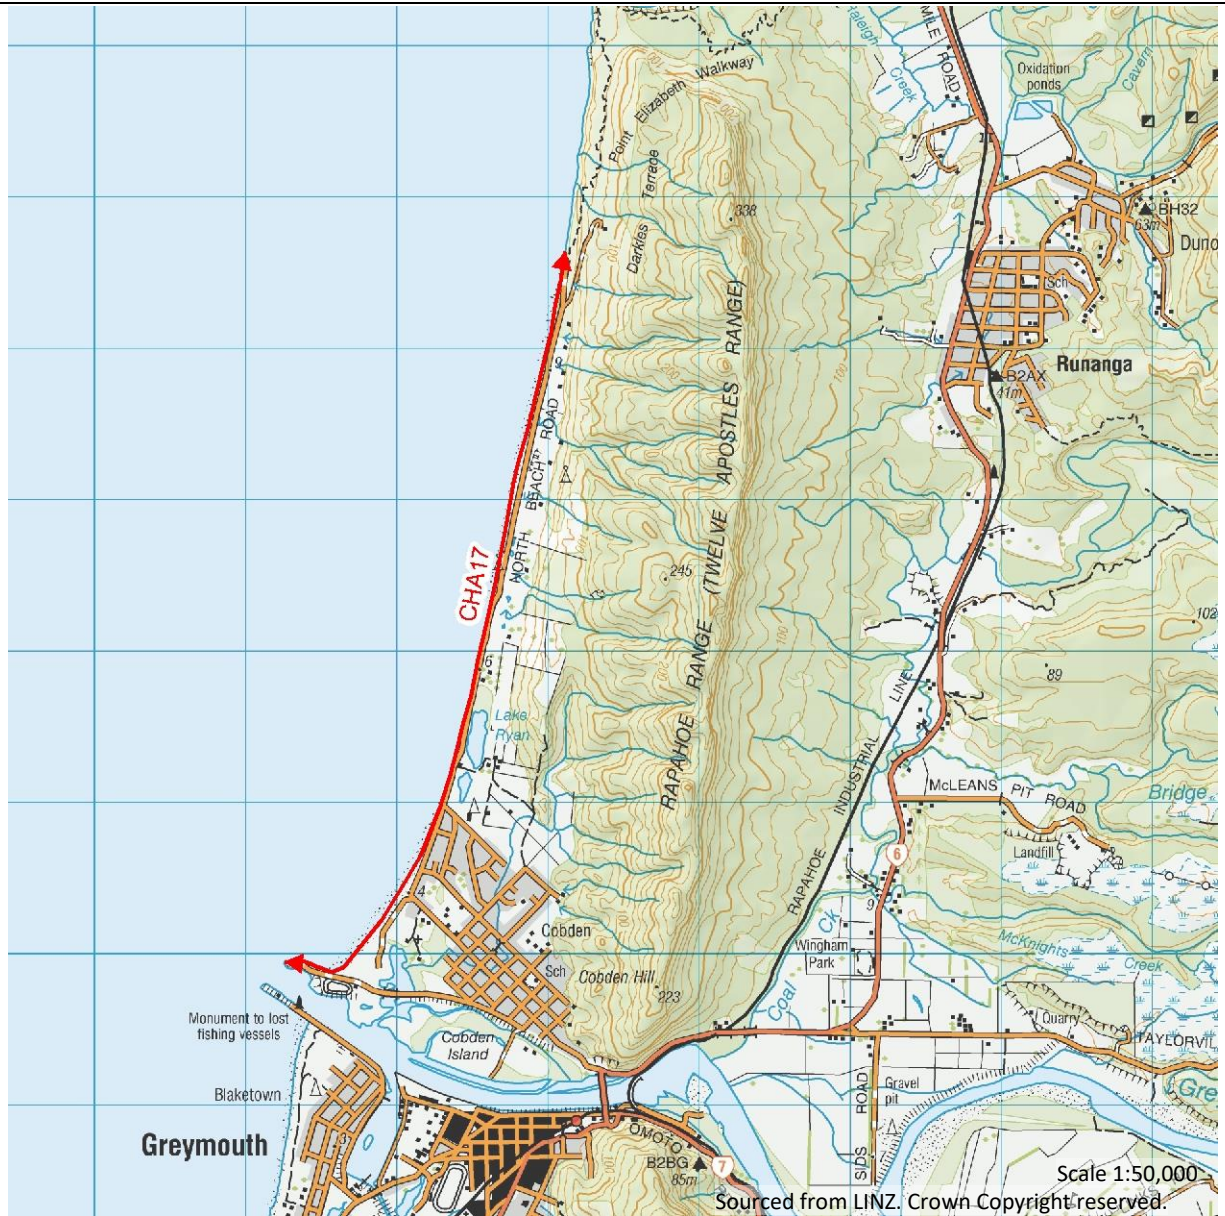
CHA 17 extends from the end of North Beach Road, north of Cobden (**BT19 531 046**, 1453110mE 5304640mN) to the mouth of the Grey River (**BT19 512 999**, 1451260mE 5299950mN). The CHA includes Cobden Beach.

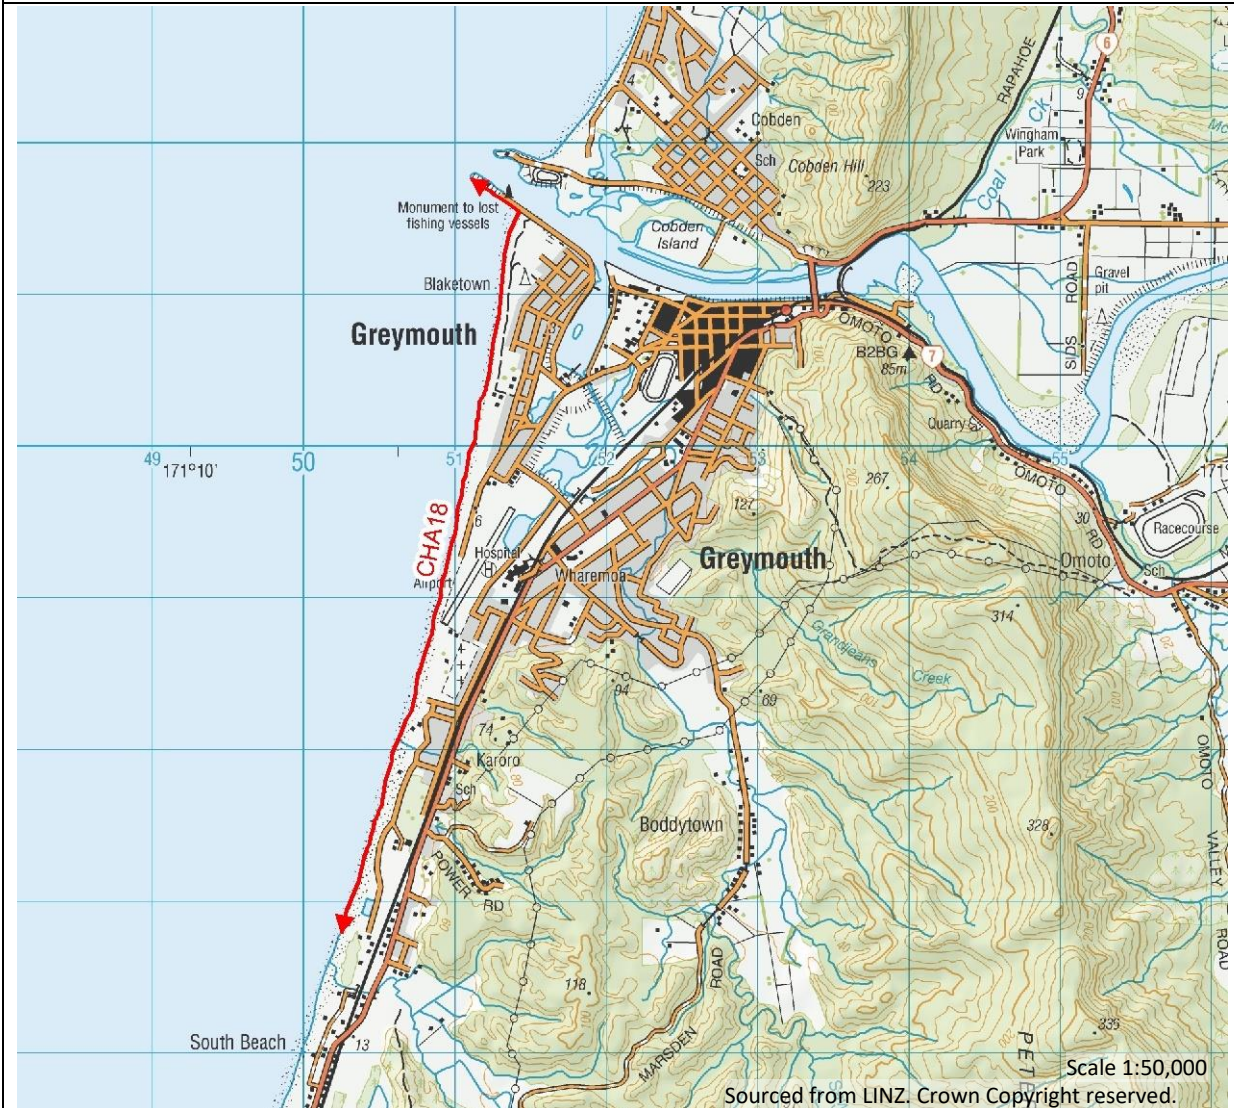
CHA 18 extends from the mouth of the Grey River (**BT19 511 997**, 1451100mE 5299770mN) to between Karoro and South Beach (**BU19 502 947**, 1450250mE 5294790mN). The CHA includes Blaketown Beach.

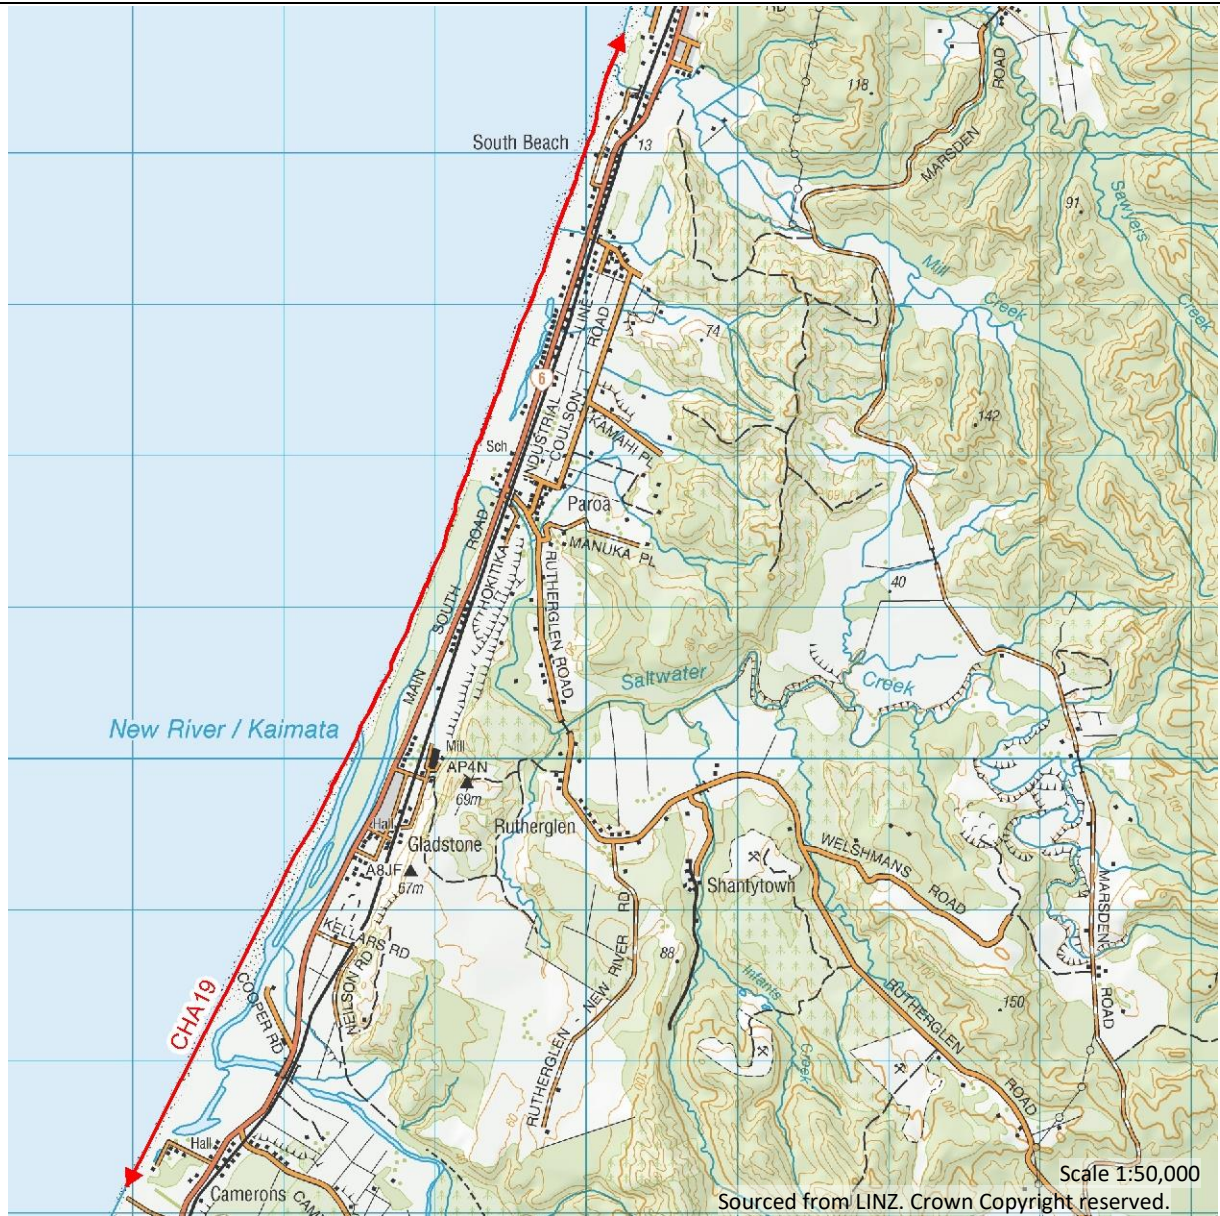
CHA19 covers the stretch of coast from north of South Beach (BU19 502 947, 1450250E 5294790mN) to Camerons (BU19 469 871, 1446960mE 5287180mN) including Paroa and Gladstone. CHA19 includes the mouth of the New River / Kaimata.

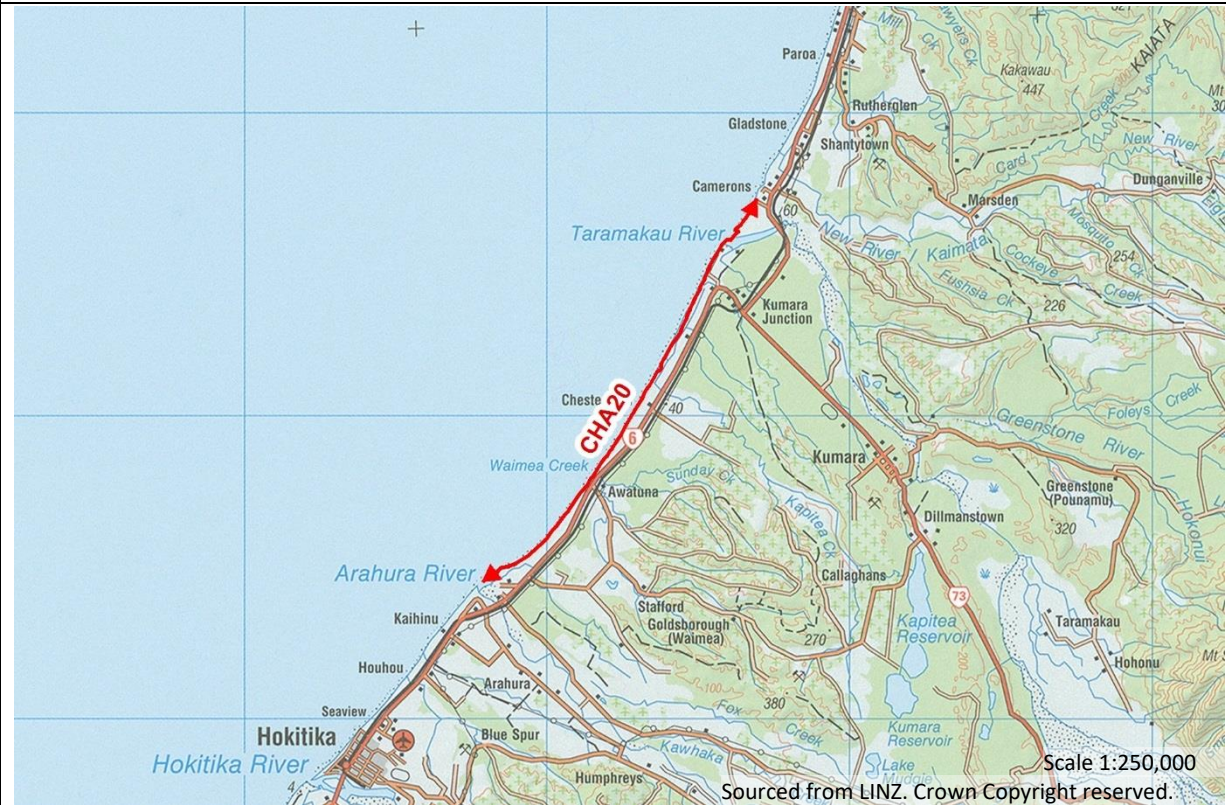
This CHA extends from north of the Taramakau River (**BU19 469 871**, 1446960mE 5287170mN) to the south side of the Arahura River mouth (**BU18 378 745**, 1437890mE 5274540mN) including Waimea Creek, Chesterfield and Awatuna.

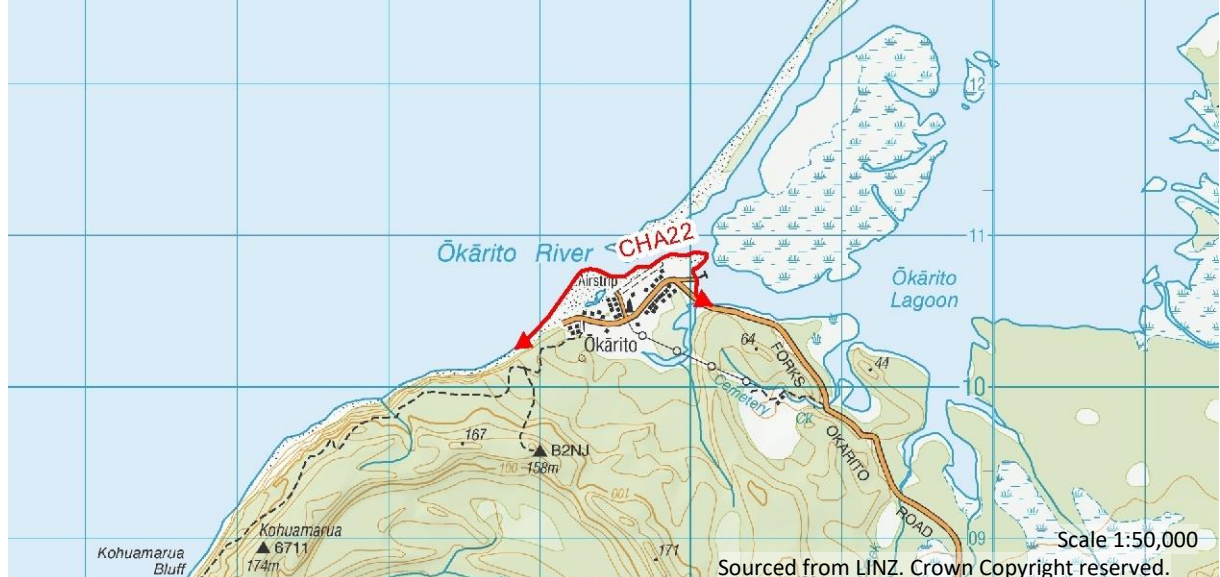
CHA22	Ōkārito
<p>This CHA covers the south side of the Ōkārito Lagoon mouth, around the settlement of Ōkārito (BW15 701 105, 1370140mE 5210540mN to BW15 688 102, 1368830mE 5210250mN).</p>

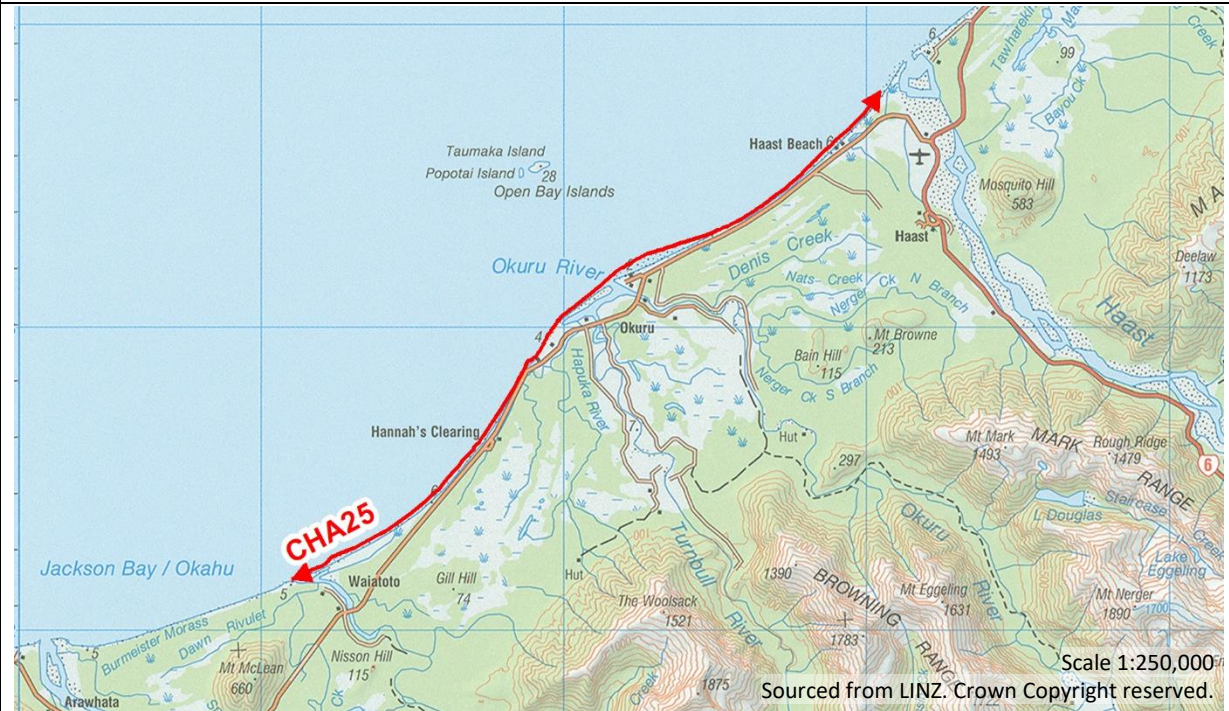
CHA 25 extends from the south bank of the Haast River (**BY11 804 377**, 1280500mE 5137780mN) to the southern limit of the Waitatoto Lagoon (**BY11 610 216**, 1261020mE 5121650mN). The CHA includes the settlements of Haast Beach, Okuru and Hannahs Clearing.

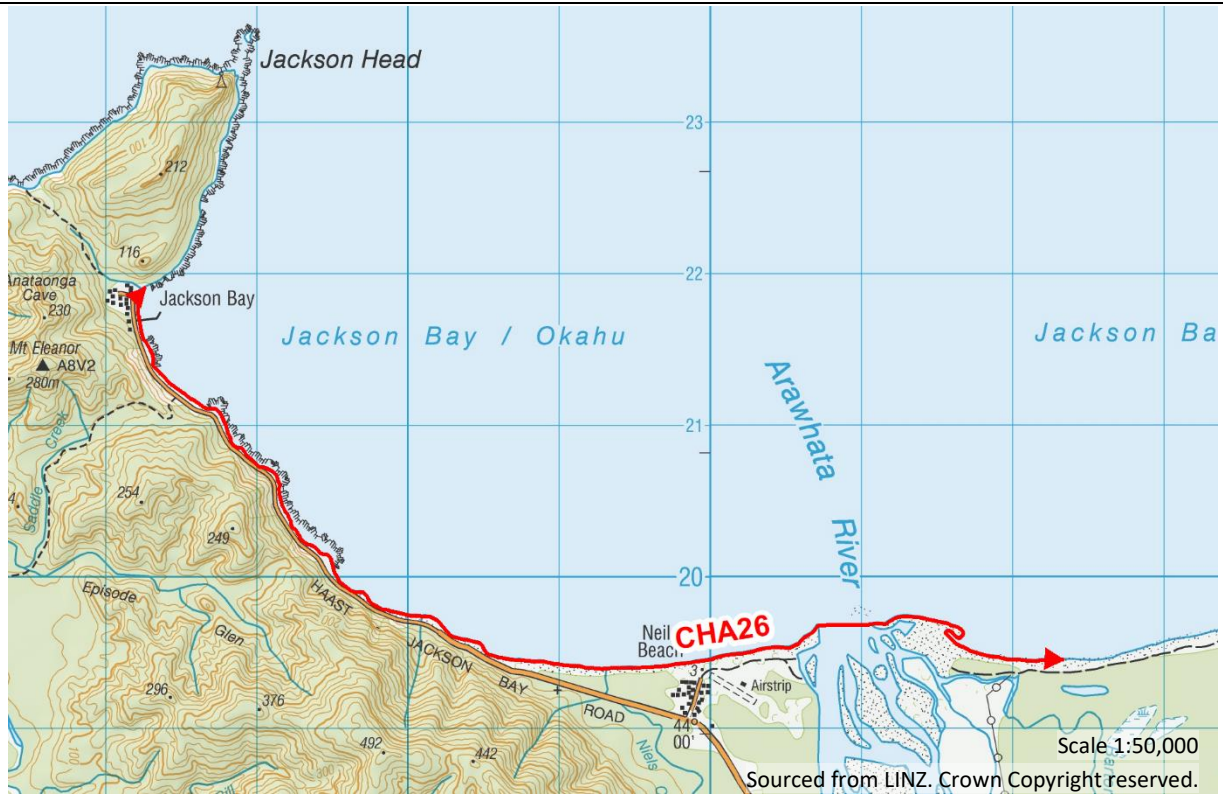
CHA 26 extends from east of the Arawhata River (**BY11 543 195**, 1254330mE 5119460mN) to Jacksons Bay (**BY10 482 219**, 1248260mE 5121920mN).
