ARCHAEOLOGICAL SURVEY REPORT
FOR
THE DEPARTMENT OF CONSERVATION
WEST COAST CONSERVANCY

P.G. PETCHEY
SOUTHERN ARCHAEOLOGY LTD.
2007

Looking down the Denniston Incline towards Waimangaroa and the Tasman Sea.

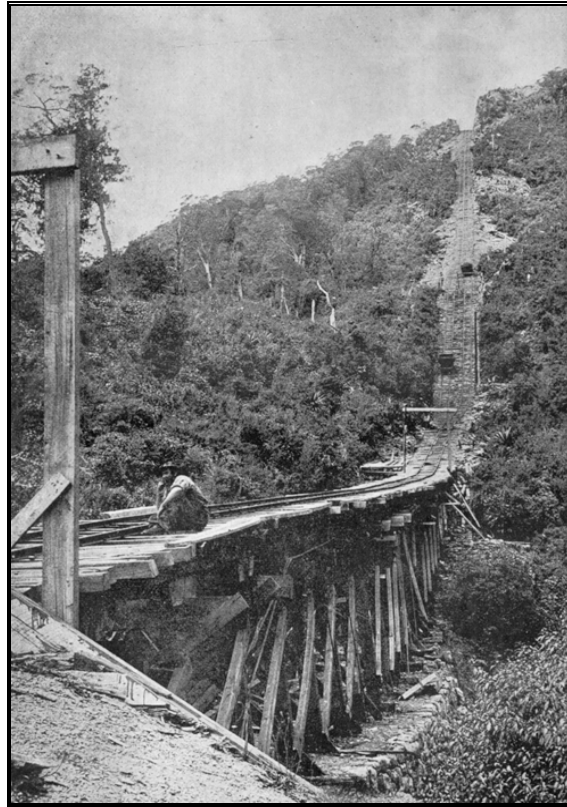
Figure 3

The upper incline and Brown's (or McDonald's) Bridge, looking up towards the Brakehead just over the horizon. (N.Z. Mining Handbook 1906).

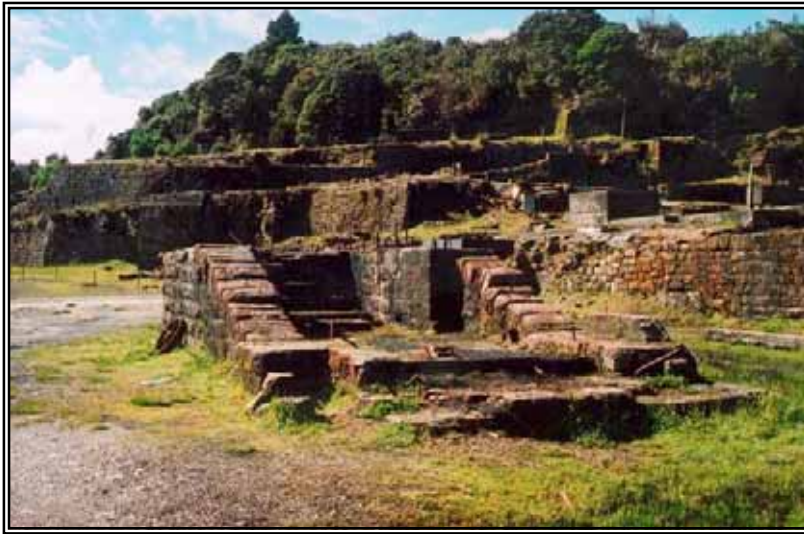
Figure 7
The foundation for the brake for the upper incline in 2006. Figure 8 (below) was taken looking in the opposite direction.

At the top of the incline, at the Brakehead, the most significant feature associated with the incline is the foundation for the brake (Figures 7 and 8). This is a stone structure (with some concrete strengthening), in contrast to the Middle Brake foundation that is of concrete. The brake foundation is located in the middle of the area where the railway yards at the top of the incline were situated. It was here that the wagons were marshalled before being filled with coal for their descent back down the incline (see Figure 8).

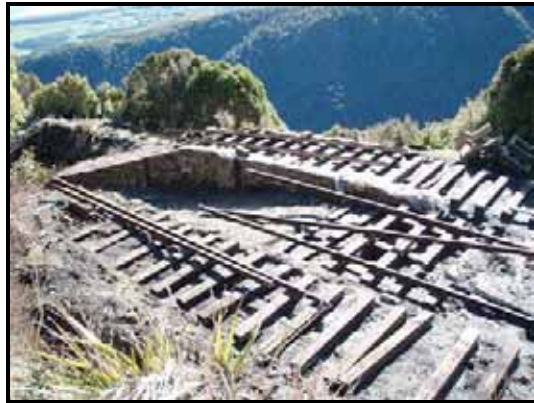
Figure 11
The top of the upper incline in 2006, before rail laying started. The original sleepers of the incline were still clearly visible.

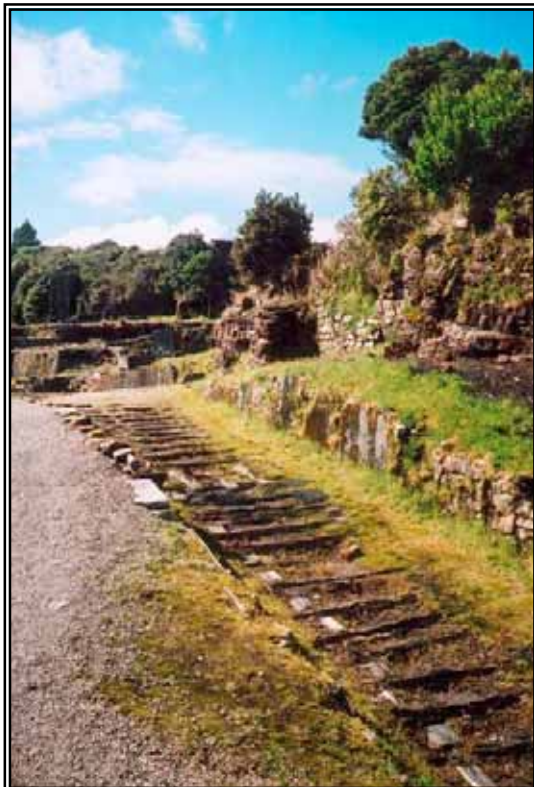
Figure 12 (left)

A view up the upper incline in 2006, from below the bridge. The Brakehead is just over the horizon.

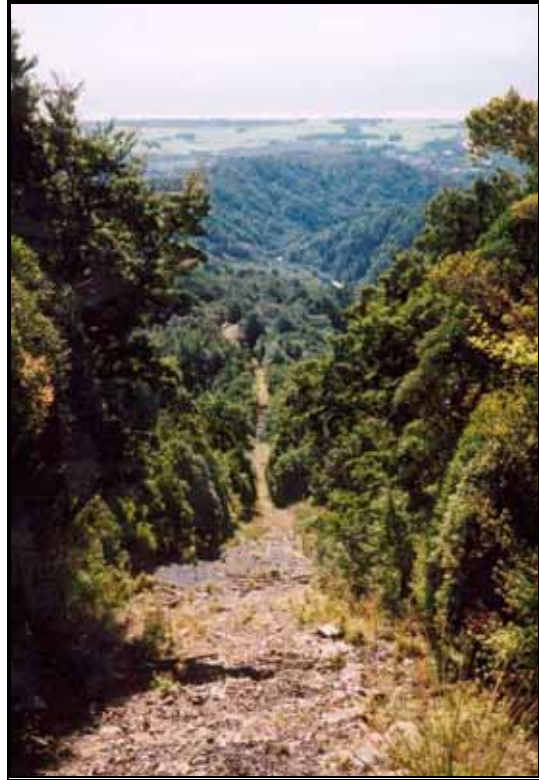
Figure 13 (right)

The opposite view, looking down the incline from below the 1968 slip. The Waimangaroa River valley and the coast are in the background.

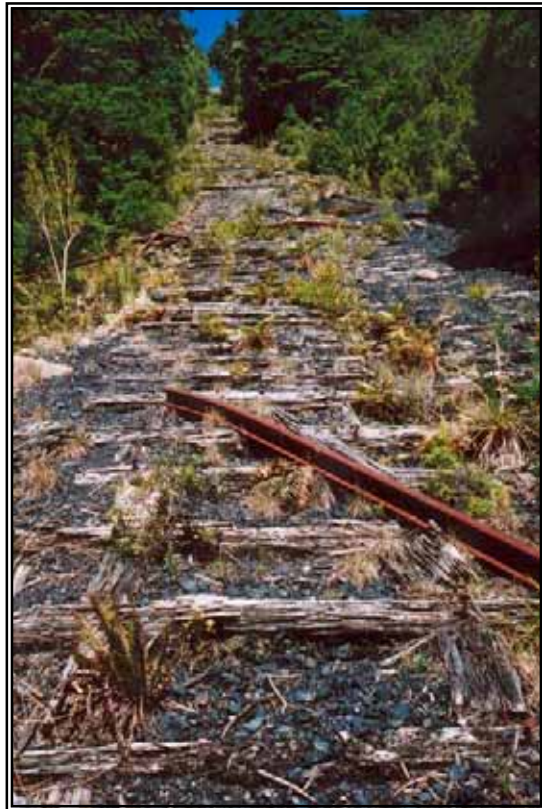
Figure 14 (right)
A detail of the upper incline, looking uphill, in 2006. Surviving sleepers and copious quantities of coal are visible.

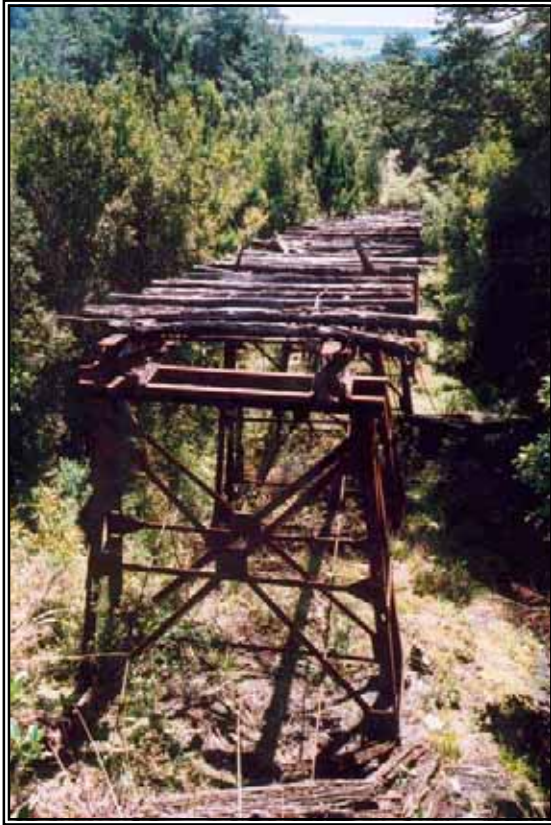
Figure 15 (left)
Looking down on Brown's/McDonald's bridge. The first span has been cut away, but otherwise it is still intact. However, the ironwork is extremely rusty and potentially unstable. Of a number of cable stays that have been connected to the bridge to stop it toppling downhill, only one (in the right foreground) remains intact.

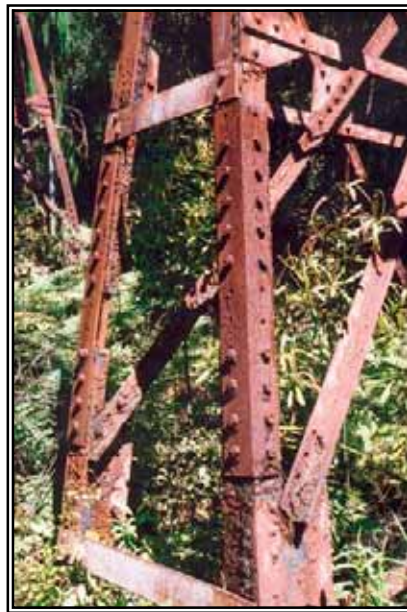
Figure 16 (right)
A detail of the legs of one of the piers of Brown's/McDonald's bridge on the upper incline. As can be seen, some of the steel members are extremely rusty. It is not known whether the angle irons bolted to the legs were to raise the structure or to repair rust-weakened areas.

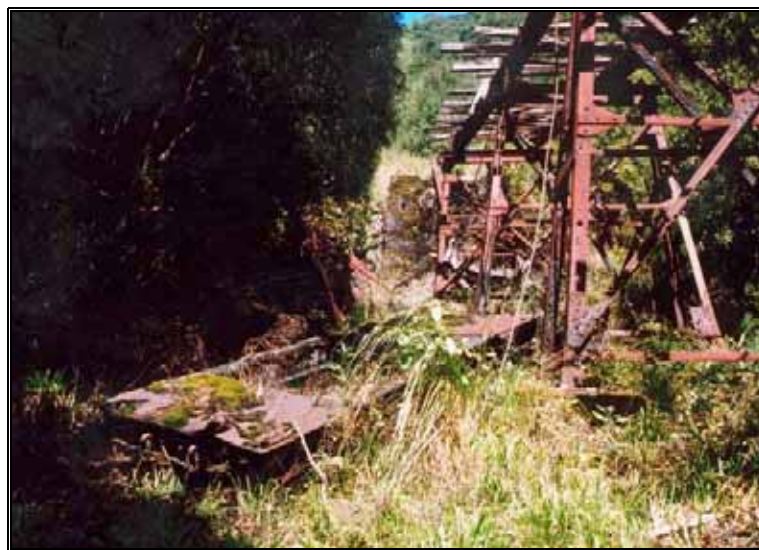
Figure 17
The twisted chassis of a 'Q' wagon underneath the bridge on the upper incline.

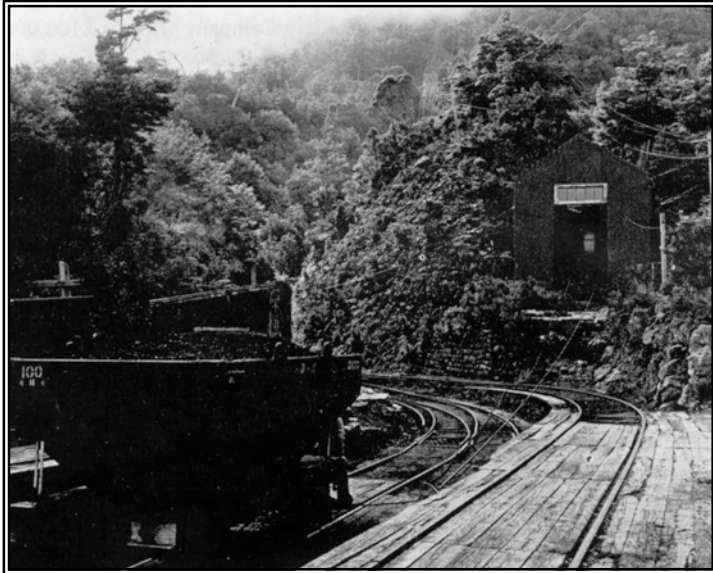
Figure 18
A 'Q' wagon and the brake shed at the Middle Brake, looking back towards the upper incline. (G.T. Radcliffe, with permission, N.Z. Railway & Locomotive Society).

The Middle Brake was the division between the upper and lower inclines. Wagons that had been lowered down the upper incline were unhitched and manhandled to the top of the lower incline, down which they continued their journey to the yards at Conn's Creek. Figure 18 shows a full wagon just arrived down the upper incline, in the process of being attached to the wire rope from the brake ready for its transfer to the lower incline. Figure 19 shows a similar wagon about to descend down the lower incline, with an empty having arrived up at the 'Donkey' side.

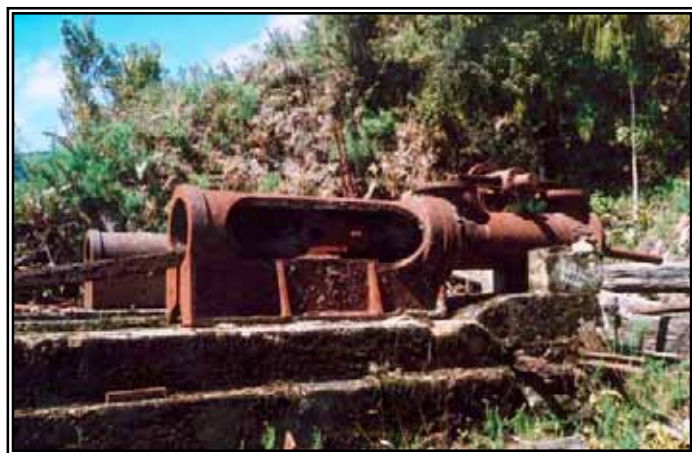
Figure 22
The Middle Brake foundations and cylinders in 2006.

The concrete foundations for the brake itself stand on the south side of the Middle Brake area. The cast iron water cylinders are still in place, and it is therefore clear that although the drum was removed in 1978 for museum display, the cylinders that are currently with the drum in the Coaltown museum are not from the Middle Brake. On the hillside behind the brake foundations is the concrete water tank, used to maintain a constant supply of cool water to the brake cylinders.

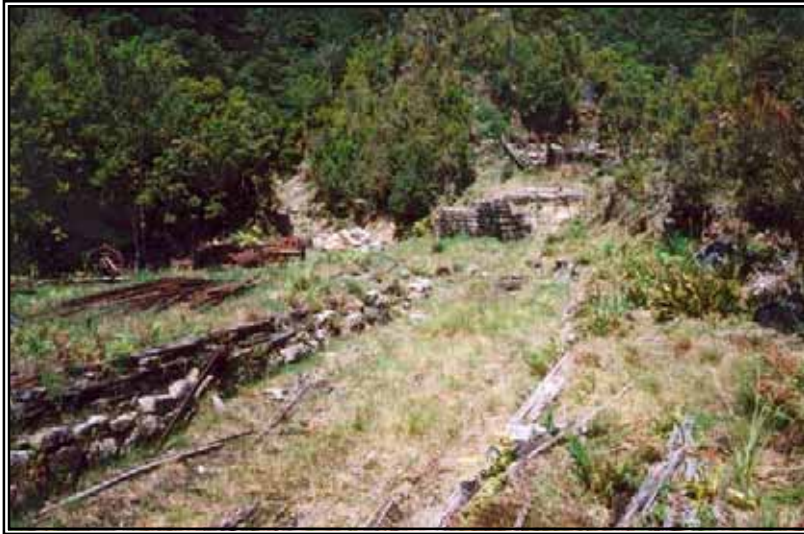
Figure 23
A general view in 2006, looking back towards the brake foundations, while standing on the 'Company' side return line. This is a similar view to that in Figure 18, taken while the incline was working.

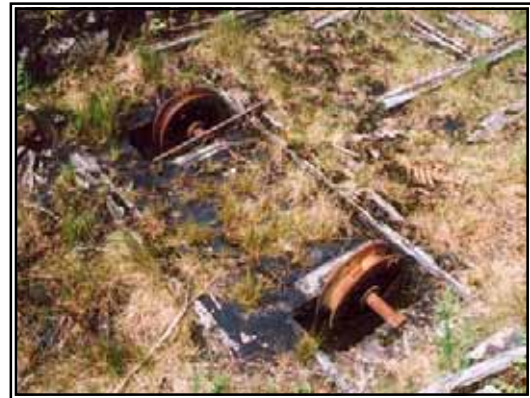
Figure 24
Cable guide wheels at the Middle Brake. These are situated in the central railbed where the loaded wagons were rolled to the lip of the lower incline. They guided the main hauling cable.

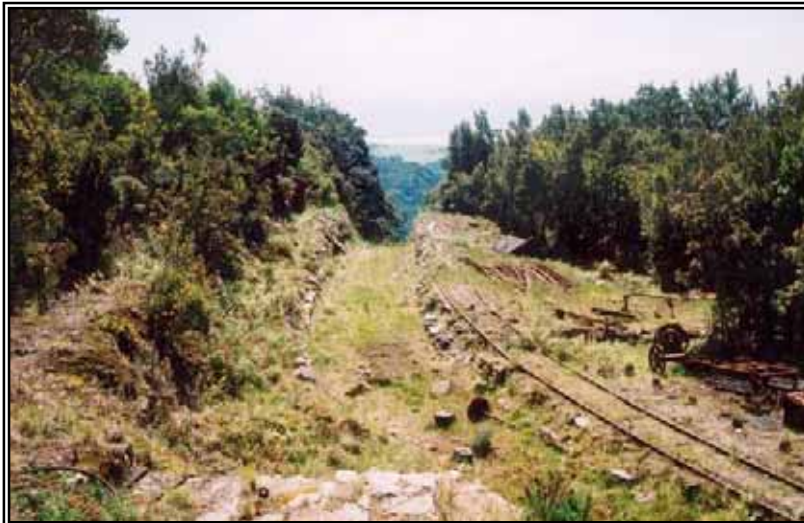
Figure 25
A general view in 2006 looking out towards the coast from in front of the brake foundation. This is a similar view to that in Figure 19, which was taken while the incline was working. Note the intact railway lines on the right ('Donkey') side.

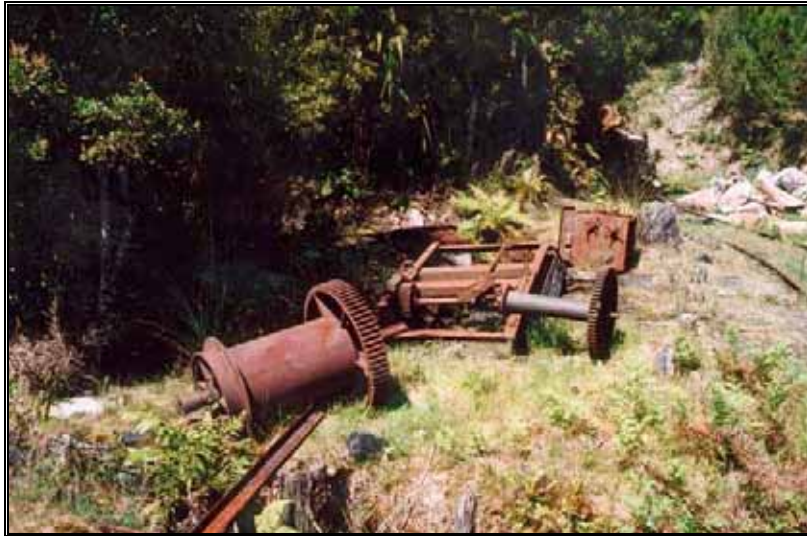
On the north-eastern side of the Middle Brake is a dismantled steam winch and a vertical cross-tube boiler (lying on its side).² Next to these is a shallow channel leading to a braked wheel, which was part of the Samsun Brake. This was used to lower each wagon to the brow before the main rope was hitched on, ensuring a gentle tensioning of the main rope.

The dismantled steam winch at the Middle Brake. In the top right background can be seen the slip that has blocked the bottom of the upper incline.

² This winch was probably converted to electric power at some time in its life, and an electrical control box can be seen in Figure 26 (upper right) (J. Staton pers. comm.).

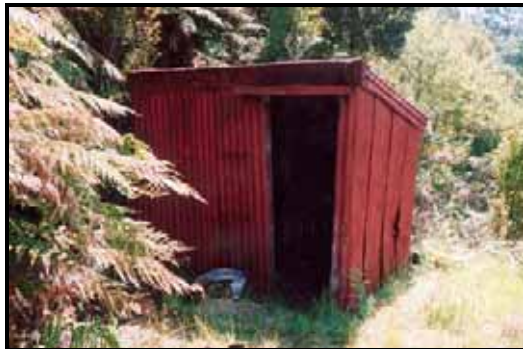
Figure 27 (left)

At the top of the lower incline, on the ‘Company’ side, one of two operator’s shelter sheds is still standing, although it too is suffering from decay of the timber framing. It is a small corrugated-iron clad shed, measuring 8ft. by 6ft. 6in. (2.43m by 1.95m).

The surviving shelter shed on the ‘Company’ side of the Middle Brake, at the top of the lower incline.

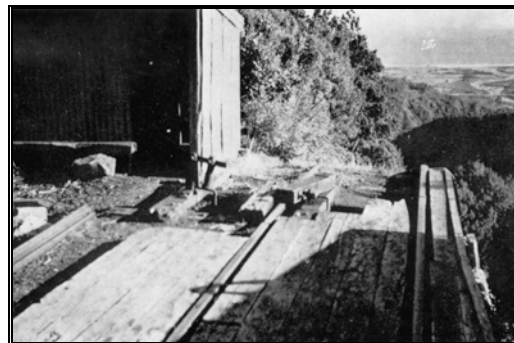
Figure 28 (right)

The same shed in the 1960s, while the incline was still in use. This photo was taken to illustrate the use of a stop block on the line. (R.J. Meyer, with permission, N.Z. Railway & Locomotive Society).

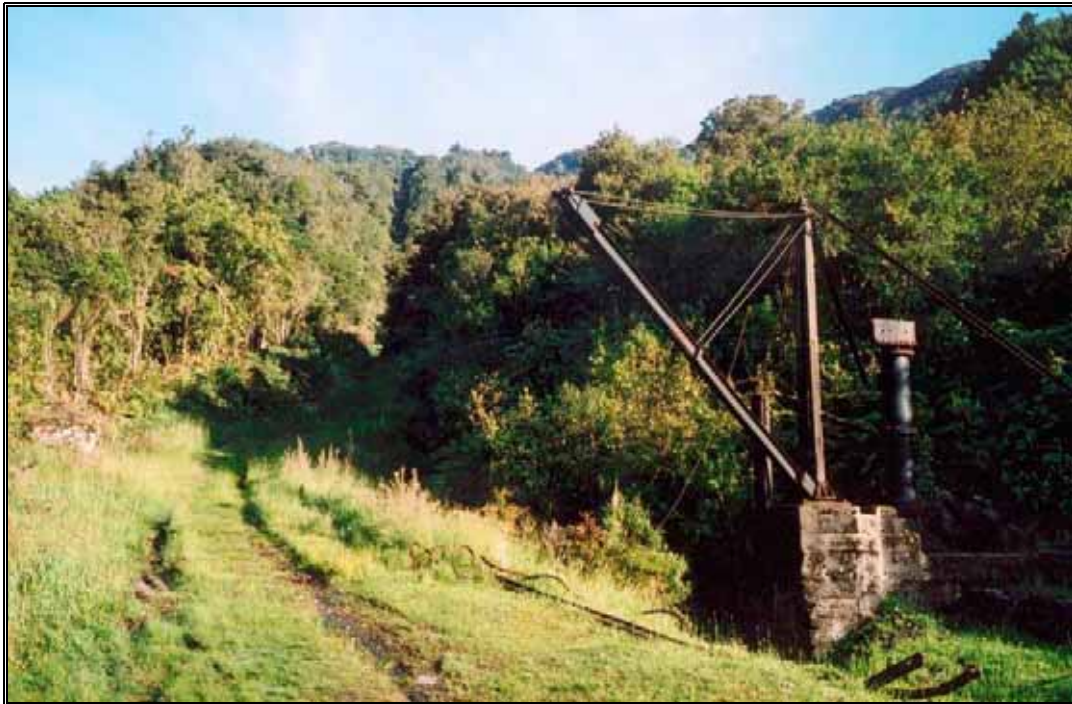
Figure 30

A view up the lower incline from the Conn's Creek yards in 2006, with the hydraulic crane on the right.

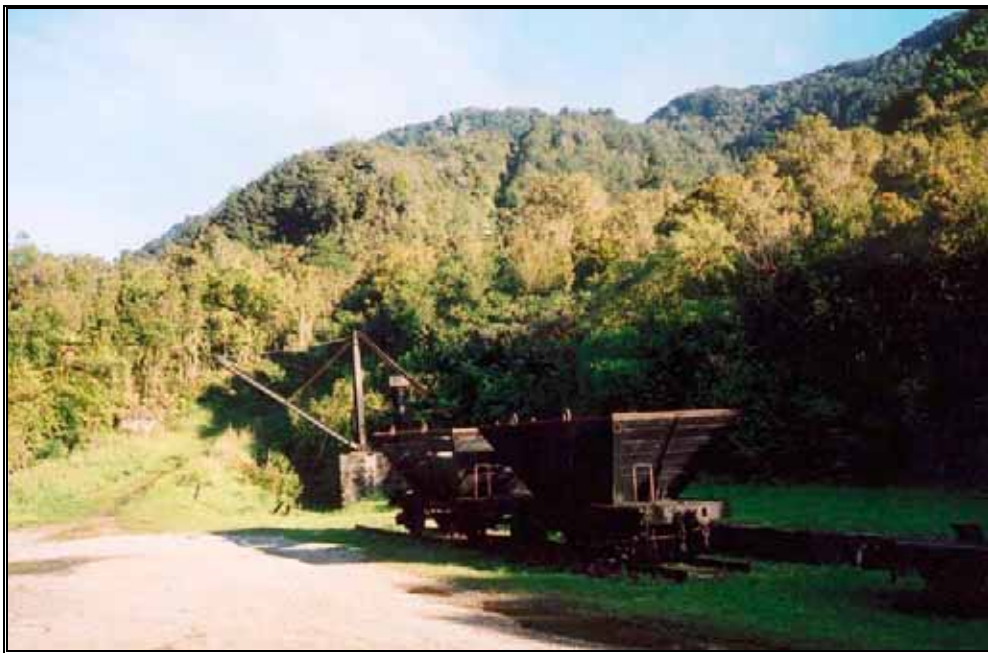
Figure 33

Conn's Creek yards in 2006. Two 'Q' wagons and the front of a 'Q' chassis can be seen on the right. The hydraulic crane is beyond them (compare this with Figure 32). The cleared line of the lower incline can be seen in the bush beyond the crane.

The Department of Conservation maintains two 'Q' coal wagons and the old hydraulic crane at the yards (Figure 33, and see also Figure 30). There are no standing remains of the buildings that once existed at the yards, but there is likely to be evidence in the surrounding bush.

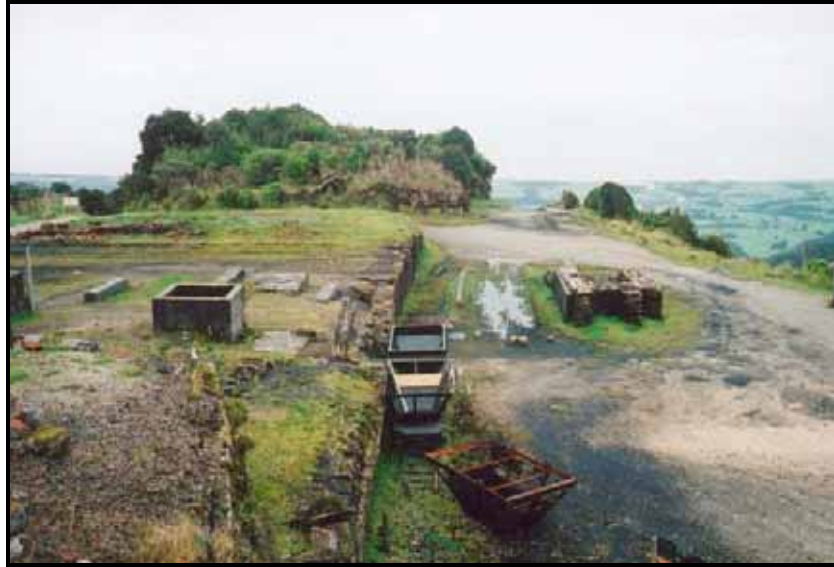
Figure 34

A general view over part of the Brakehead area, showing the top of the incline (top right), and brake foundation in the middle of the rail yards area (right). On the higher terrace to the left is the water tank for the pressure accumulator (left centre) and bins area (beyond water tank).

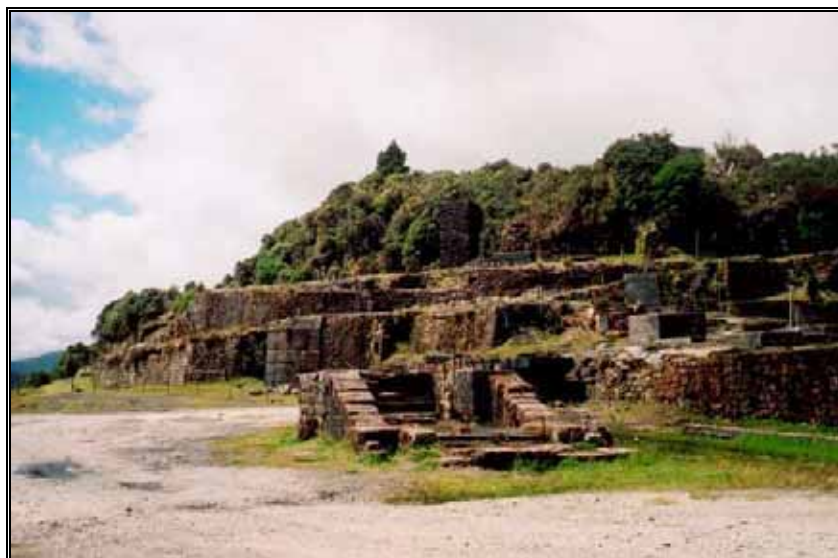
Figure 35

A view of the Brakehead area from the opposite direction to Figure 34. The photograph was taken from near the top of the incline. Looking up towards the power house and rope road terrace. The bins were off to the right.

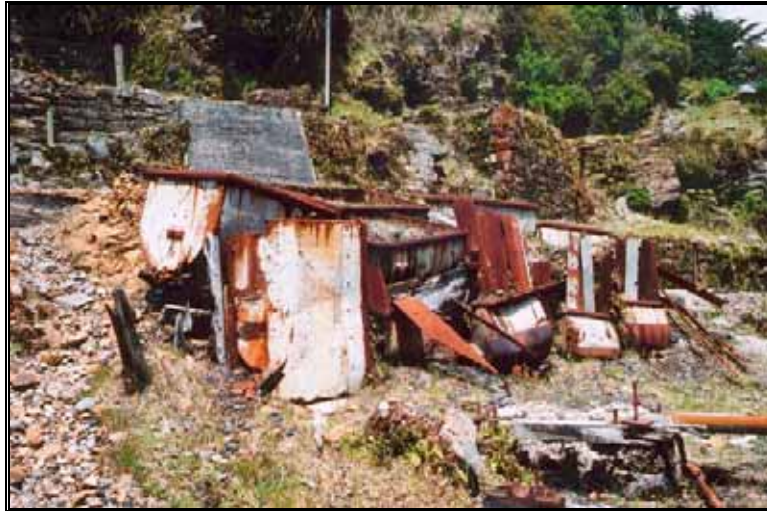
Figure 36

Coal tubs used as a revetment, fronting the ramped track between the bins level and power house level.

Some areas of filled ground are now beginning to cause serious problems, with slumping and subsidence evident in a number of places, and with the partial failure of some stone revetments. One section of unusual revetment, showing a high degree of improvisation on the part of the builders, was constructed by using coal tubs (as used for hauling coal from the mines) filled with slack coal (Figure 36, and marked as 'I' on Figure 37).

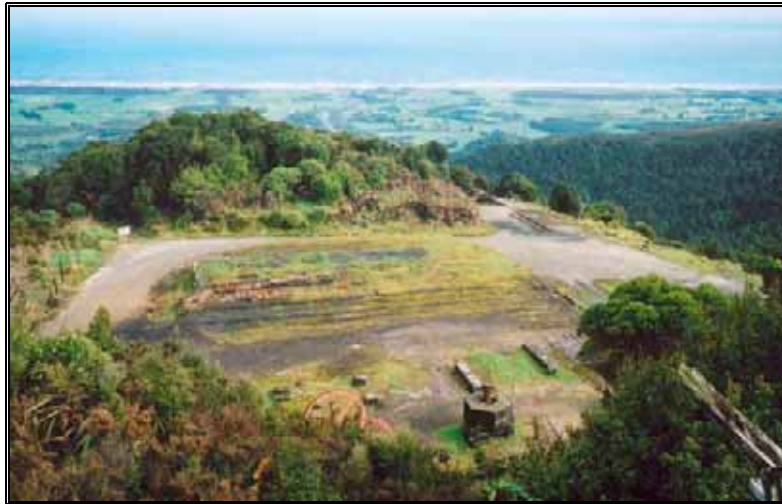
Figure 39

A general view of the bins site from the carpark above. The bins were in the centre of this view. To the upper right is the top of the incline. The road that curves around behind the bins was cut when the incline closed in 1967 to allow trucks to load from the bins.

All that remains of the bins themselves are a series of heavy timber beams set into the ground ('B' in Figure 37, and see also Figure 39). There is ample evidence of the fire that destroyed the bins in 1979, as the timber beams are charred, and there is still a great deal of coke (created by heating coal in the absence of oxygen, as would have happened in the centre of the fire). Although most of the debris of the destroyed bins have long since been cleared away, a surviving cast iron cable wheel is sitting on the site, and has been distorted in the fire (Figure 40). As iron melts at 1,535°C, this illustrates how hot was the fire at the bins.

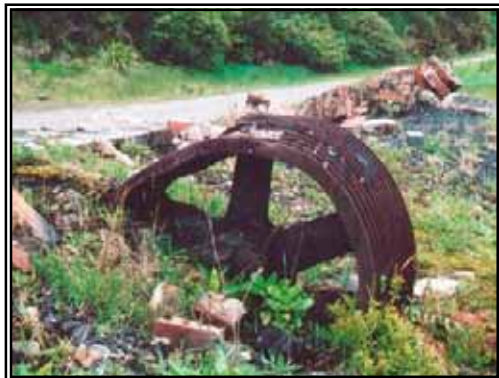
Figure 40

An iron cable wheel at the bins site. Note how this has begun to distort in the heat of the fire that destroyed the bins.

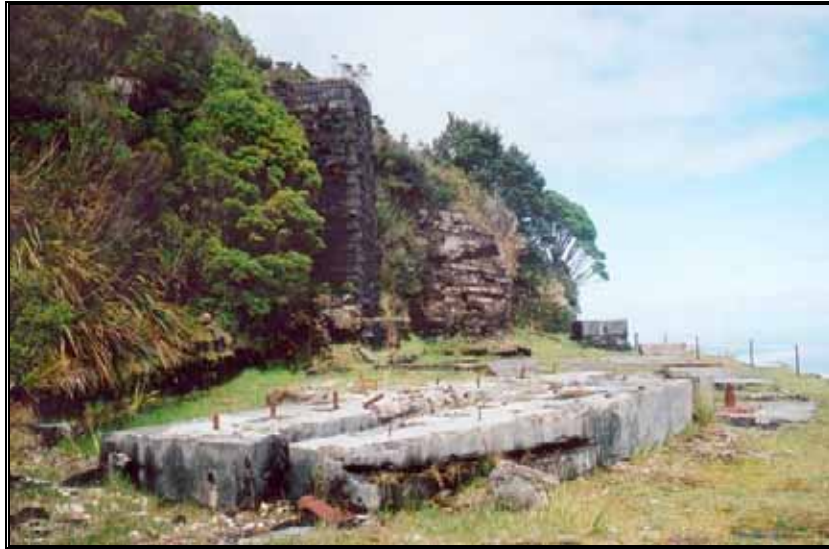
Figure 41

The concrete bed for the rope road hauler in the foreground, with the boiler house site behind. At the left rear is the ashlar masonry chimney base for the power house.

The power house and winding house for the rope road were situated on the top terrace of the Brakehead site ('G' and 'H' on Figure 37). The power house was equipped with four boilers, but all that remains now is the concrete floor and the base of the stone chimney, the top of which was demolished by the Murchison earthquake in July 1929. The chimney base displays some of the finest stonework to be found at Denniston, all of the revetment work at the Brakehead being quite rough. The concrete bed of the hauler for the rope road is situated immediately to the east of the power house. To the west of the boiler house site are a series of concrete foundations for a generator (J. Green, pers. comm.).

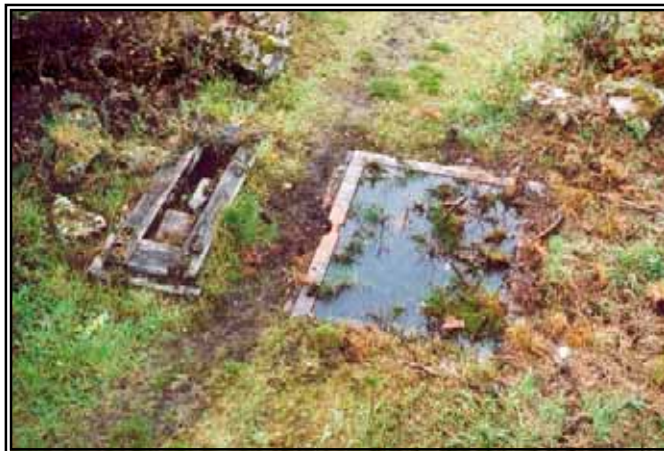
Figure 42

The weighbridge on the rope road between the workshop and power house sites.

From the hauler site, the rope road formation leads off to the south, towards the workshops site (Figure 43). On the rope road formation the remains of the weighbridge are still obvious (Figure 42), close to the brick chimney from the Smoko Shed (see Figure 43).

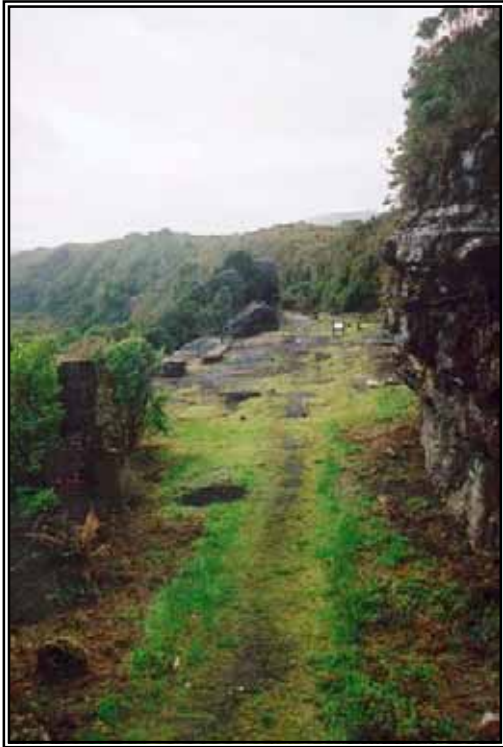
Figure 43 (left)

A view along the site of the workshops in 2006, standing on a slip boulder beside the weighbridge. This view looks directly down the line of the rope road. The rocks on the right have names and dates marked on them. The chimney of the smoko shed is on the left.

There were numerous buildings in the workshops complex, including the Fitters' Shop, Welding Shop, Blacksmiths' Shop, Tub Repair Shop, and various storage sheds. What remain now are numerous concrete machinery beds, the stubs of iron girders from the frameworks of some of the buildings, timbers and a scatter of artefacts (see Figures 43 and 44).

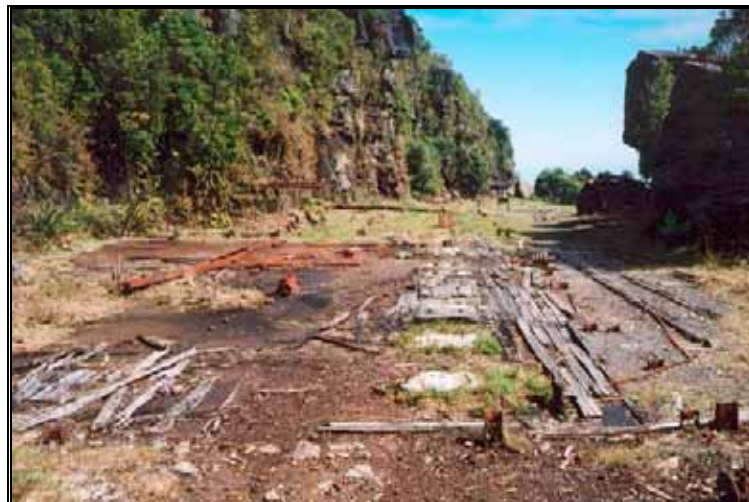
Figure 44

The site of the Fitters' Shop in 2006. The concrete beds for various lathes and the steam hammer can be seen. The rope road formation is on the right.

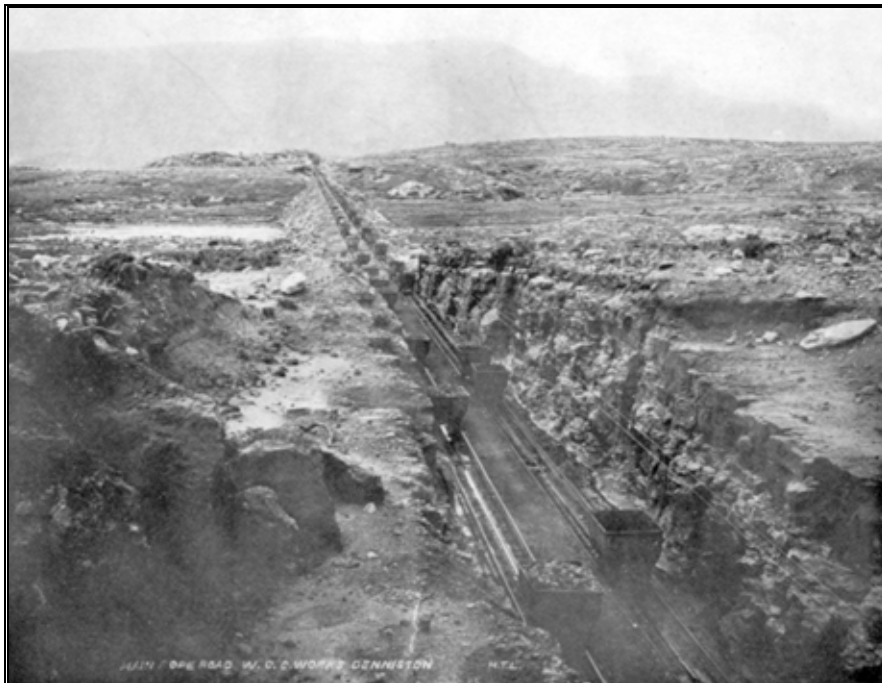
Figure 47
The rope road between Burnett's Face and the Brakehead in about 1906.
(Morgan & Bartrum 1915)

The rope road was laid with 30lb to the yard steel rails, to a gauge of 2ft., carrying mine tubs with a capacity of 12cwt. (609kg). The tubs were attached to the rope by means of chain clips, and were delivered to the screens at a rate of eighteen score per hour (NZ Mining Handbook 1906: 400).

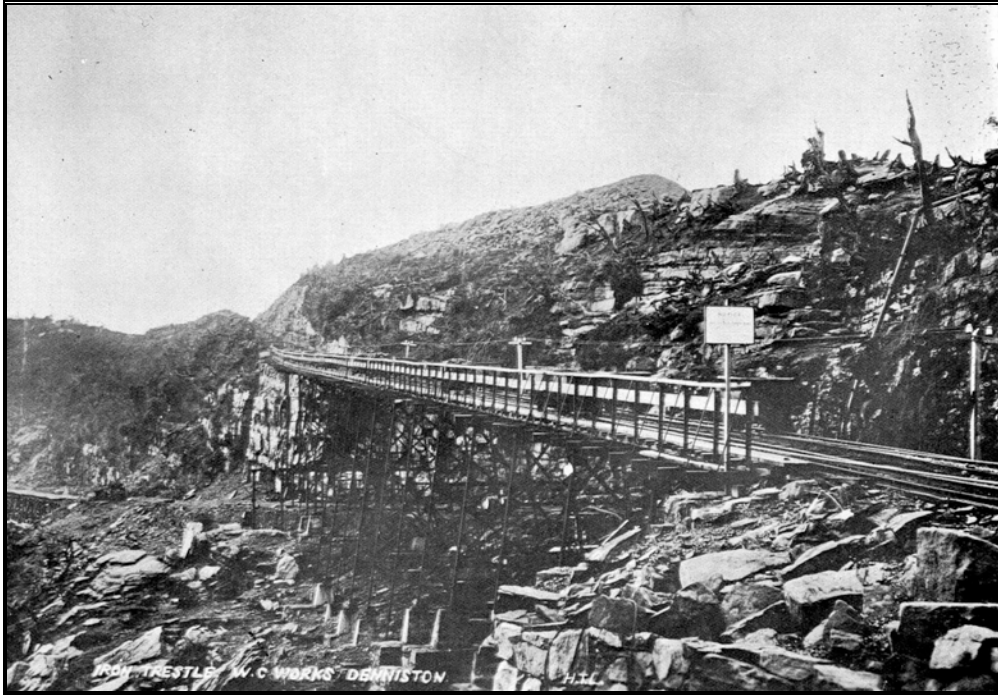
Figure 48
The rope road trestle just past the workshop site in about 1906. The old tramway to the Banbury Mine can be seen to the left, at a lower level than the far end of the new trestle. (Morgan & Bartrum 1915).

From the Brakehead the rope road passed the workshops and then immediately was carried on an iron trestle (Figure 48). Most of this trestle has now collapsed or been felled, and many twisted girders and cast iron posts lie in the scrub. But a short length at the south-eastern end is still standing (Figure 49).

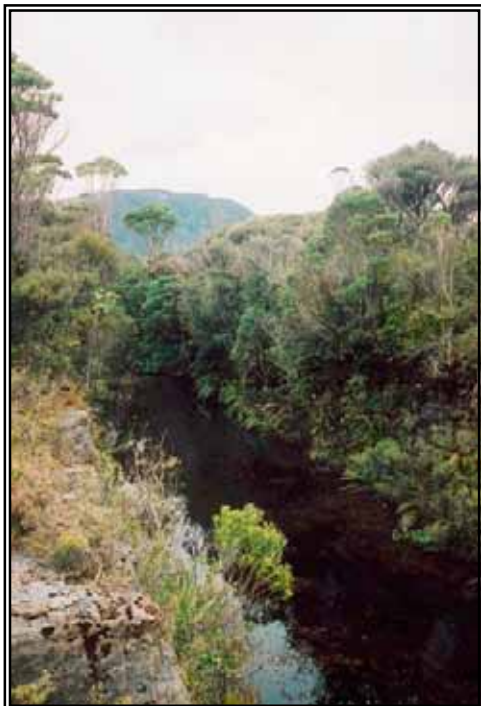
Figure 50 (left)
The rope road formation where it passes Denniston. A road embankment has blocked the cutting, causing it to flood.

Beyond the trestle the rope road ran in a series of shallow cuttings or embankments across the plateau. Much of this line is now partially overgrown, and sections in cuttings have become boggy. One section where the rope road passed Denniston, and a side road crossed the rope road twice, has had the two road bridges replaced by embankments, effectively damming the rope road, which is now flooded for a distance (Figure 50).

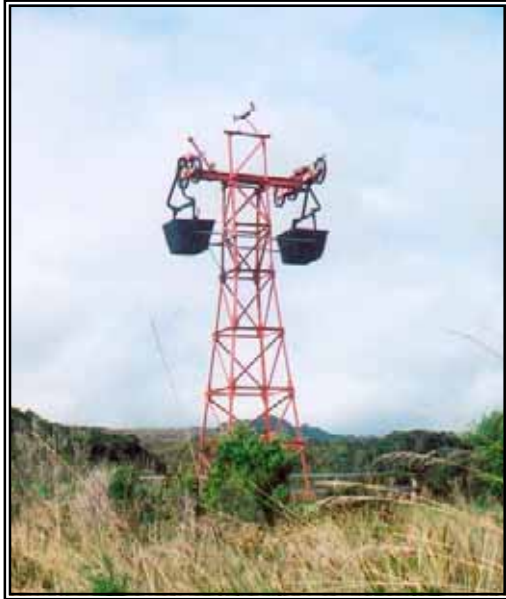
Figure 53

The surviving aerial ropeway tower above the Brakehead in 2006. This tower is maintained by the Department of Conservation. Two buckets have been mounted on the tower to give an impression of how it would have appeared when working. Note that the buckets have been braced to withstand the strong winds in this area.

Most of the cableway towers were removed for scrap, but several were left standing and are now maintained by the Department of Conservation (see Figure 53). The terminal tower at the bins (with giant return wheels) and the tensioning mechanism were also left on site adjacent to the bins. The terminal tower remained for some years after the bins were destroyed by fire in 1979 (Figure 52), but it was finally demolished in the 1990s. The two return wheels were then set up on new concrete plinths in front of the place that the tower stood.

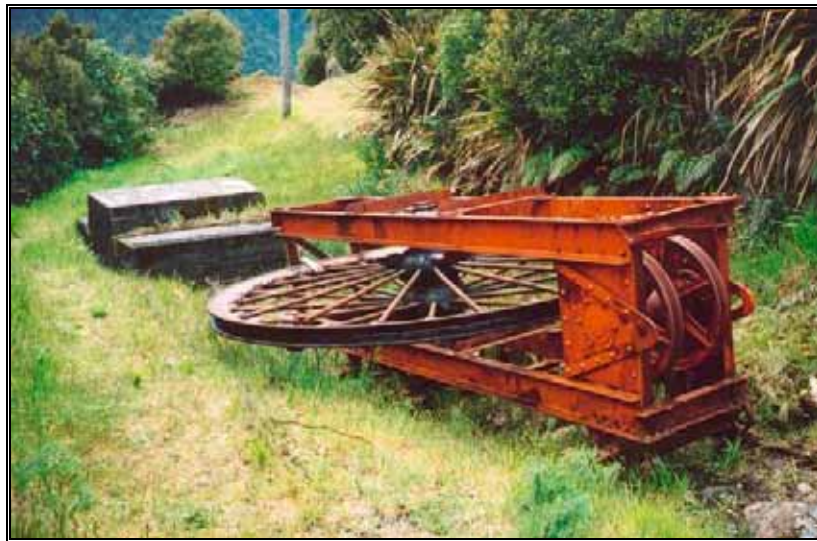
Figure 54

The Monocable Aerial Ropeway tension trolley in 2006. This can also be seen in the middle of Figure 51, beneath the closest tower.

Parts of the cable tensioning apparatus do survive, on the hillside above the bins site (Figure 37). These consist of the tension trolley (Figure 54), part of the back balance adjustment, and the back balance weight. The way these operated is illustrated in Figure 55.

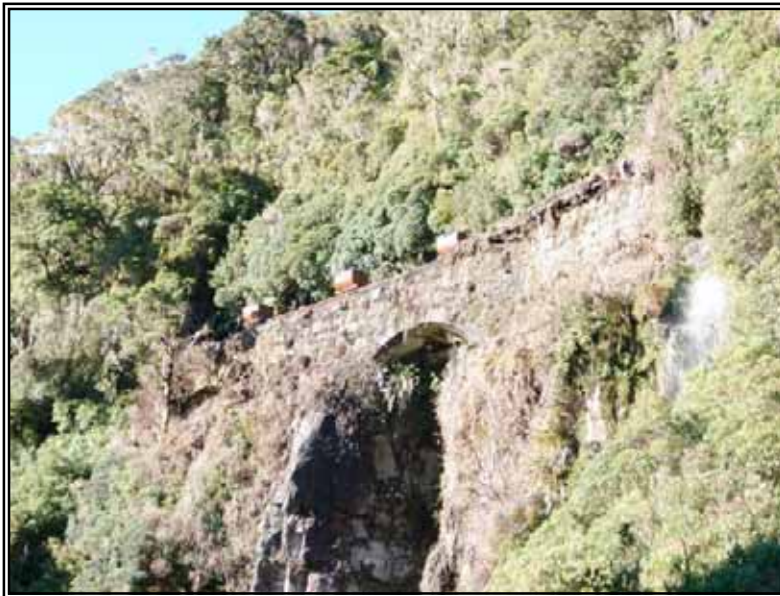
Figure 57
The entrance to the Banbury Mine in 2006.

The Banbury Mine has been gated just inside the portal to prevent visitor entry. It is not known how much of the underground workings remain standing.

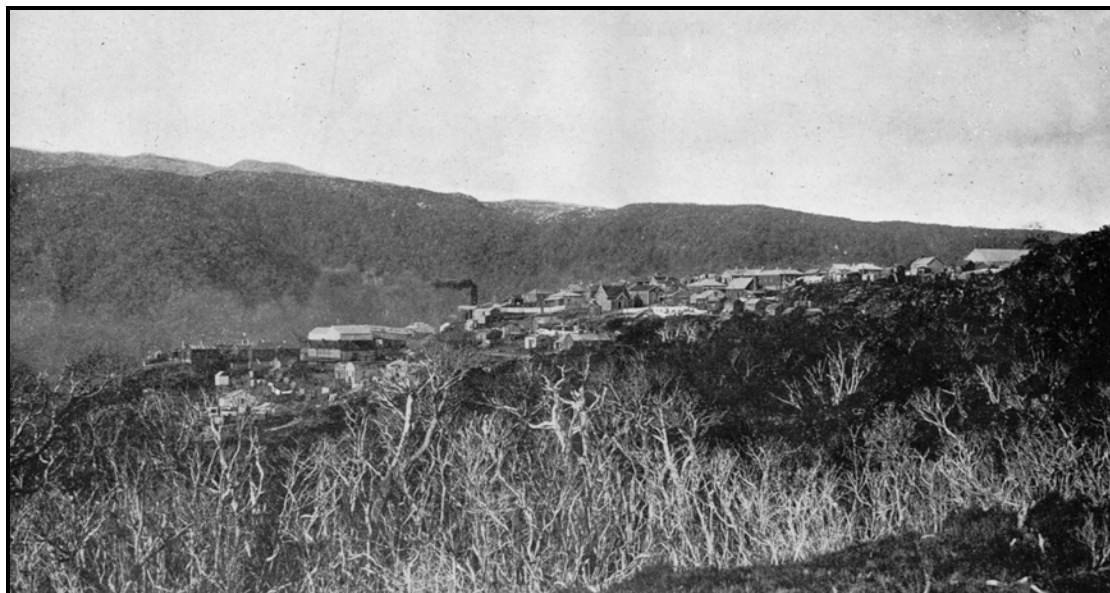
Figure 58

Denniston in 1906. The bins at the Brakehead can be seen to the left of centre, with the smoke from the power house chimney to their right. By this date houses were spread from the Brakehead all the way up to the plateau (Morgan & Bartrum 1915).

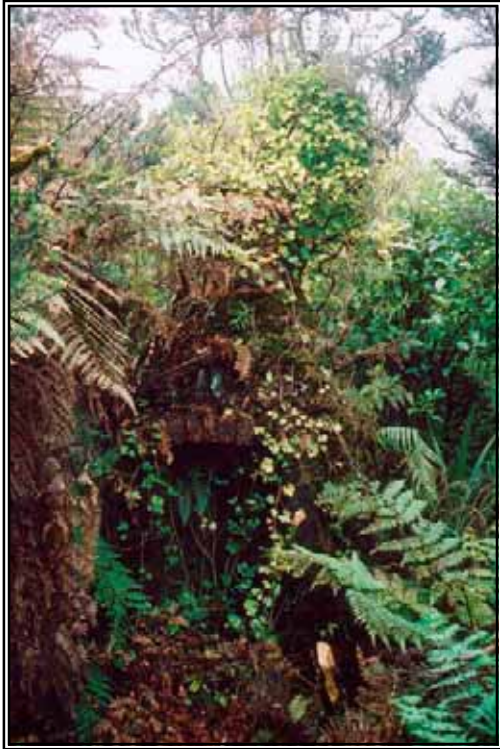
Figure 61
The overgrown (by introduced ivy) brick chimney of Harrison's Hotel (site 16) at the Camp in 2006.

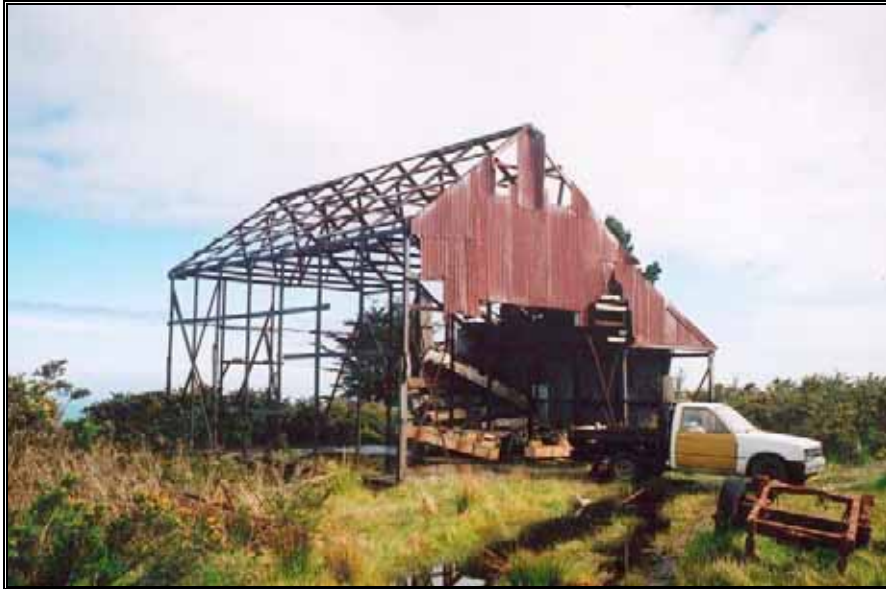
Figure 63
The old State Mines Department workshop at Denniston. Site 9 in Figure 62.

- 1 Brakehead.
- 2 Site of carpenters' shop.
- 3 Foot track.
- 4 Abandoned section of foot track (overgrown).
- 5 Two brick chimneys and concrete water tank beside a clear grassed area.
- 6 Chimney and concrete tank (overgrown).
- 7 Chimney base and water tank.
- 8 Chimney bases.
- 9 Steel frame of workshop for Monocable Aerial Ropeway (Figure 63).
- 10 Old ambulance shed.
- 11 Police house and gaol (privately owned).
- 12 Remains of three houses. Chimneys and chimney bases in recently cleared area.
- 13 Fire station building. Privately owned.

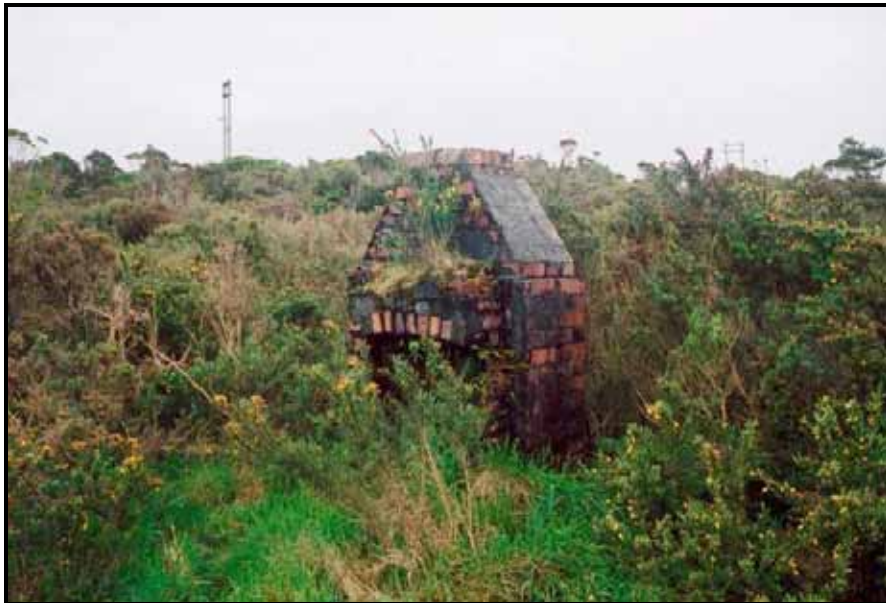
Figure 64
Typical brick fireplace at an abandoned house site, surrounded by gorse. Site 20 in Figure 65.

- 14 Chimney and timbers.
- 15 brick chimney and concrete foundations.
- 16 Concrete water tank and old car chassis.
- 17 Concrete foundations of doctor's house.
- 18 Concrete foundations.
- 19 Brick chimney, wooden piles and garage site.
- 20 Concrete water tank, brick fireplace (Figure 64), timbers.
- 21 Concrete water tanks.
- 22 Chimneys.
- 23 Chimney and timbers beside row of pine trees.
- 24 Fireplace and concrete foundations. Site of Catholic Church.
- 25 Two brick chimneys.
- 26 School site.

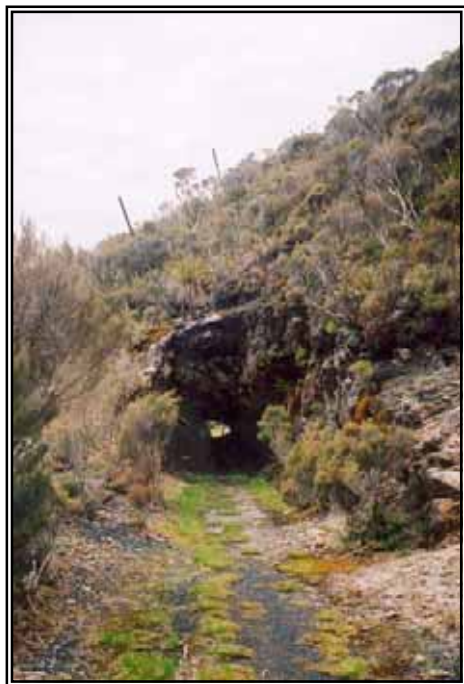
Figure 68 (left)
The tunnel at the Coalbrookdale Sheds. A view looking from the western (mine) end.

The site of the Coalbrookdale Sheds is reached by following the walking track along the old rope road from Burnett's Face. After two long straight stretches, the rope road bore right, crossed two bridges and passed through a 48 metres long tunnel (Figure 68). On the western side of this tunnel is a flat area with a two-storey brick chimney.

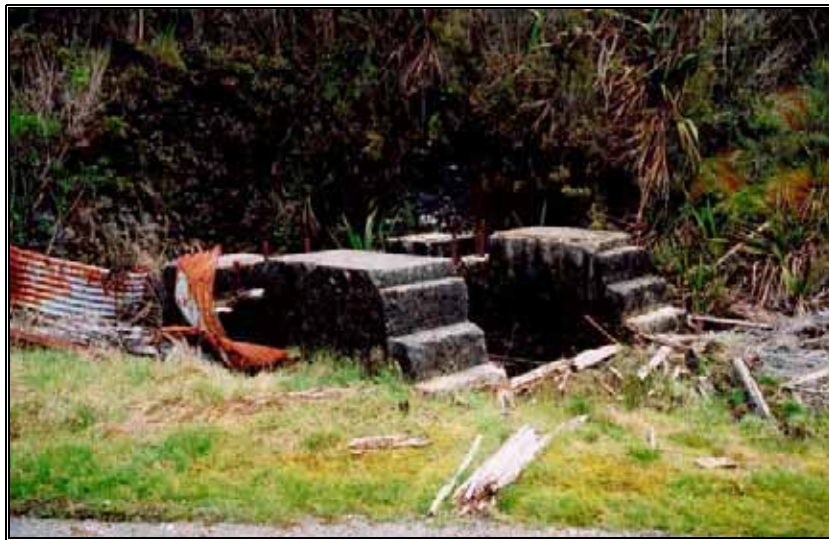
Figure 70

The bed for the hauler that powered the rope road along the Coalbrookdale Valley from the Coalbrookdale Sheds to Burnett’s Face. It is surrounded by timber building debris, and an old corrugated iron water tank

The three hauler beds are situated close to each other, and each faces squarely the line of the rope road that it once powered.

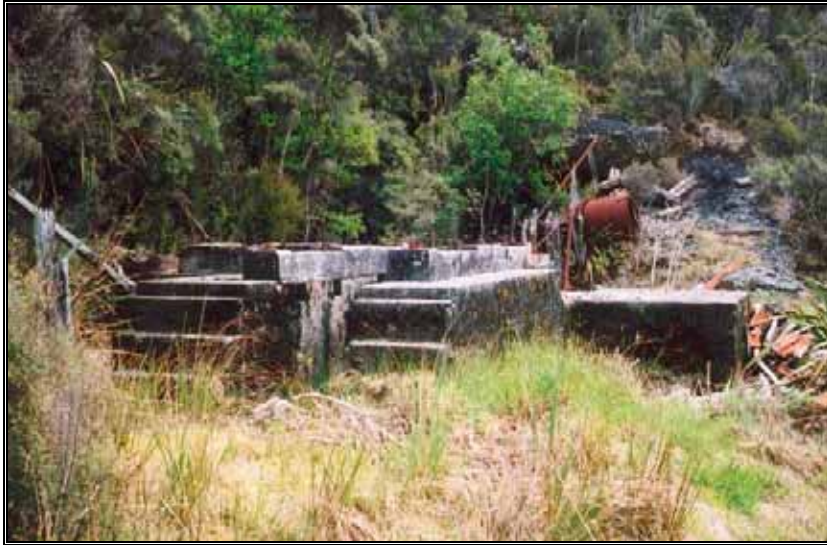
Figure 73

The hauler that drove the rope road on the western side of the stream from the Coalbrookdale (Wharearea section) Mine prior to the reconstruction of the system in 1946-47. Behind the bed are the remains of the counterweight tension system that kept the rope road cable taut.

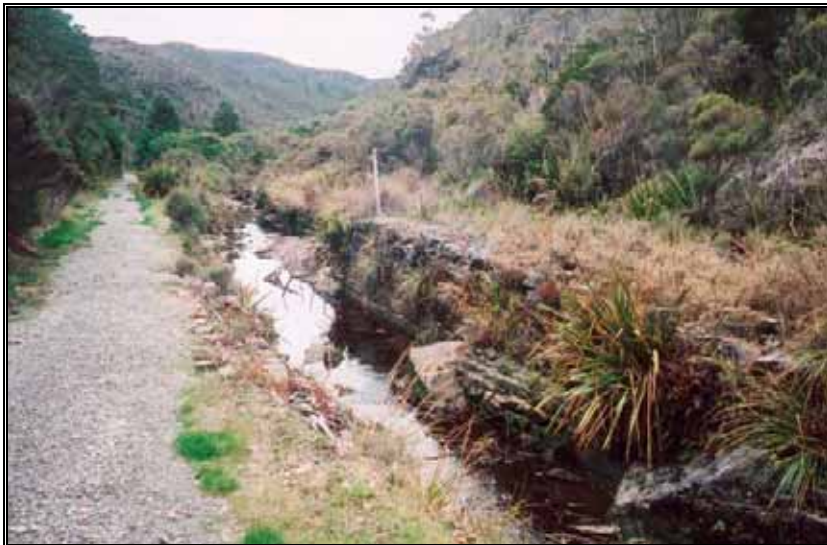
Figure 74

A view looking to the north along the Coalbrookdale Valley towards the Coalbrookdale sheets (out of sight). The walking track (on the left) follows the old rope road formation to the Coalbrookdale Mine (Whareatea section), while on the other side (right) of the stream is the old Cascade rope road that was changed over to the Coalbrookdale Mine in 1946-17.

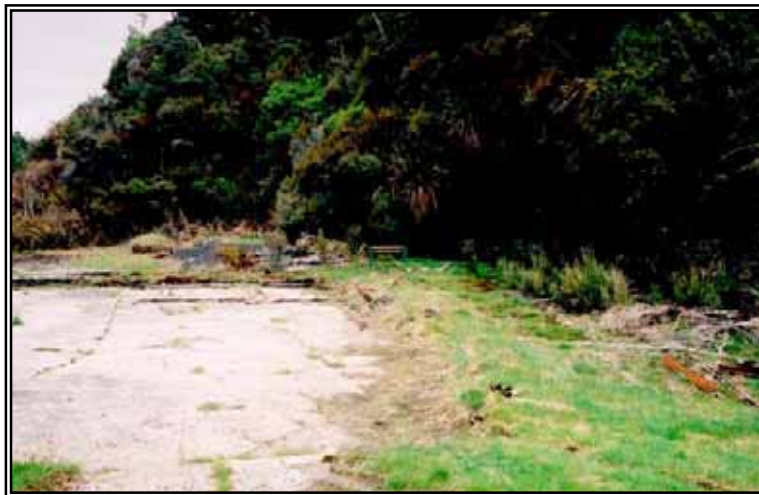
Figure 75
The floor of the Coalbrookdale bath house (left) and the entrance to the Coalbrookdale Mine (right).

The site of the bath house and entrance to the Coalbrookdale Mine is today kept clear by the Department of Conservation. When the Sumner & Sumner surveyed it in 1983 this area was heavily overgrown in gorse (Sumner & Sumner 1983: 102). The concrete floor of the bath house is now (2006) clearly visible, along with the bases of some of the cubicle division walls. The foundations have been partially cut through by the construction of a later rope-road from the Coalbrookdale Mine entrance (discussed further below). The surviving foundations indicate that the bath house building measured 34 metres by 9.5 metres (111ft 6in by 31ft). On the west side of the bath house foundation are two brick fireplaces and a brick foundation. Sumner & Sumner (1983: 105, item 16) identified these as being part of the mine offices.
