ARCHAEOLOGICAL SURVEY REPORT
FOR
THE DEPARTMENT OF CONSERVATION
WEST COAST CONSERVANCY

P.G. PETCHEY
SOUTHERN ARCHAEOLOGY LTD.
2007

Looking down the Denniston Incline towards Waimangaroa and the Tasman Sea.

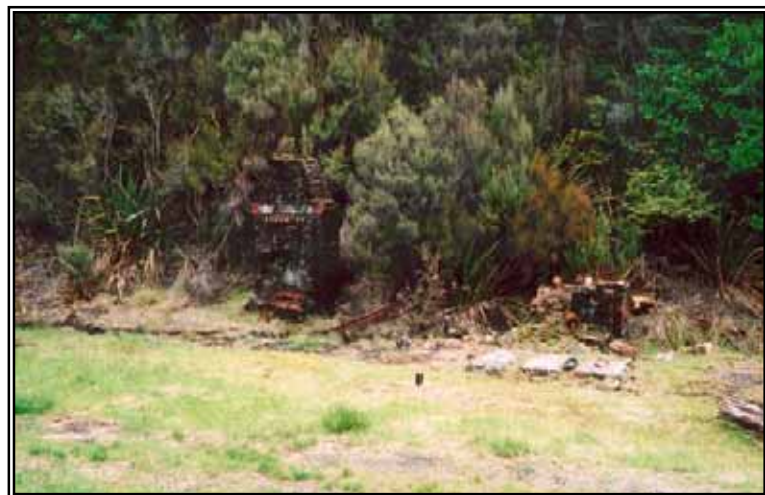
Figure 76
The chimneys of the mine offices beside the entrance to the Coalbrookdale Mine.

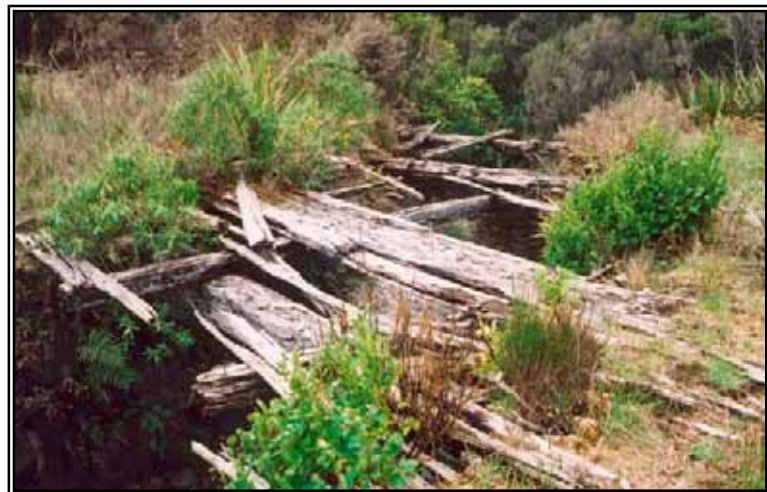
Figure 79
The bridge over the Coalbrookdale Stream. Note the pile of discarded wire rope beside the track. This is discarded hauling cable from the rope road.

All four bridges (the three over the side stream and one over the Coalbrookdale Stream) were still partially standing in 2006 (Figures 78 and 79). The main stringers were all still in place, although obviously decaying, but the rest of the woodwork was in poor condition. The present walkway bridge is built over the western bridge (but does not rely on it for structural strength).

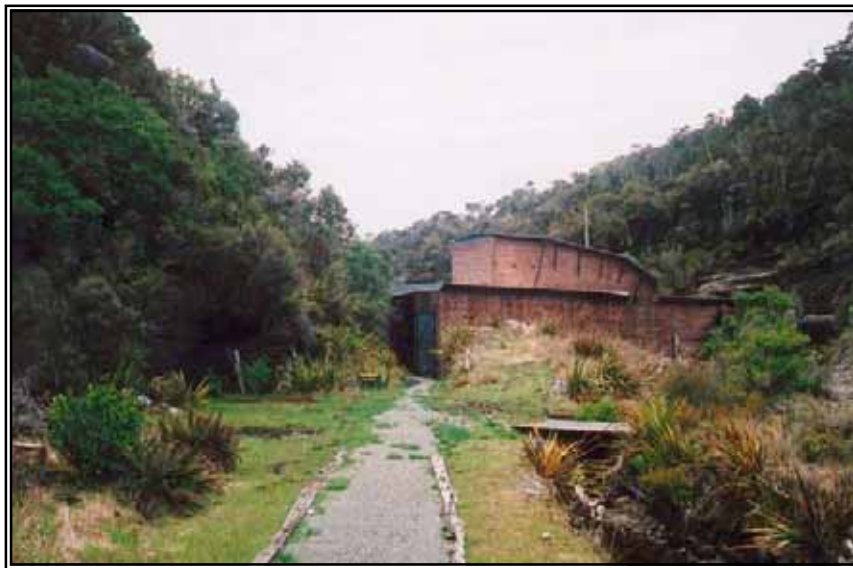
Figure 80
The 1912 Fan House with the entrance to the Cascade section of the mine on the left. This view looks along the walkway, which follows the line of the old rope road. In the left foreground is the site of the stables and mine office.

Today the 1912 Fan House is the main destination feature at the end of the Coalbrookdale walkway. The brick Fan House (Figure 80) is actively managed by the Department of Conservation, and has recently had a roof built over it to prevent water damage. The original concrete roof is still in place. New doors have also been installed, preventing visitor access into the Whareatea section of the mine. The Cascade return airway is also blocked.

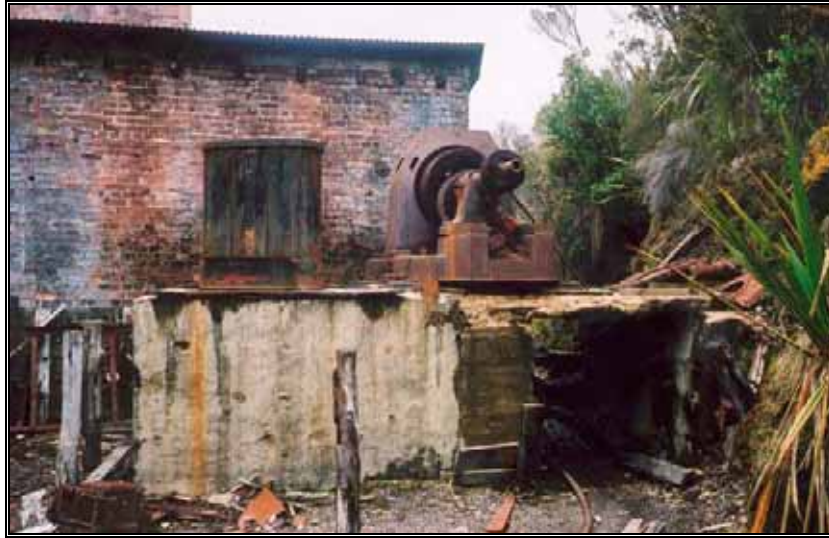
Figure 82

The motor floor at the rear of the Fan House, showing the transformer (left) and electric motor (right).

At the rear of the Fan House is the concrete motor floor, along with the stripped-down remains of the power transformer and electric motor that drove the fan (Figure 82). The motor house superstructure does not survive, although the Fan House Conservation Plan (Wright 2000) recommends the construction of a roof over the surviving motor parts.

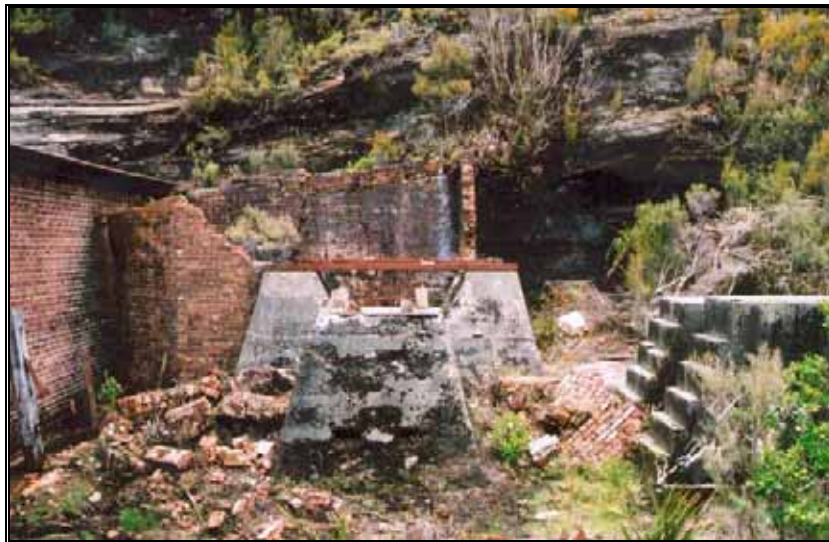
Figure 83

The remains of the 1904 Fan House, with the 1912 replacement to the left. In the right foreground is part of the steam engine foundation for this fan. In the right background is an opening to the mine.

On the north-west side of the Fan House are the remains of the earlier, 1904, Fan House and its steam engine foundations (Figure 83). Behind these is a fenced-off opening to the mine.

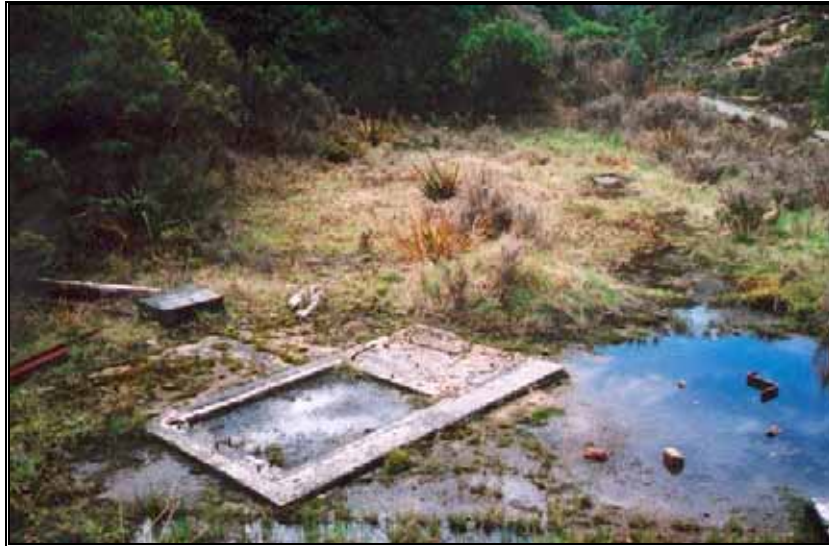
Figure 84

The pit pony paddock and the concrete winch foundation for the Cascade section of the Coalbrookdale Mine. This was originally the site of the steam plant and air compressors for the mine.

On the western side of the stream and track, to the north-west of the Fan House is an area that was used as a paddock for pit ponies. This had earlier been the site of several industrial buildings. The concrete foundations (Figure 84) at the southern end of the paddock are from a winch house for the Cascade workings, and a structure is visible there in the 1946 aerial photograph of the area (Run 1277). This paddock area had earlier been the site of the steam plant and compressors for the mine (and presumably the Fan House prior to electrification). A distinctive indentation in the bank at the rear of the area was the site of the chimney (Notes from G. Kitchin).
