CHASM STREAM RAILWAY LINE, SEDDONVILLE: AN ARCHAEOLOGICAL ASSESSMENT

ROSIE GEARY NICHOL AND KATHARINE WATSON
UNDERGROUND OVERGROUND ARCHAEOLOGY LTD

NOVEMBER 2013

UNPUBLISHED REPORT FOR COLLIERS LTD

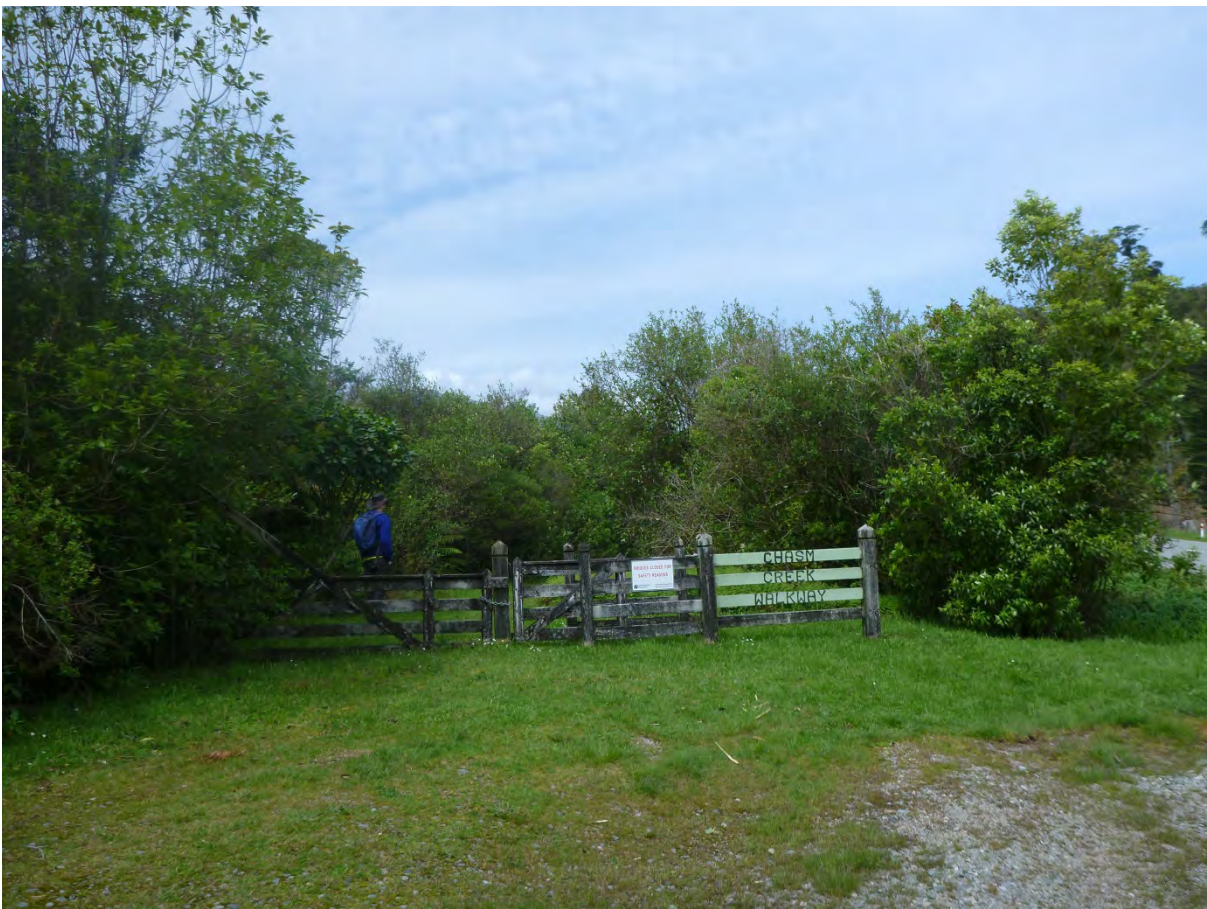
Looking east along towards the 'start' of the Chasm Stream railway line (although the sign refers to 'Chasm Creek', topographic maps call the relevant stream Chasm Stream).

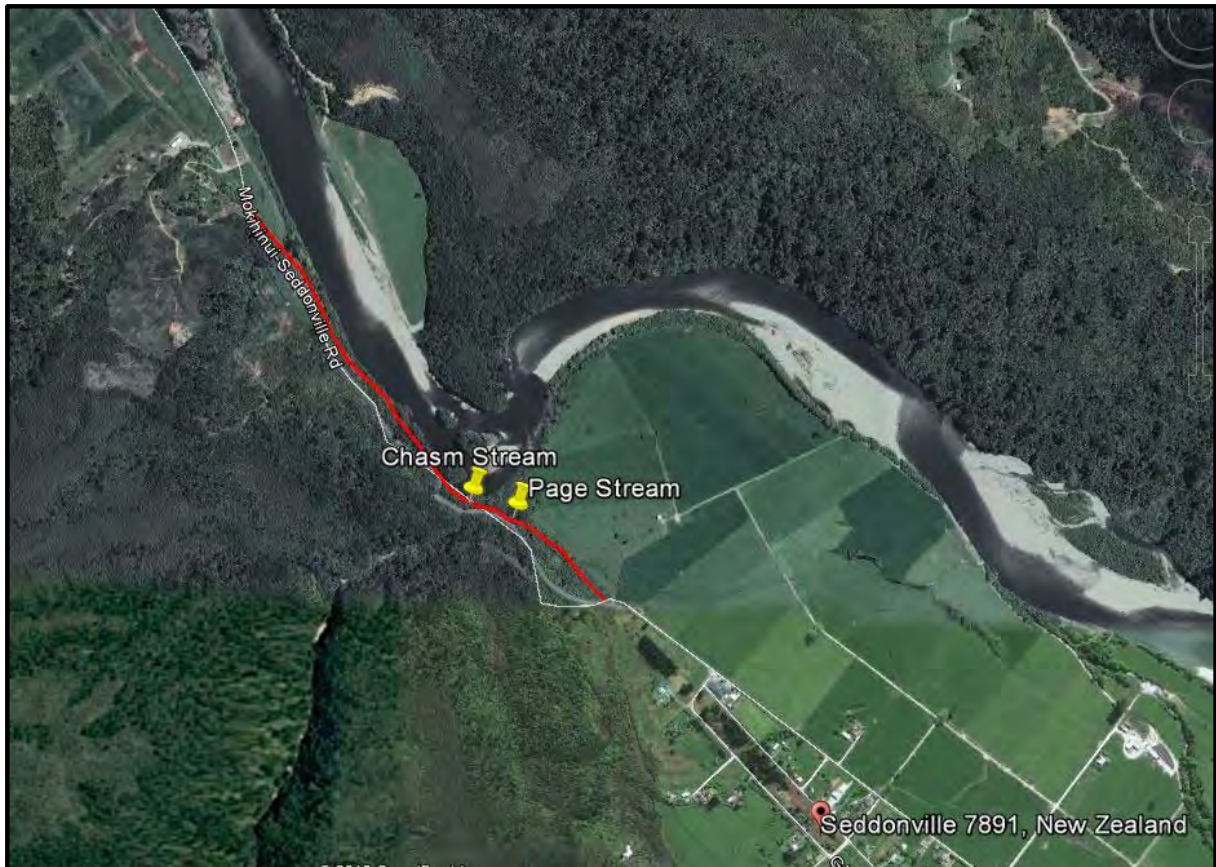
Figure 2. The red line on this aerial photograph shows the location and extent of the Chasm Stream railway line. The two bridges that remain in situ on the line cross Chasm Stream and Page Stream. Image: Google Earth.

Land Information New Zealand (LINZ) manage some unallocated Crown land at Seddonville, which is the site of a former railway line (Figure 1 and Figure 2). Until recently, this section of railway line has been a public walk but recent concerns about the safety of two bridges on the railway line/walk led to the closure of the walk. The bridges cross Chasm Stream and Page Stream, and as such, this section of railway line is referred to as the 'Chasm Stream railway line' throughout this assessment. Colliers subsequently commissioned this assessment on behalf of LINZ, to determine whether or not – and to what extent – the archaeological provisions of the Historic Places Act apply to the Chasm Stream railway line. This line comprises the line itself, two bridges and a tunnel. The assessment has been prepared in accordance with NZHPT (2006) guidelines on preparing an archaeological assessment. At this stage there is no proposal to alter the archaeological site.

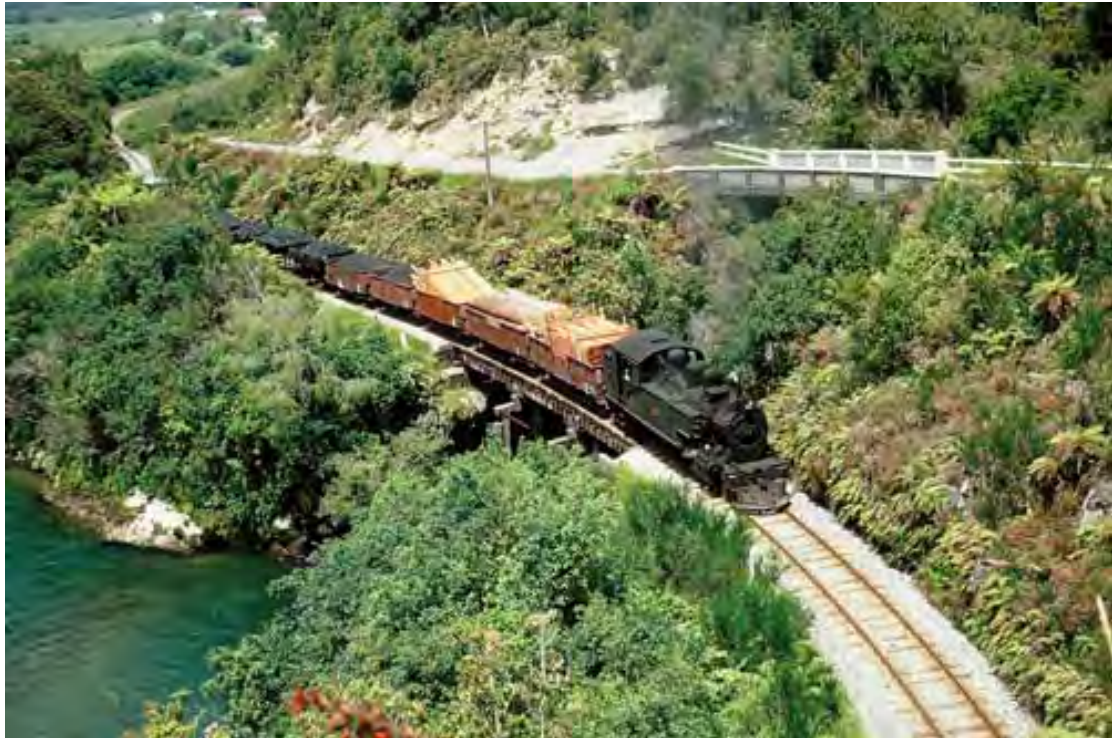
Figure 8 shows a train crossing the Chasm Stream bridge in 1968. It is interesting to note that the train is carrying milled timber and coal.

Figure 8. A train crossing the Chasm Stream bridge in 1968 (McClare 1968).

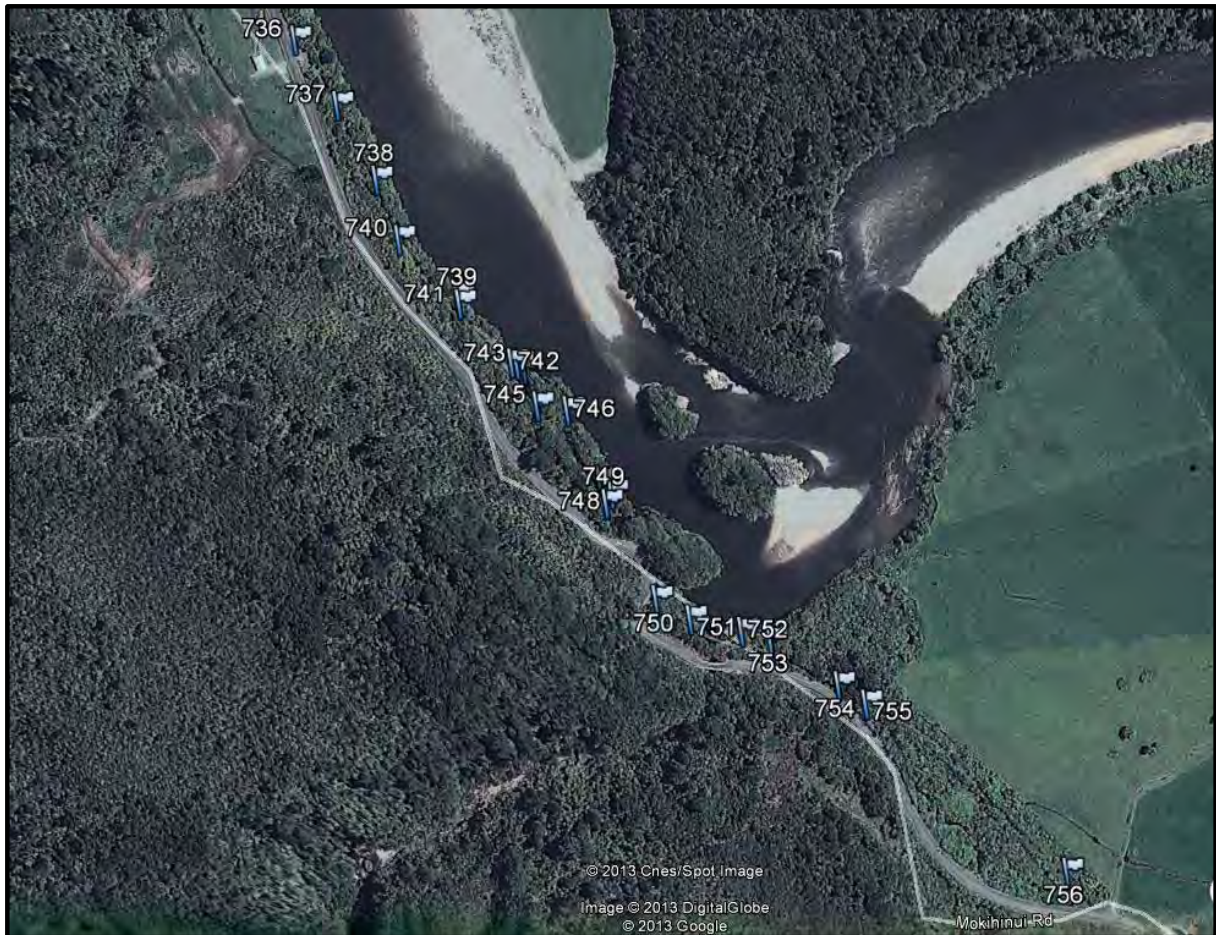
Figure 9. The waypoints recorded during the archaeological survey. Full details about each waypoint are provided in Appendix 1.

The Chasm Stream railway line is 900 m long, and runs along the south bank of the Mokihinui River. The former railway line meets the Mokihinui-Seddonville Road at each end, and there were no doubt level crossings in these areas, prior to the line being lifted. The line was walked from west to east for the archaeological survey (Figure 9).

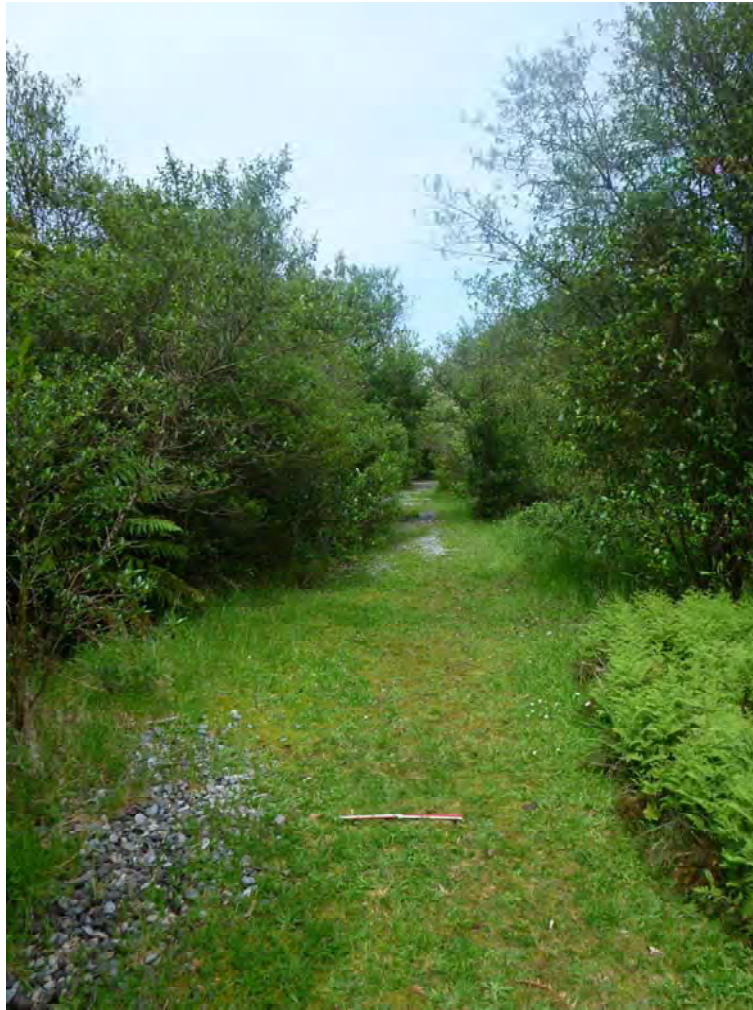
Figure 10. Looking west along the Chasm Stream railway line, waypoint 736. Ballast is visible on the embankment.

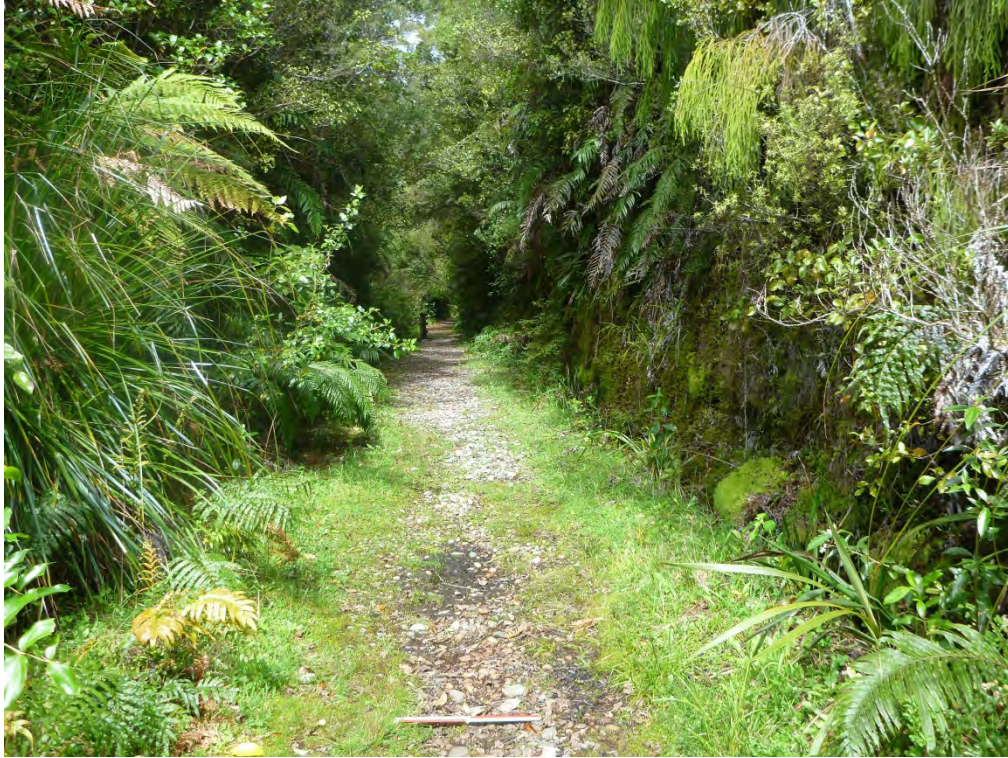
Figure 11. Looking east down the cutting at waypoint 744. This is 3.6 m wide at the base and approximately 27 m long, with a side drain on the south (right) side.

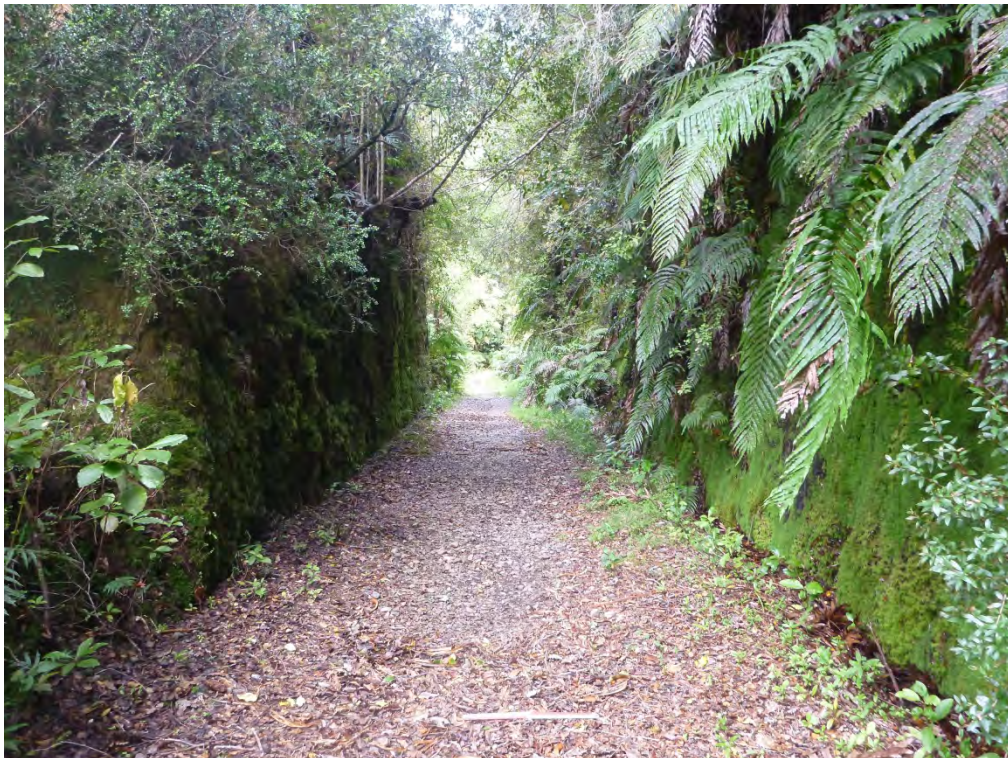
Figure 12. The cutting at waypoint 746. This was 23 m long, and 3.7 m wide, with a side drain on the south (right) side.

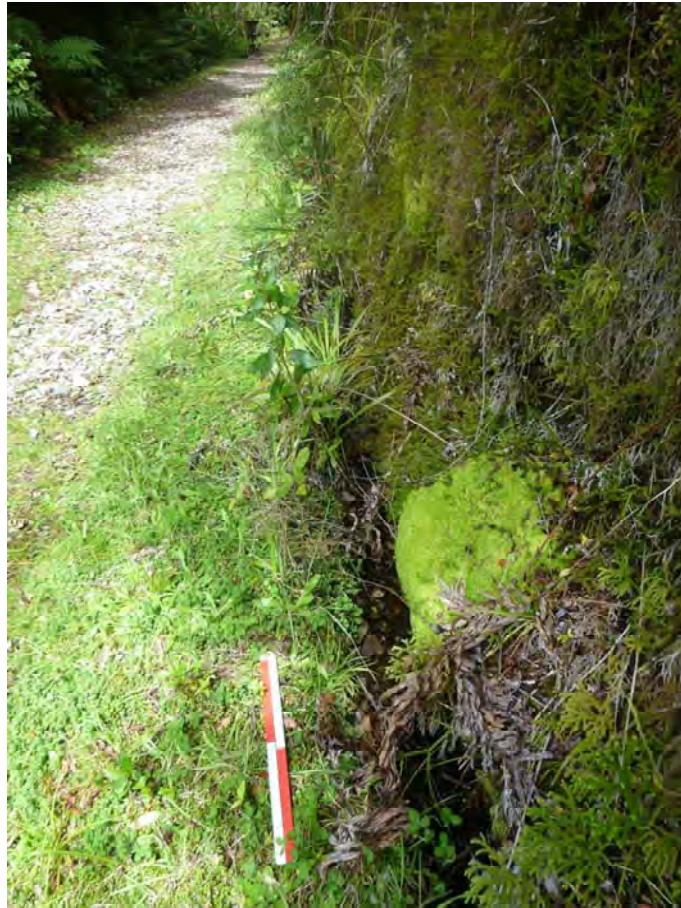
Figure 13. The side drain in the cutting in Figure 11.

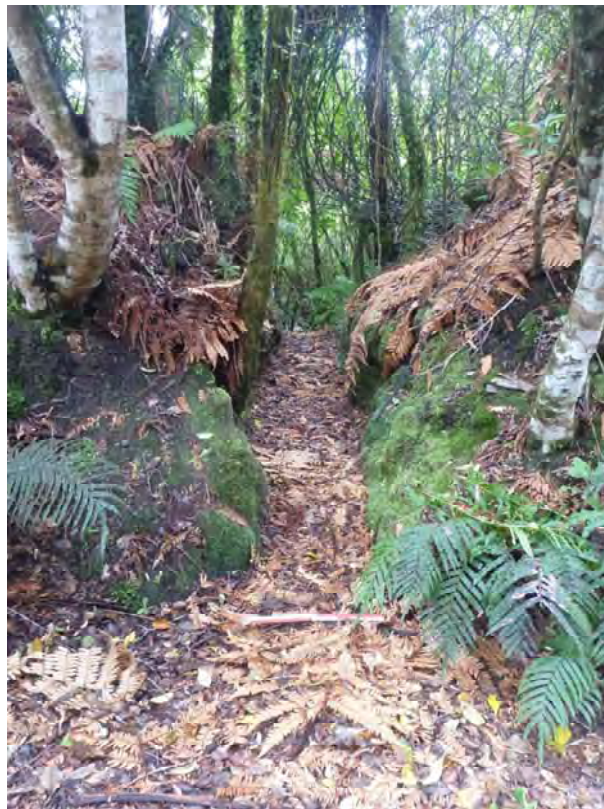
Figure 14. The cut-out on the north side of the longest cutting (waypoint 753).

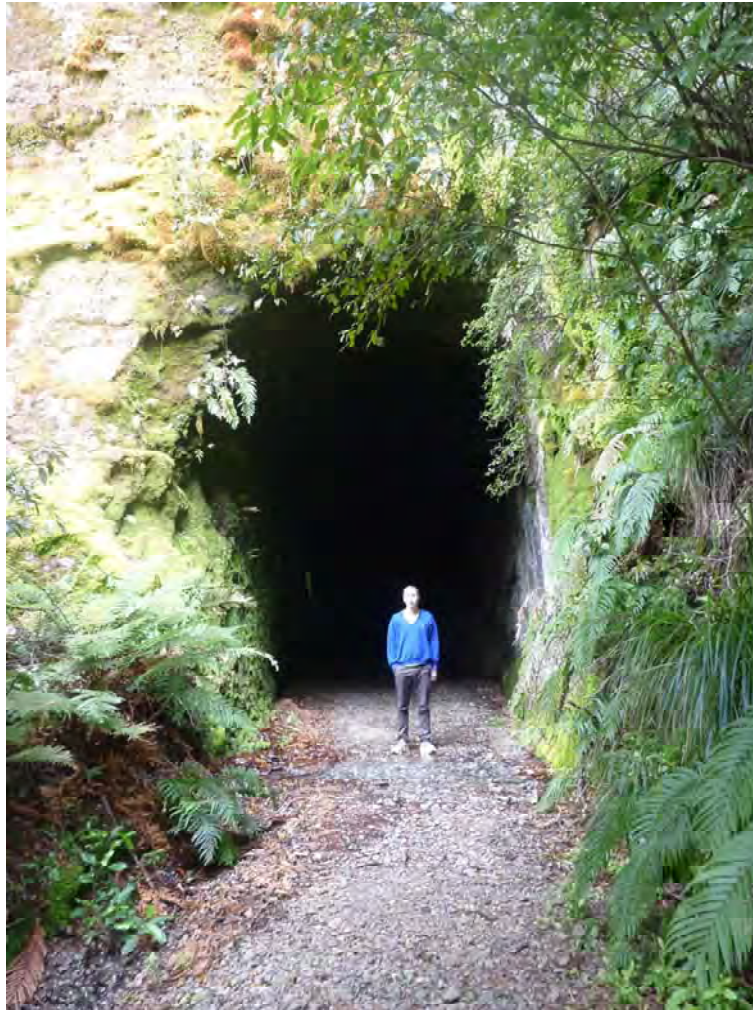
Figure 15. The west end of the tunnel, which is 3.1 m wide and 73 m long.

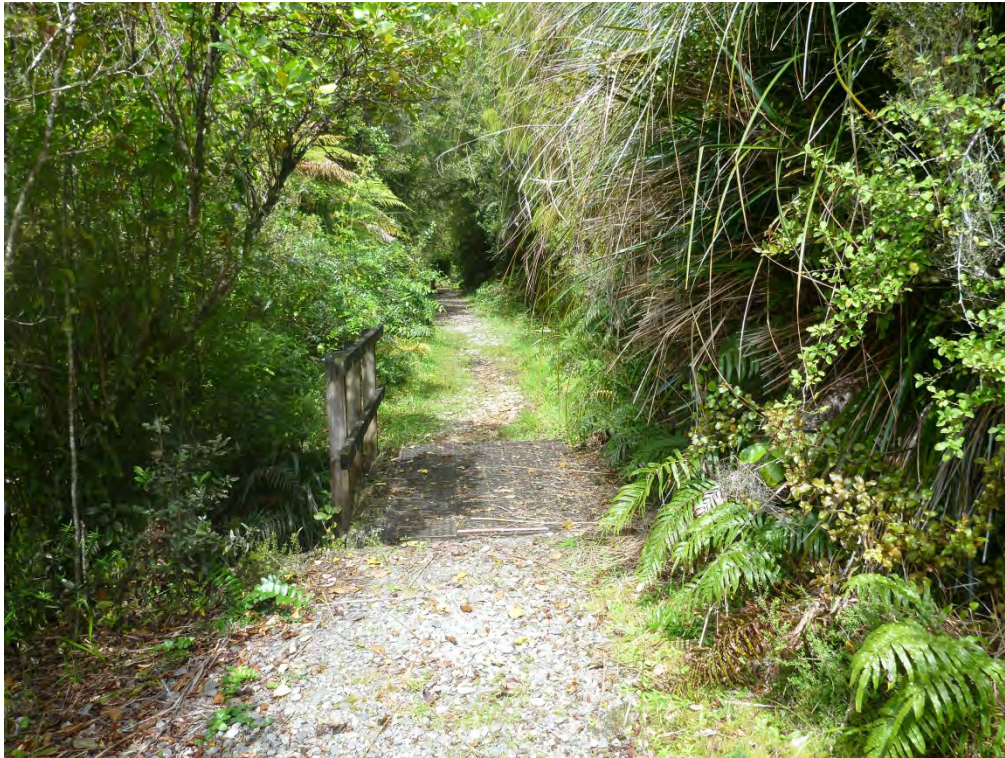
Figure 16. Footbridge 1, at waypoint 742, looking east.

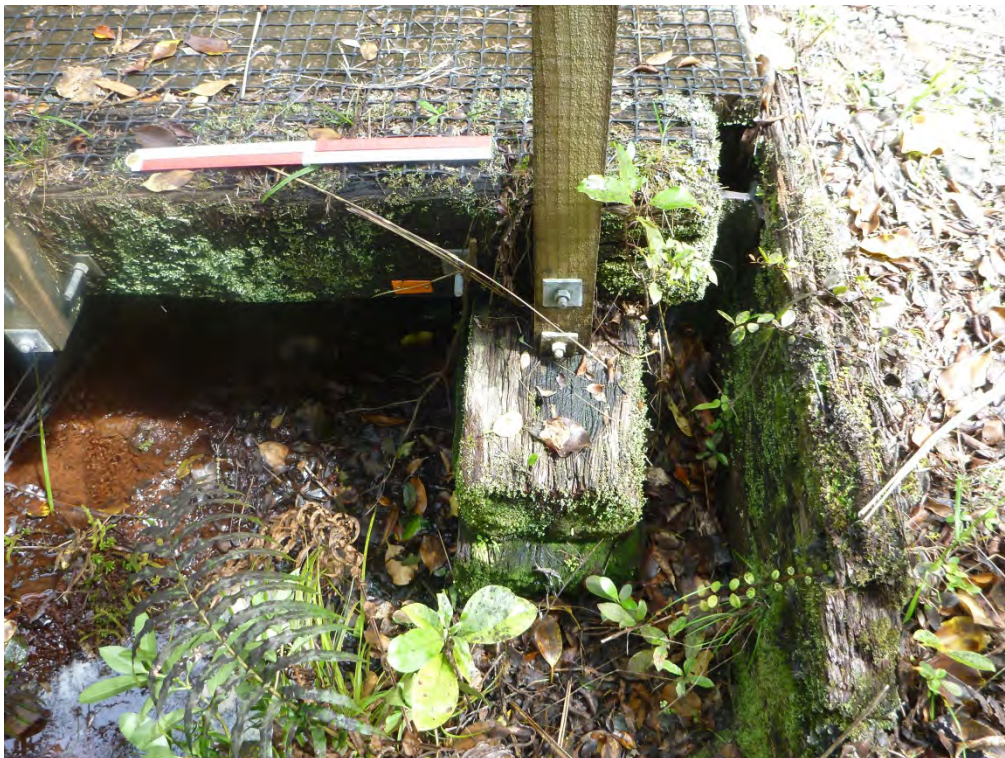
Figure 17. The west end of Footbridge 1, showing the ballast guard at that end.

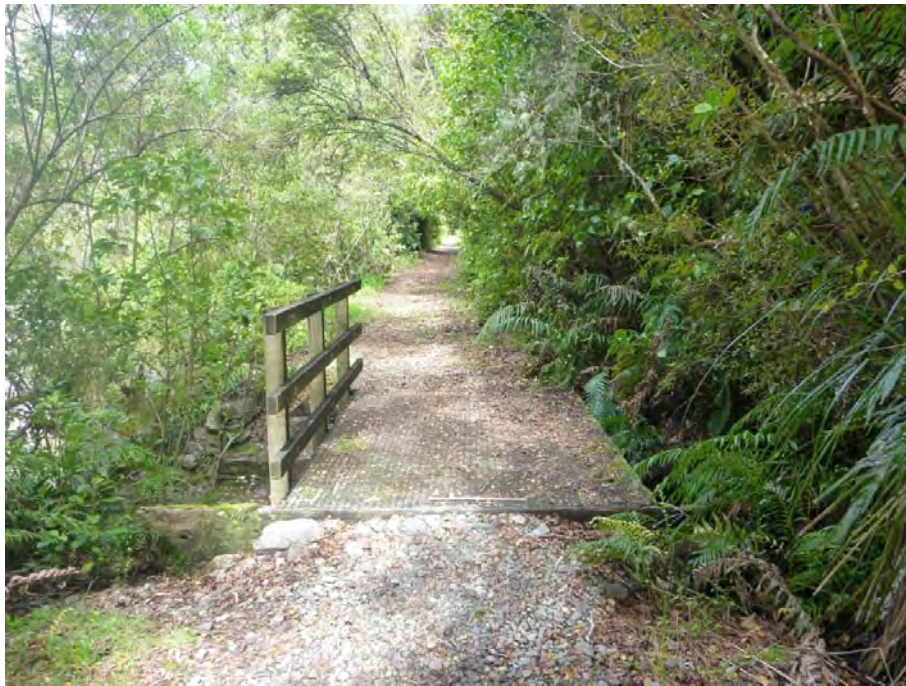
Footbridge 2 (at waypoint 745) has been built over what was clearly an old culvert, which carried water from a stream that flowed through the railway formation (Figure 18). A stone-lined channel (Figure 19) had been formed (and its base lined with concrete) for the stream to run through (Figure 19). There is also stone revetting on the corner of the railway formation on the east side of this bridge, and concrete between the edge of the stone channel and the revetting (Figure 20). The form and nature

Figure 18. Footbridge 2 at waypoint 745, looking east.

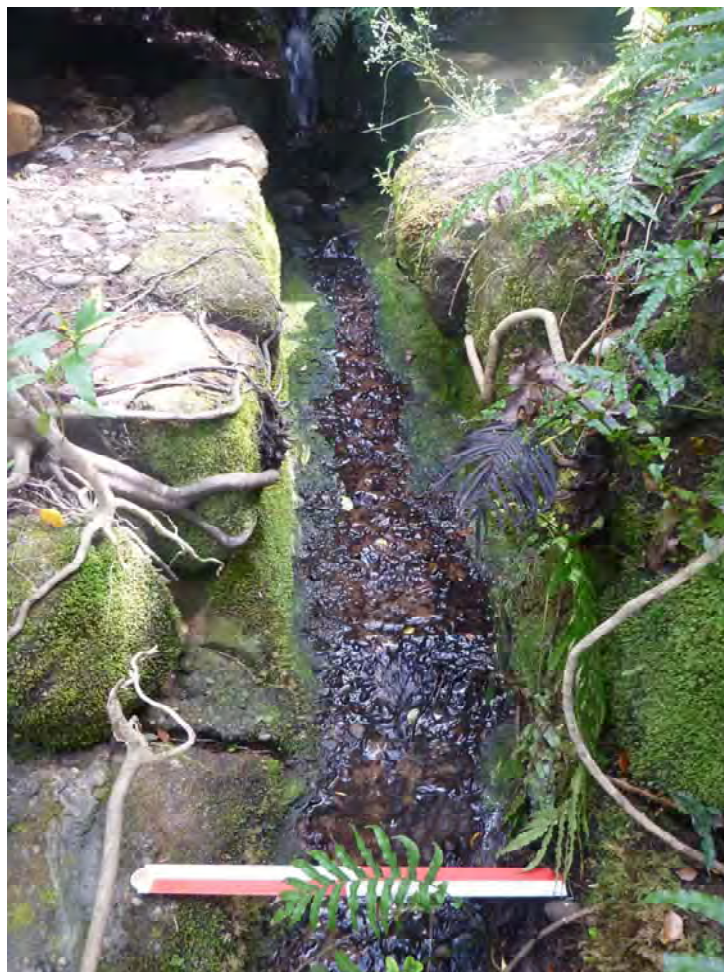
Figure 19. The stone-lined channel under Footbridge 2.

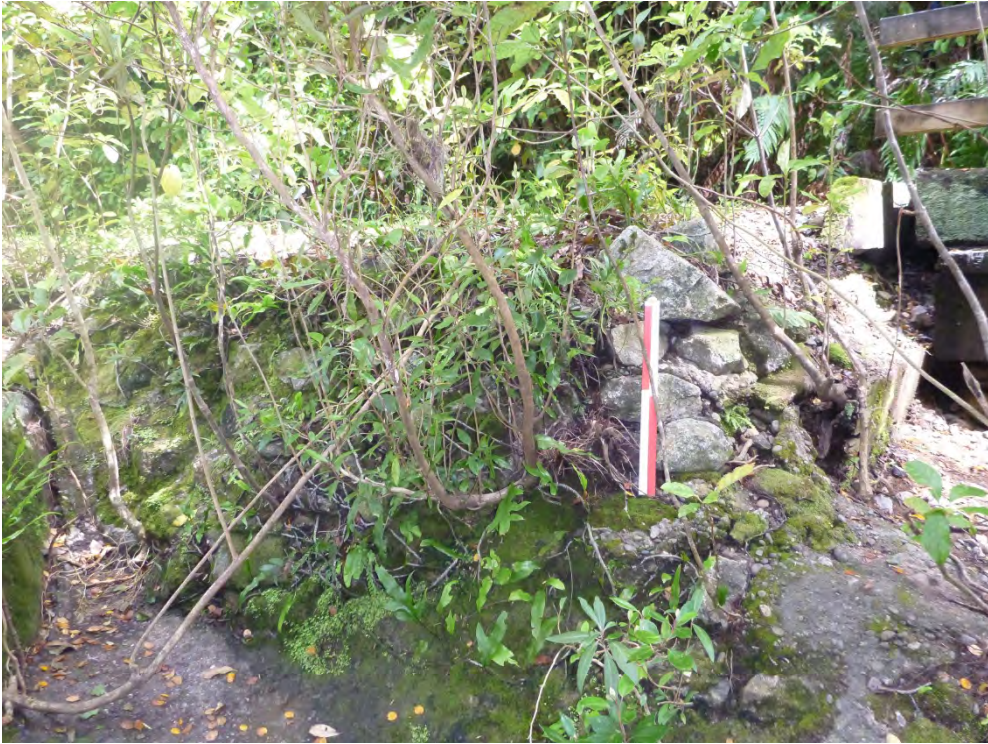
Figure 20. Stone revetting on the corner of the railway formation on the east side of Footbridge 2. Note the concrete in the foreground.

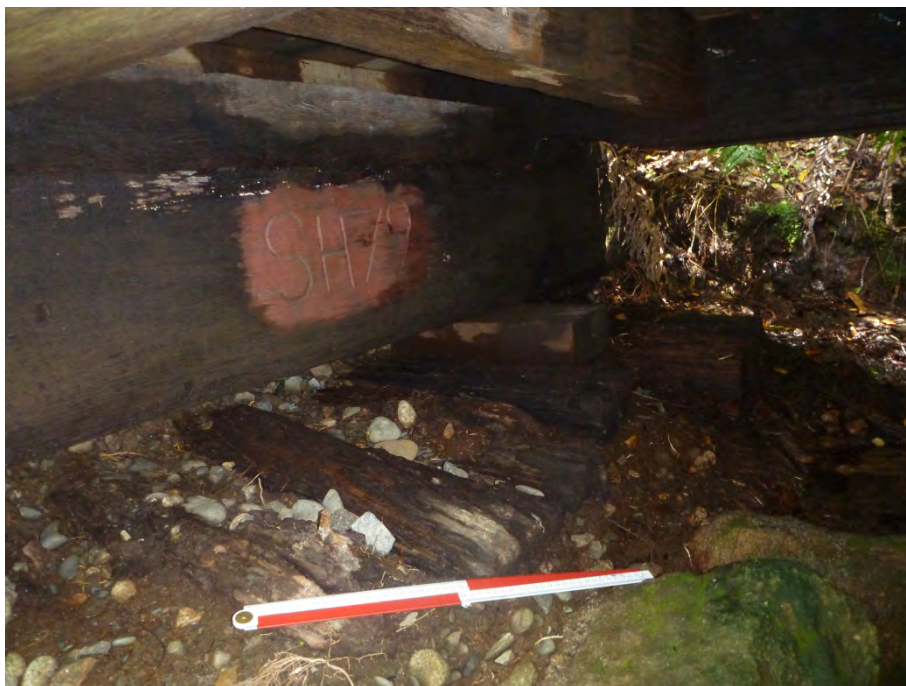
As with Footbridge 1, Footbridge 2 had been built using a mixture of railway and modern fabric, including beams that were second hand in 1974 and 1979 (Figure 21). It is not clear whether these beams were installed here in the 1970s (when the railway was still functioning), or if the timbers were added here when the footbridge was built. Recycled bridge beams were also used in the bridge platform. These dated from 1963 (Figure 22).

Figure 21. A bridge beam date-stamped SH79, indicating that it was a second hand beam installed in 1979, Footbridge 2. Note also the timber the scale is sitting on. Its function is not clear.

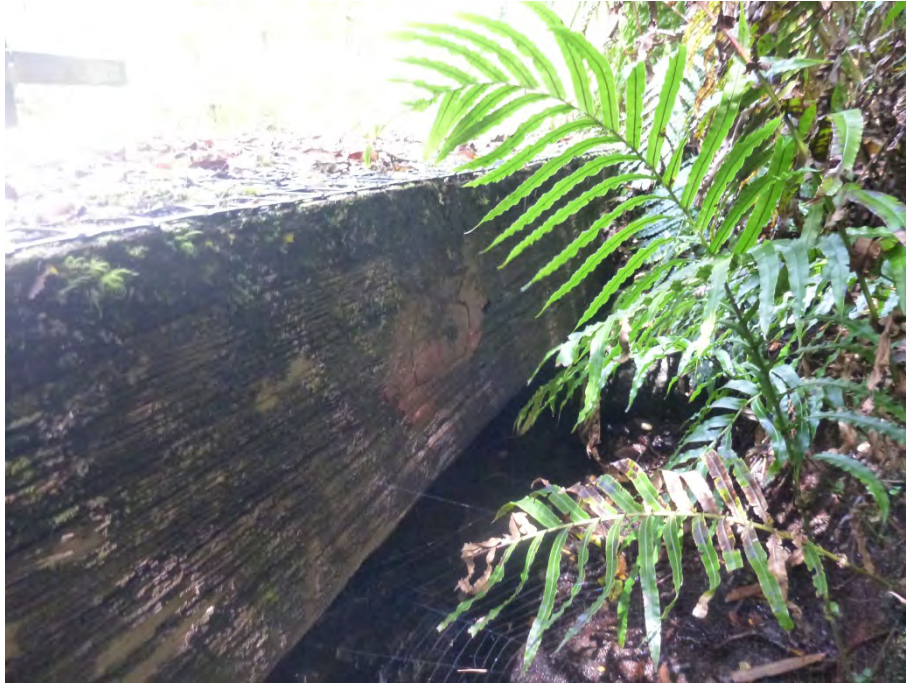
Figure 22. A bridge beam date-stamped 63 (indicating it was installed in 1963, although not necessarily in this location), Footbridge 2.

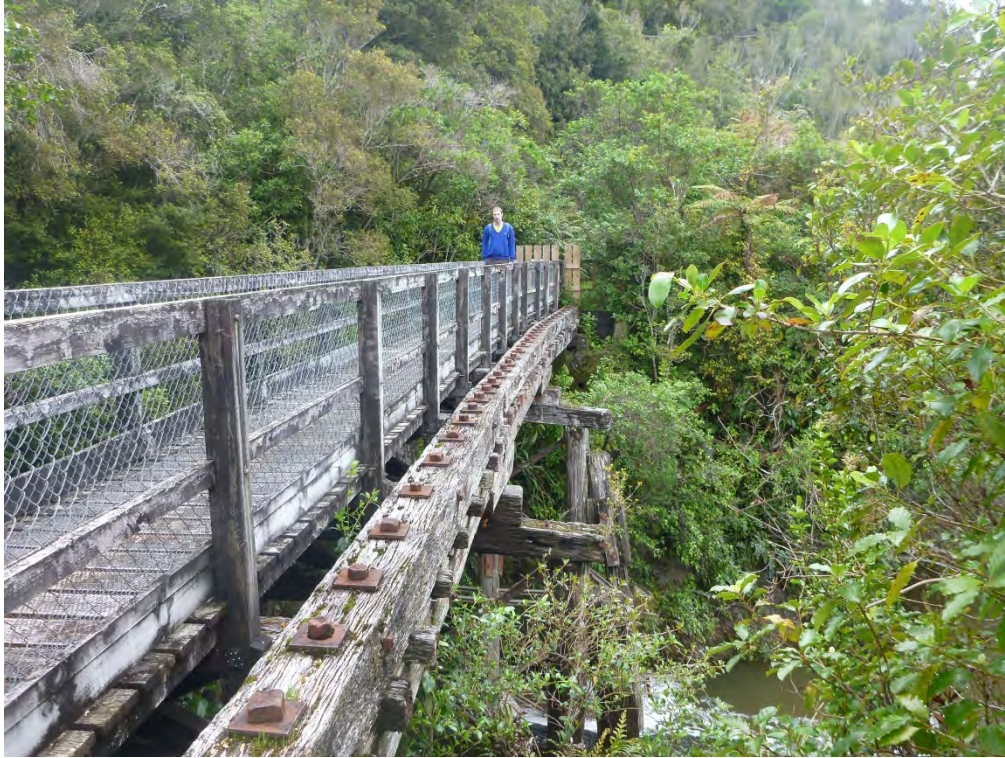
Bridge 37 is a three-span bridge, supported by four piers, that curves to the left (Figure 23 and Figure 24). The spans comprise two beams, bolted together, with cross-members running at right-angles between them (Figure 25). This type of span is known as a built-beam. These are clearly not the plate iron girders that were proposed in 1901. Date stamps were only visible on Span 1: the top beam was stamped 03 (1903) and the bottom 60 (1960), indicating that neither beam was original, and suggesting that, even if plate iron girders were not installed in 1901, modifications were made to the bridge in the early 20th century.

Figure 23. Looking west along Bridge 23.

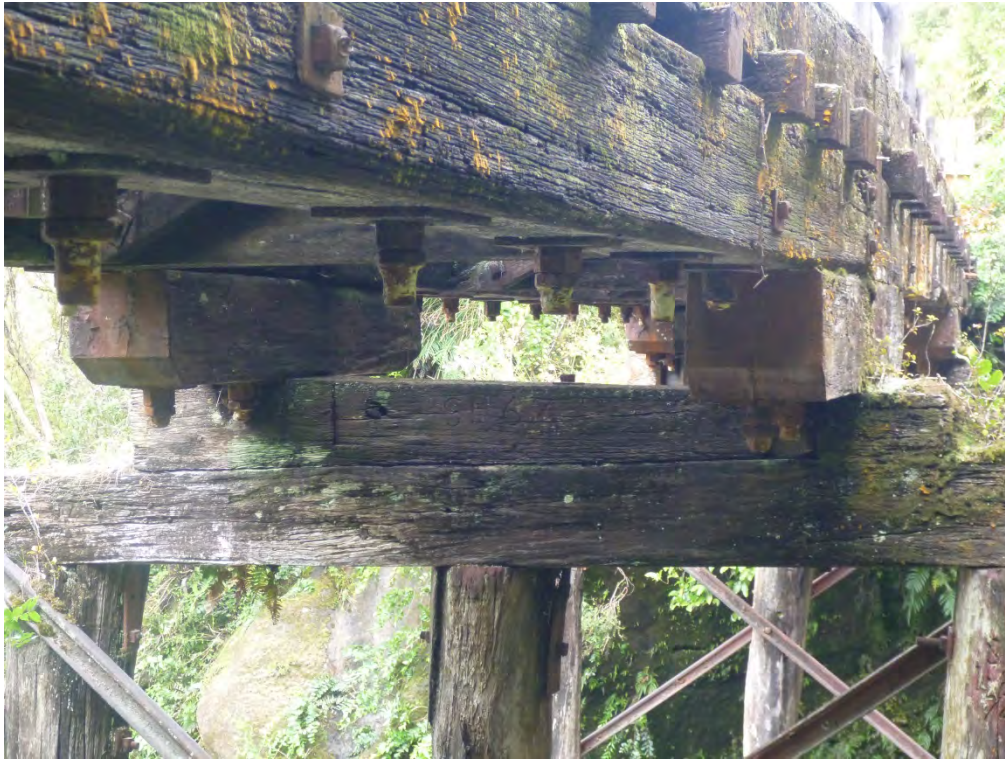
Figure 25. The structure of the spans, Bridge 37.

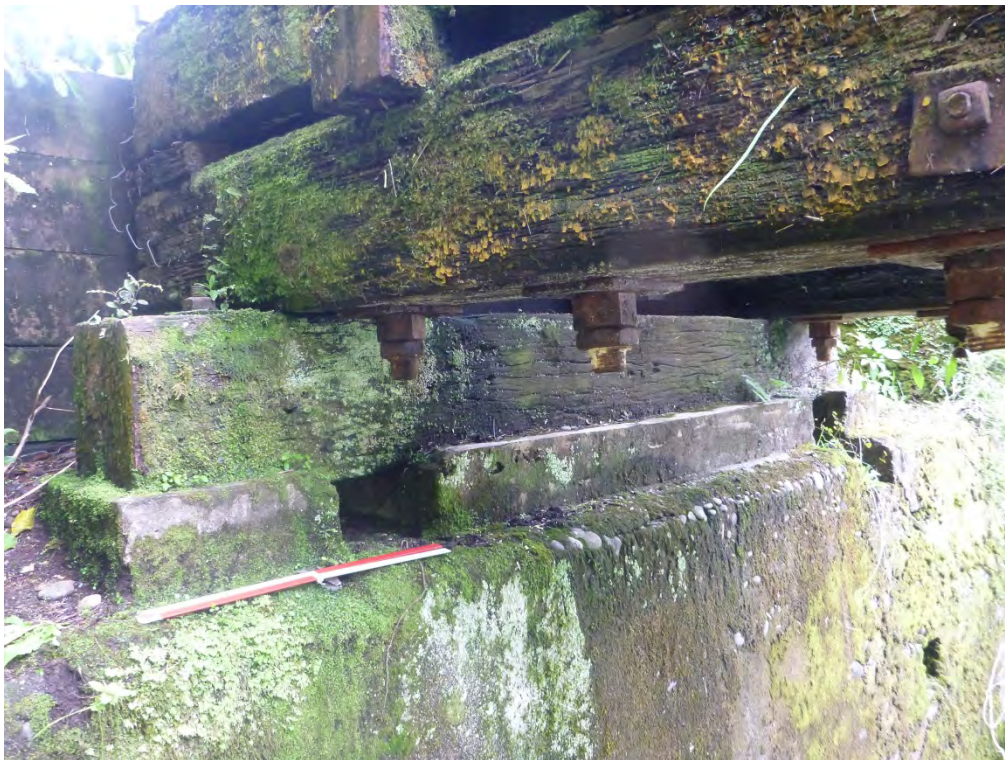
The ballast guards at each end of the bridge were modern tanalised timber, but the concrete piers in front of each of them (Piers 1 and 4) were probably original (Figure 26). Piers 2 and 3 both had three piles with a raker on each side and bracing and waling, as well as a cap and beams (Figure 27). The bolster on Pier 2 was second hand and had been installed in 1967. Piles 2 and 3 in Pier 2 had no date stamps, and Pile 1 had been stumped in 1974. It was not possible to get close enough to see any date stamps on Pier 3.

Figure 26. Ballast guard 1 (the modern tanalised timber at rear left) and Pier 1 (the concrete structure in the foreground). Ballast guard 2 and Pier 4 (at the east end of the bridge) were of the same fabric.

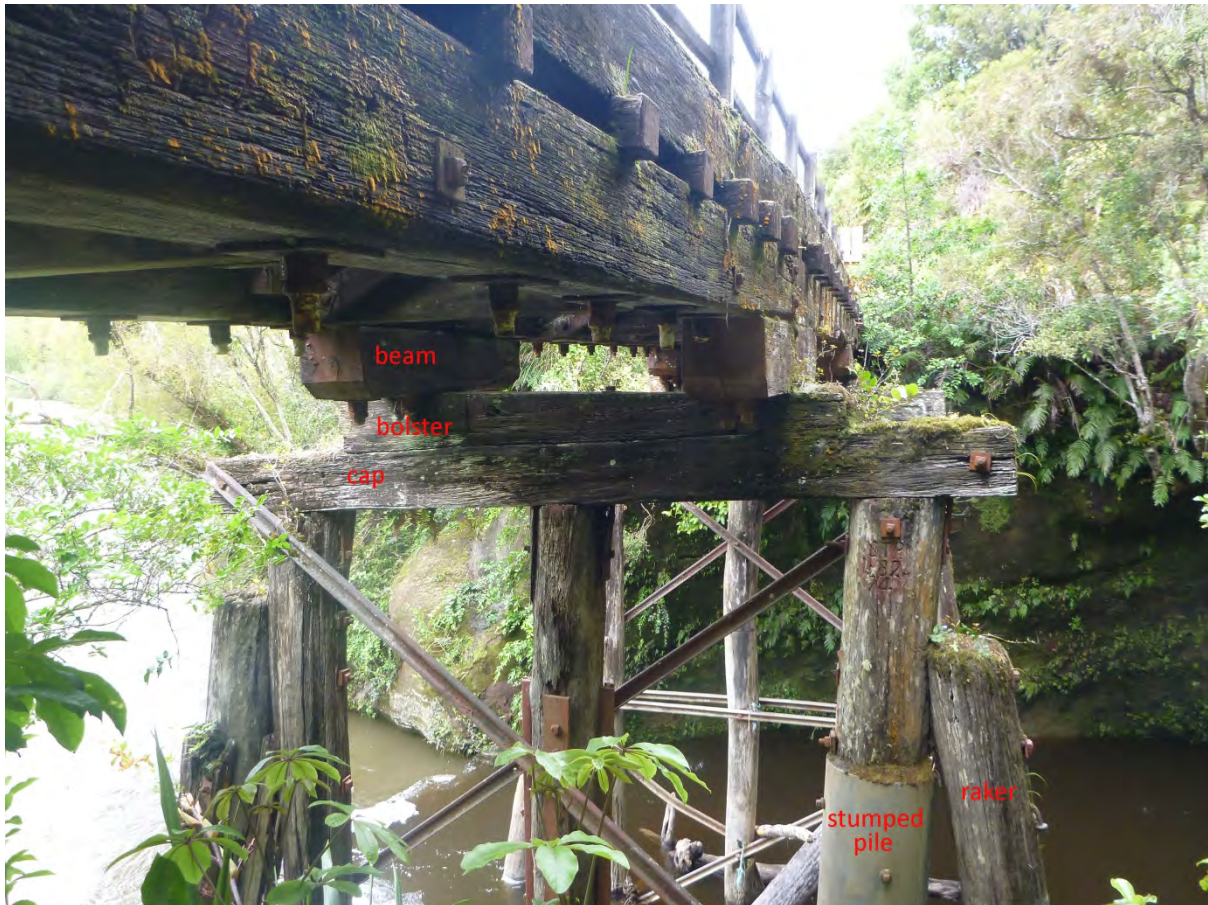
Figure 27. Pier 2, with various components labelled.

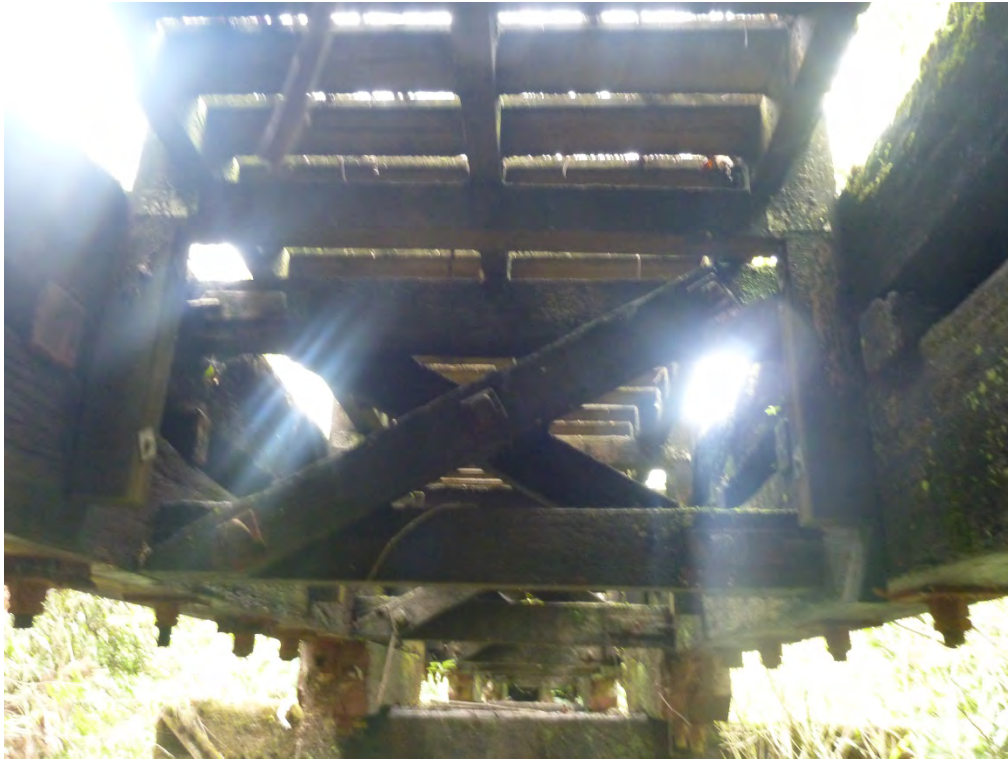
Figure 30. Cross-bracing under the bridge decking, Bridge 38.

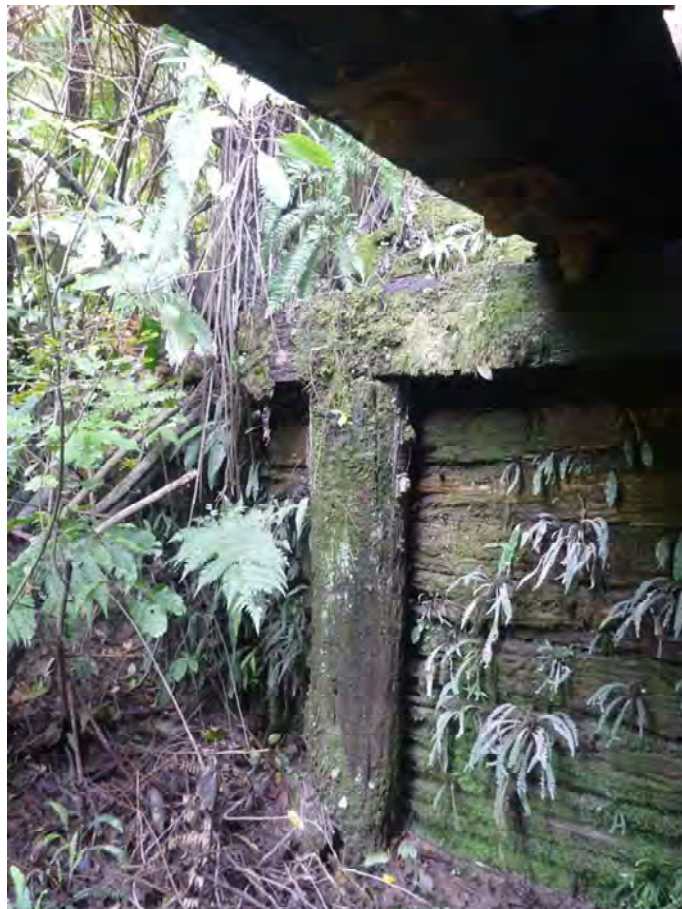
Figure 31. Ballast guard 1 with Pile 1 of Pier 1 in front of it. (Refer to Figure 24 for the numbering system used for the piles – the upstream pile is always Pile 1).

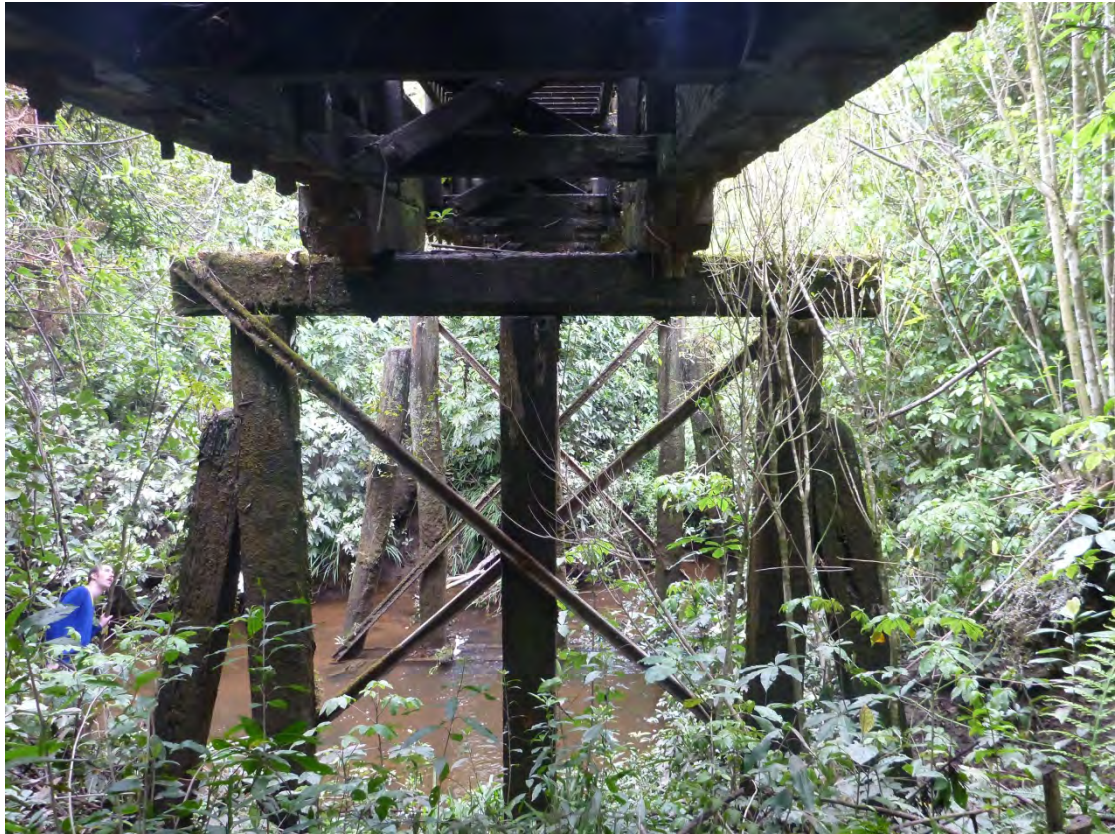
Figure 32. Looking east under Bridge 37, with Pier 2 in the foreground.
