Memo

To: Dr Ann McEwan
From: TJ O'Connell
cc: n/a
Date: 21/12/2023
Re: Mokihinui-Seddonville railway line (NZAA Site Number L28/36)

The purpose of this archaeological advice memo is to provide comment on the nature and form of Mokihinui-Seddonville railway line archaeological site (NZAA Site Number L28/36) and to provide comment on associated archaeological significance. This advice memo is a high-level desk-based exercise and does not constitute a full archaeological assessment of the site. This memo relies heavily on a review of a previous archaeological assessment prepared for the site (Nichol & Watson 2013) and information available through ArchSite. A site visit was not undertaken.

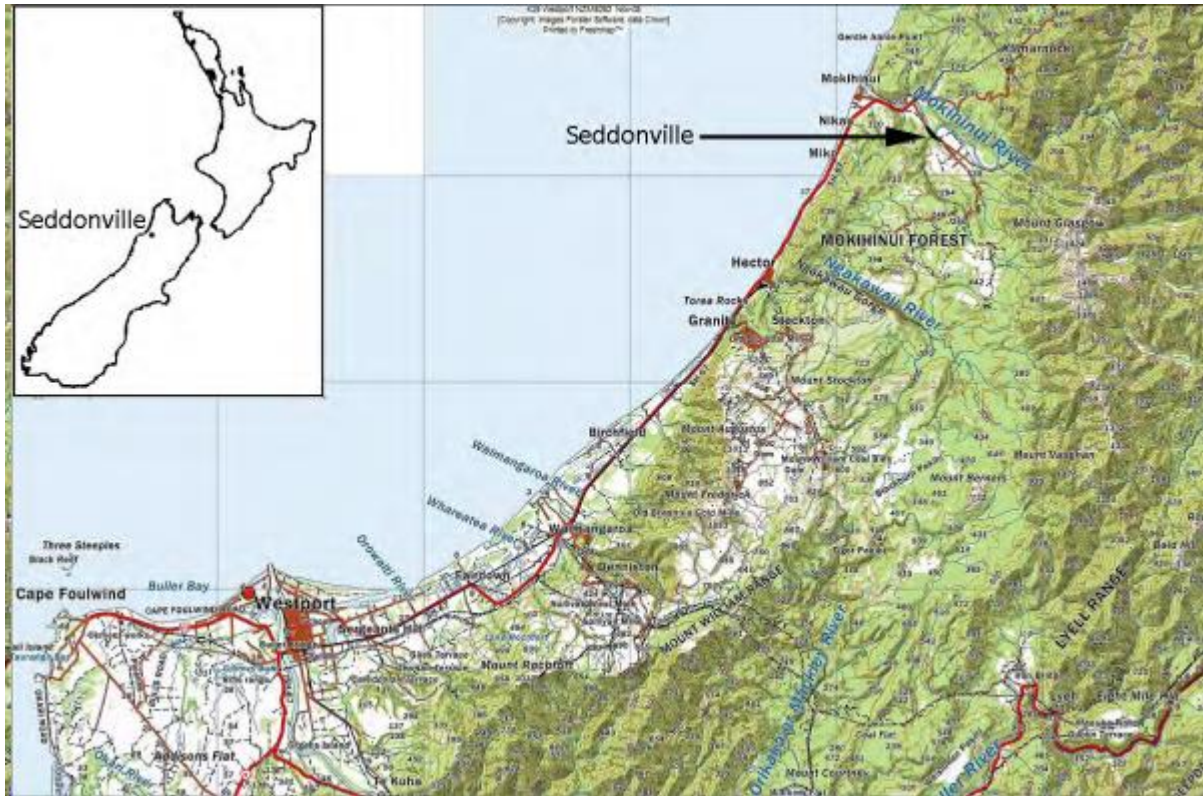
Figure 1. The Buller region, showing the location of Seddonville. Source: Nichol & Watson 2013.

Mokihinui-Seddonville railway line (NZAA Site Number L28/36) is located at Seddonville, to the north of Westport on New Zealand's West Coast. The railway line is located on the south side of the Mōkihinui River (Figure 1-2).

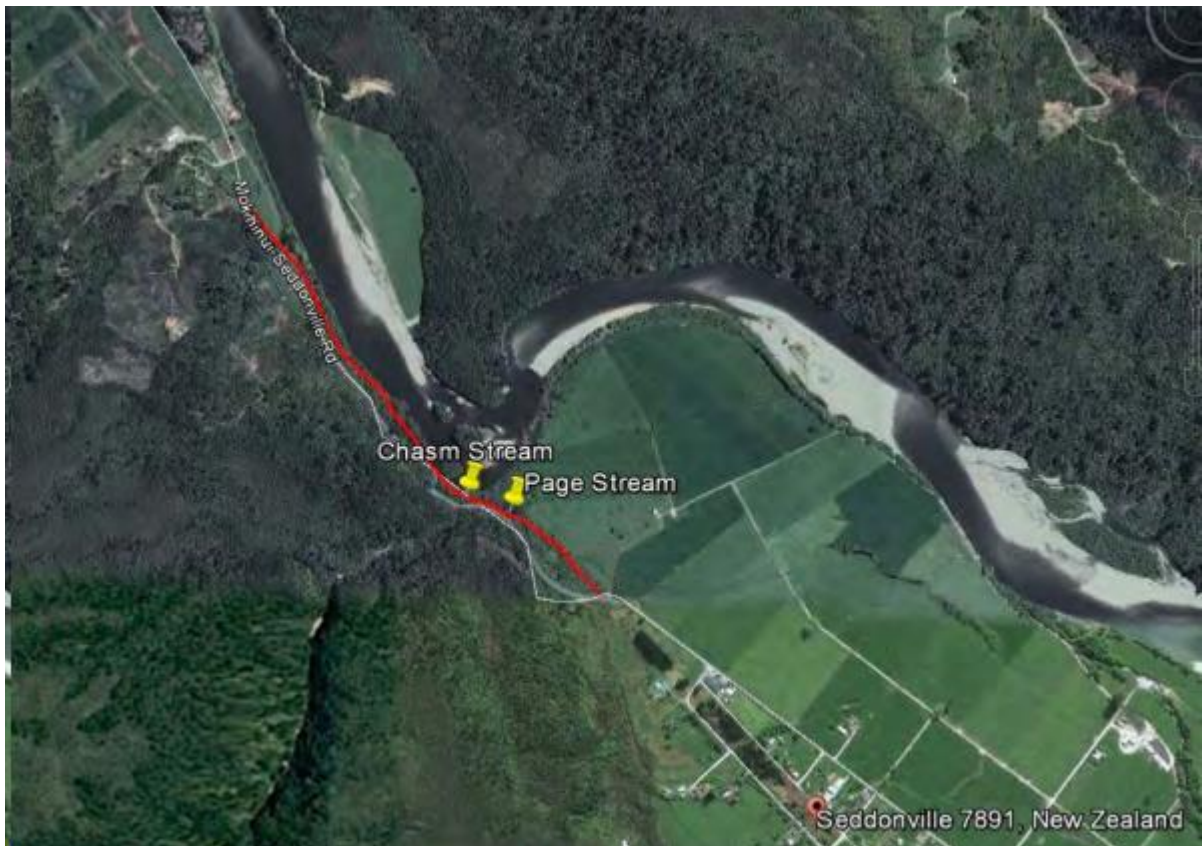
Figure 2. The red line on this aerial photograph shows the location and extent of the Chasm Stream railway line. The two bridges that remain in situ on the line cross Chasm Stream and Page Stream. Source: Nichol & Watson 2013.

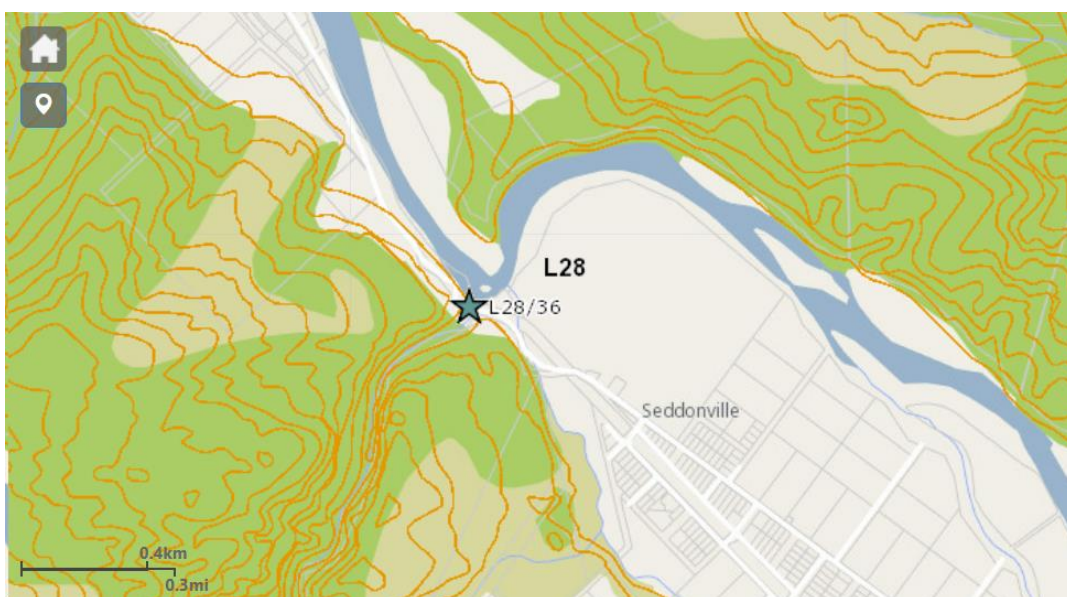
Figure 4. Chasm Stream section of the Mokihihui-Seddonville railway line is recorded as an archaeological site in the New Zealand Archaeological Associations database of recorded archaeological sites known as ArchSite (NZAA Site Number L28/36).

Chasm Stream section of the Mokihihui-Seddonville railway line is recorded as an archaeological site in the New Zealand Archaeological Associations database of recorded archaeological sites known as ArchSite (NZAA Site Number L28/36, see Figure 3). Summary details of information contained within the site record form is presented in Table 1.
