**STATEMENT OF PLANNING EVIDENCE OF BARRY JAMES MACDONELL
ON BEHALF OF FOREST HABITATS LTD**

**Submitter S186.001 / Regarding 117 Arthurstown Road, Hokitika (Proposed
Re-Zoning)**

Subdivision Suitability Report

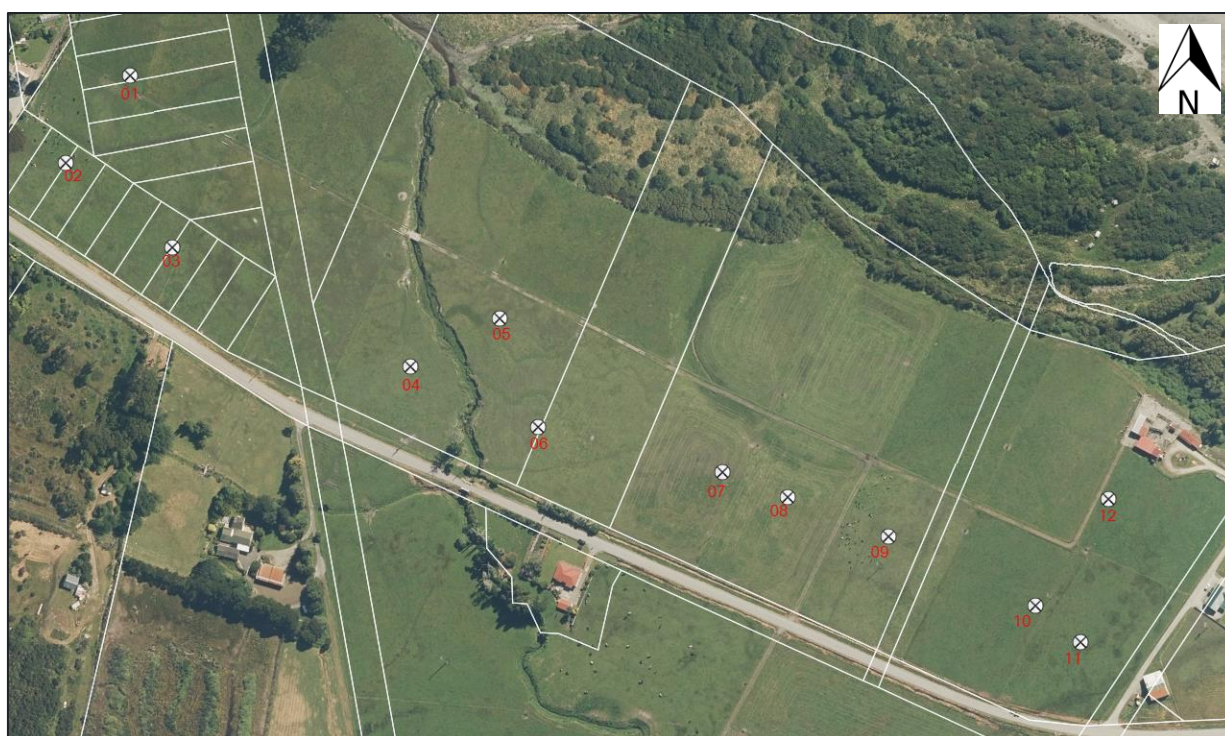
Figure 3. Approximate test locations (Eliot Sinclair, 2022)

On 7th September 2022 a site investigation was undertaken to determine the soil profile and bearing capacity. The investigation included eight test pits, in a grid like pattern across all proposed lots, and 12 dynamic cone penetrometer tests. The results from these tests can be found in Appendix B.

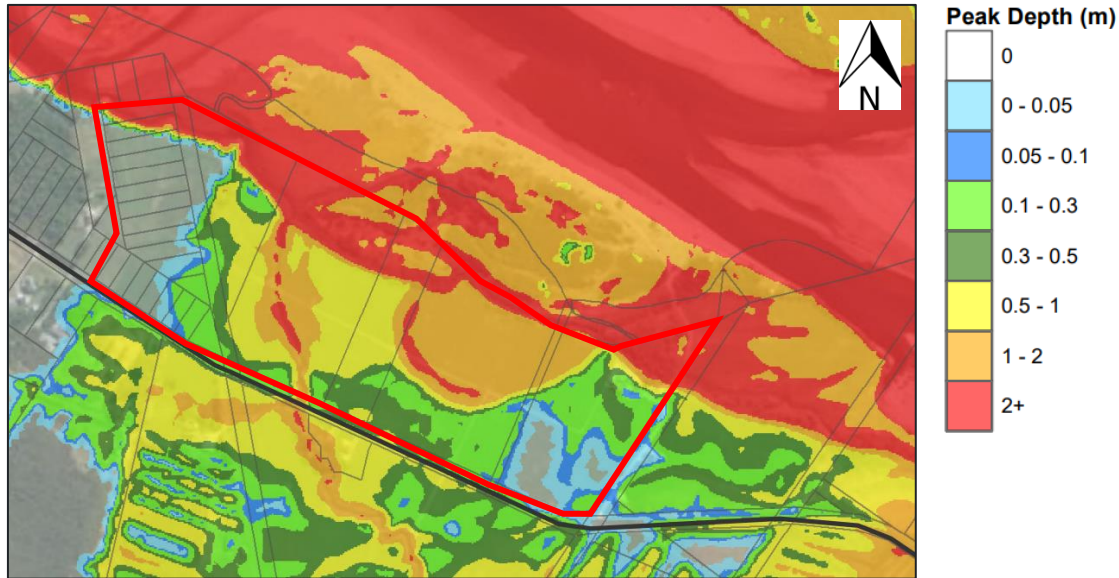
Figure 5. Flood water depth during 1:50-year event

We recommend any future dwellings within these lots are located towards the south side of the lots close to Arthurstown Road. The minimum floor heights for any proposed dwellings within the subdivision should be above the modelled water depth plus freeboard. Westland District Council should advise on the final floor levels for dwellings within the proposed subdivision as part of the consenting process.

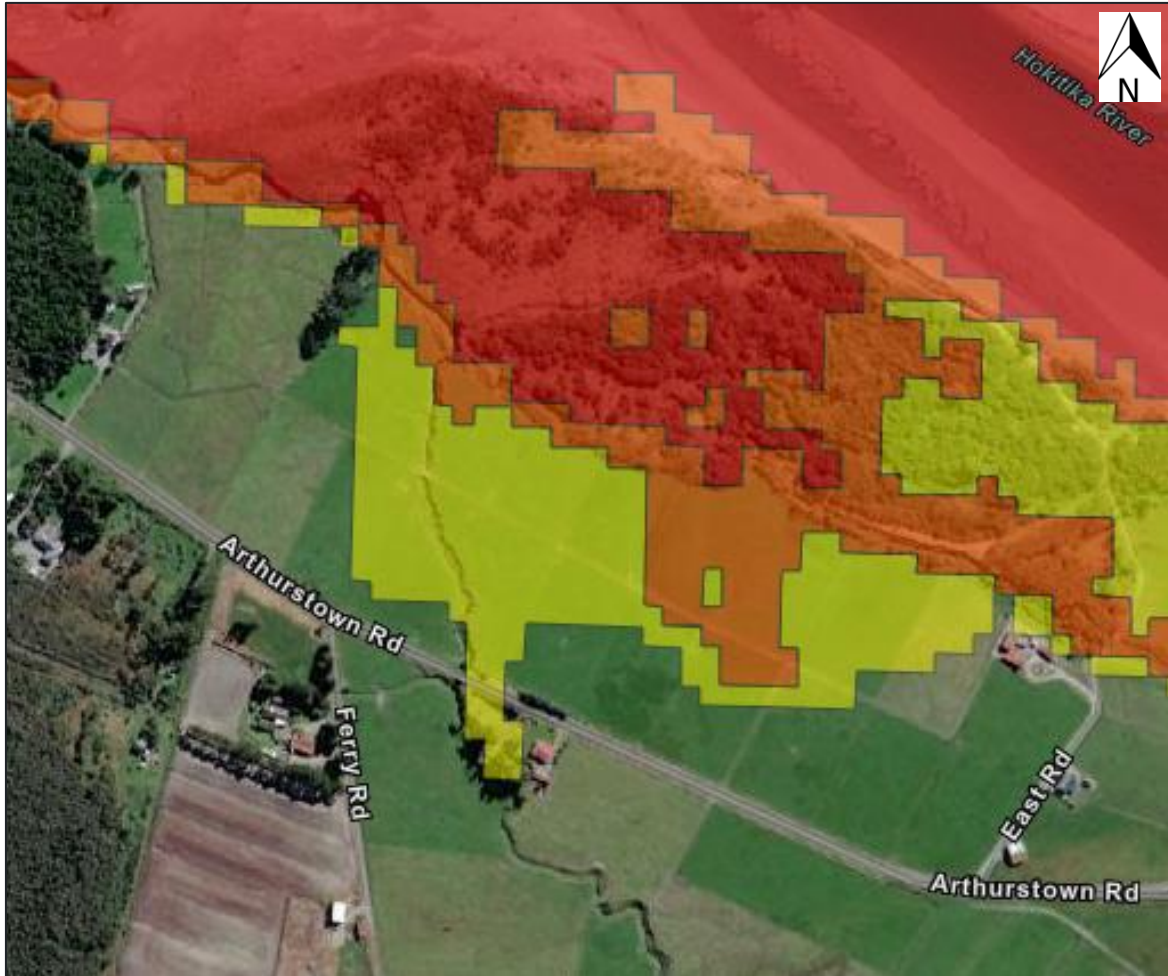
Due to the location of the site (adjacent to the Hokitika River and 1.5km from the Tasman Sea) it is susceptible to Tsunamis on a larger scale. Below is the Tsunami Hazard Map showing areas of the site being in the orange and yellow zones. The yellow zone covers the largest area that would need to be evacuated in the event of a maximum-impact tsunami, the orange zone shows areas to be evacuated in a 1m to 5m event.

Figure 6. Tsunami Evacuation Zones (<https://www.civildefence.govt.nz/get-ready/get-tsunami-ready/tsunami-evacuation-zones/>)

Most intended building sites are outside of the yellow zone, but it is important that the occupants are aware of the Civil defence recommendations that should be followed *'this area must be evacuated if there is a long or strong earthquake. The earthquake may be the only warning of a tsunami, so people are advised not to wait for further instructions, notifications or advice, immediate evacuation is required after shaking has stopped'*.

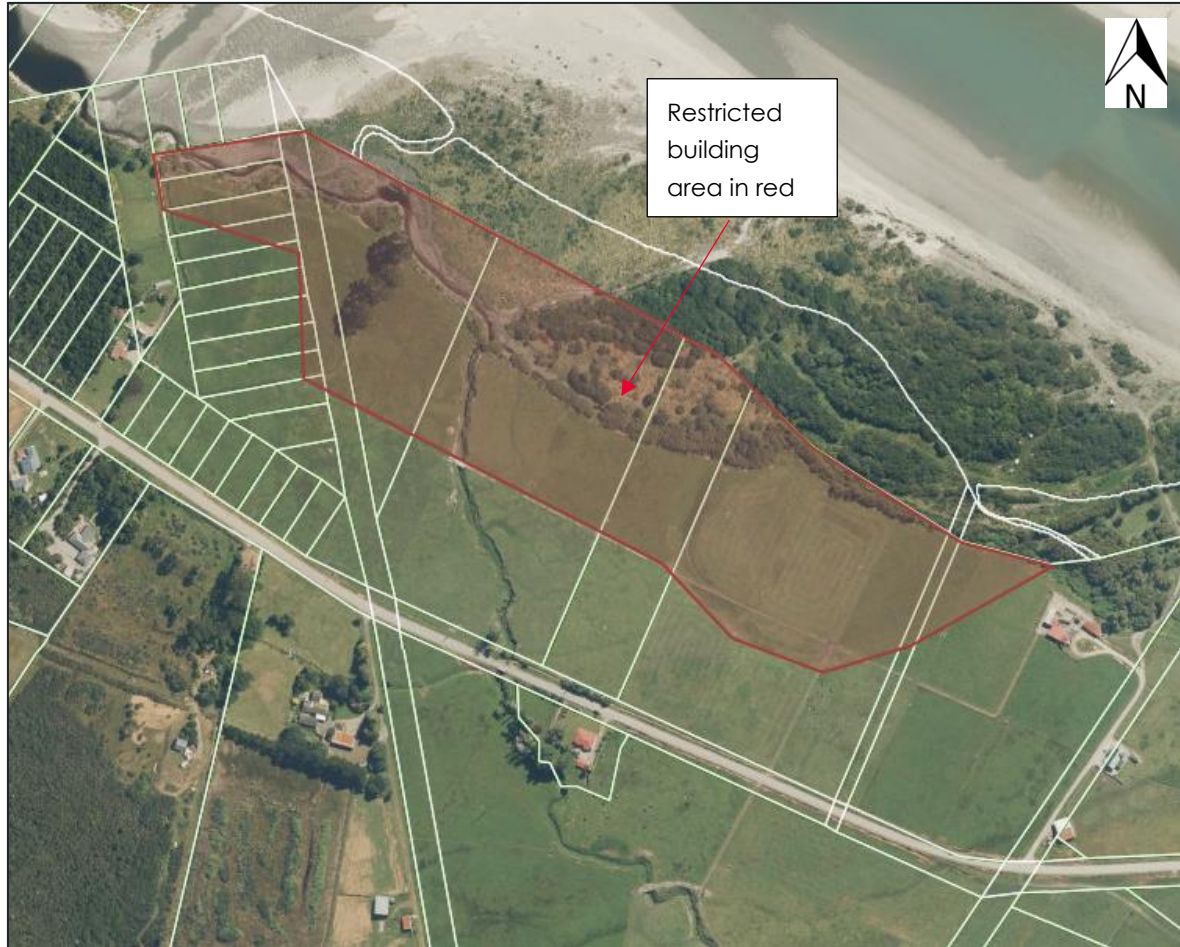
Figure 8. Area to be restricted from building (Eliot Sinclair 2022)

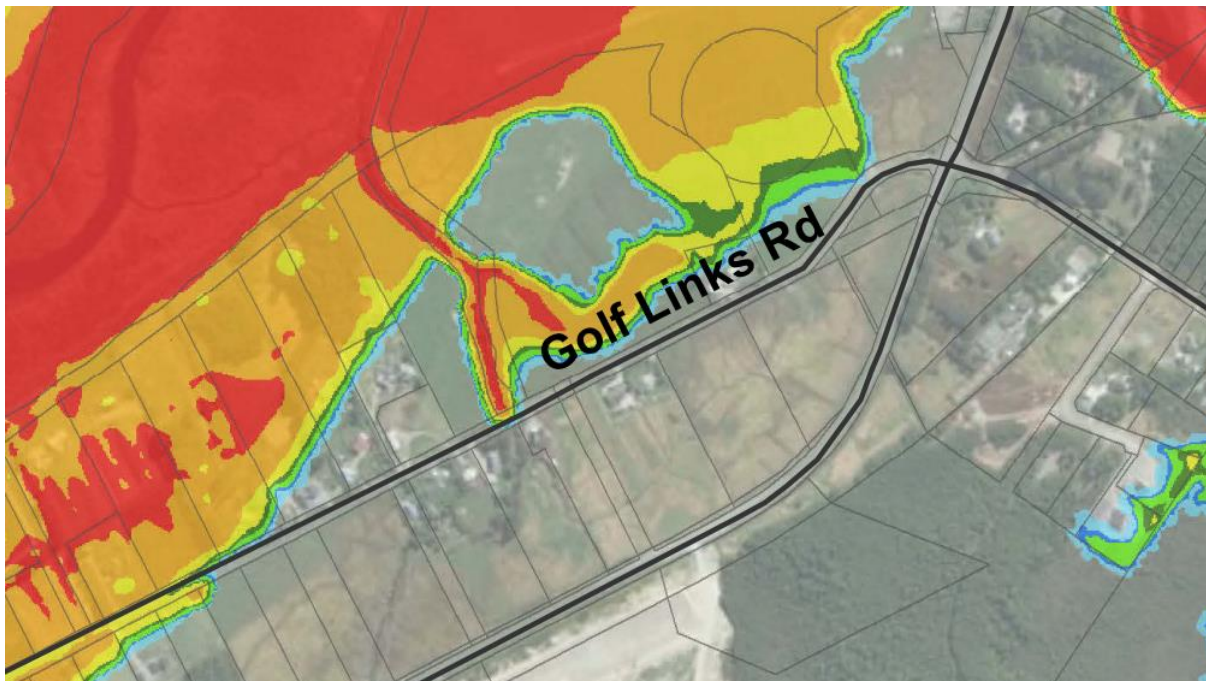
Figure 2. 1 in 100 year event including climate change (2100) RCP Scenario 8.5, 1.4m Sea Level Rise, 0.4m Storm Surge
