**PUNAKAIKI ROCKFALL STUDY**

# FINAL REPORT

## Punakaiki Rockfall Study

52944-001/R001D

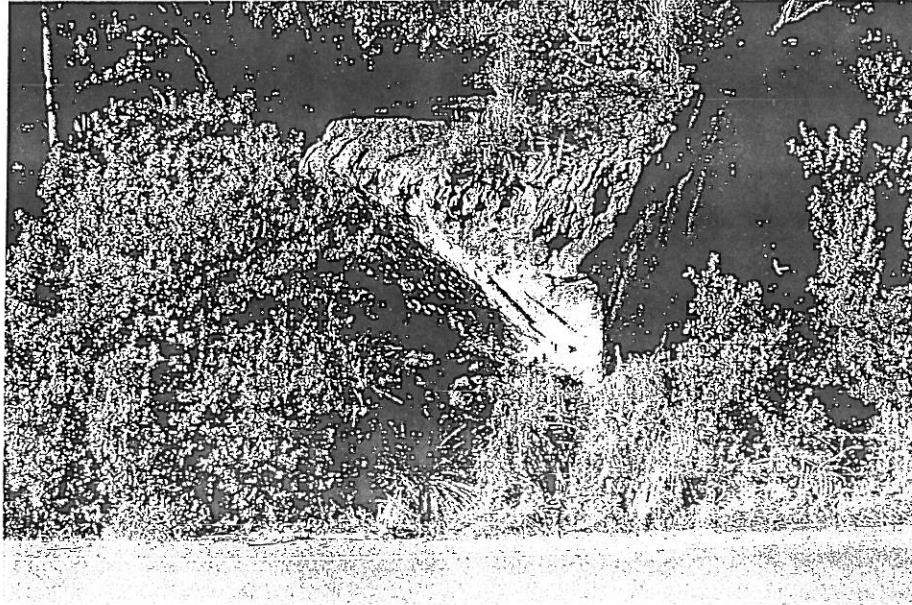
**Figure 7: Photograph of a large block in the talus beneath the limestone cliff**

Typical joint spacing observed in the limestone cliff is in the order of 2 to 10 m, with an average estimated to be about 5 m. Much larger blocks have occurred within the rockfall debris as shown by Figure 7. The largest block is approximately 30 m in the longest dimension.

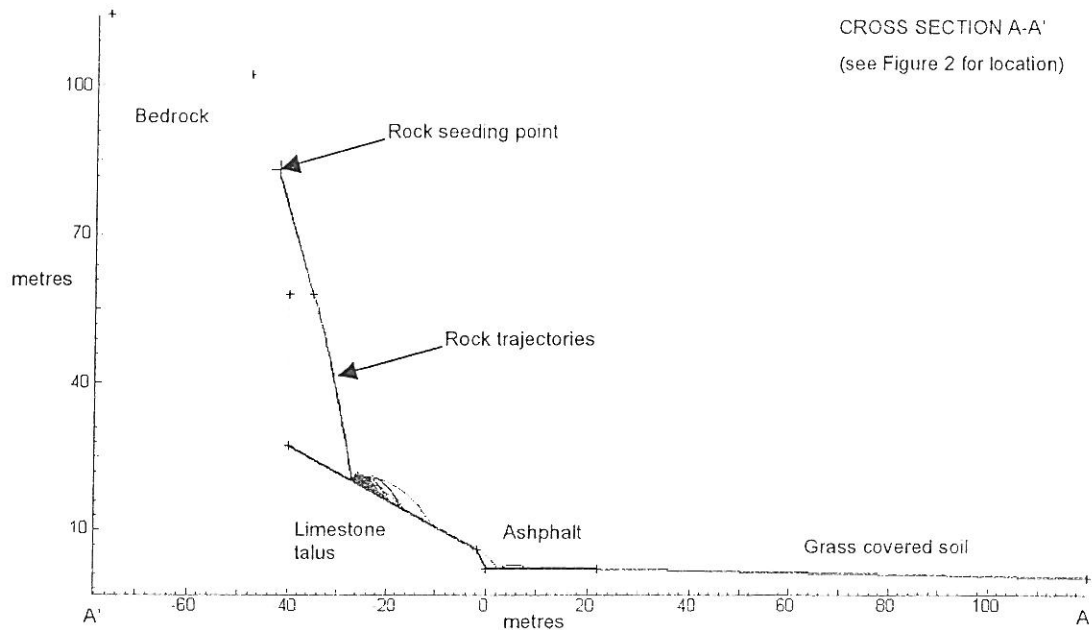
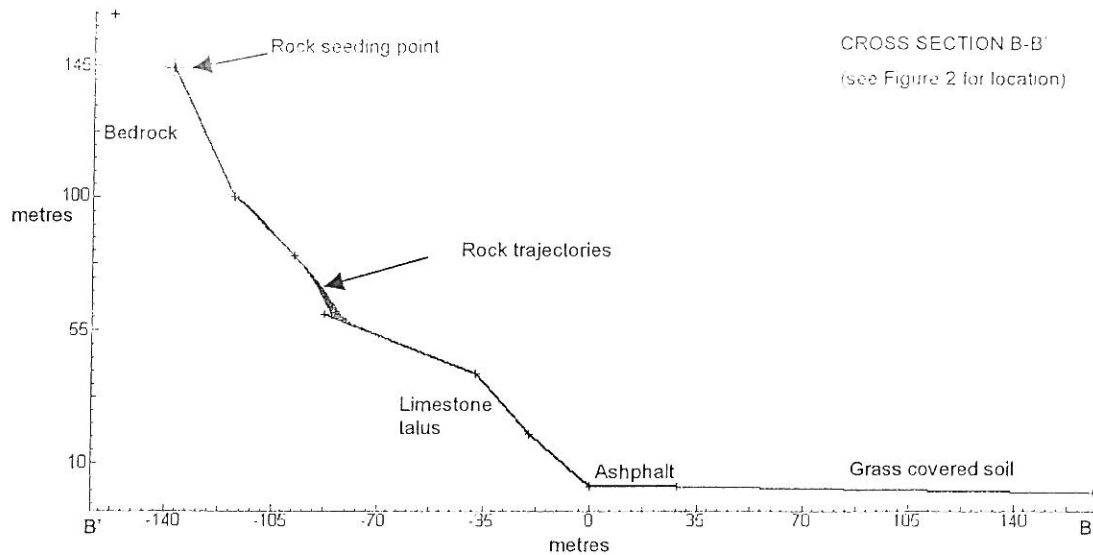
# Appendix C – Rockfall Trajectory Analysis Data

RocFall by RocScience was used for trajectory analysis of falling limestone blocks from the limestone cliff at Punakaiki. The slope was divided into rock surface materials, which were chosen according to default parameters within the program. One hundred blocks were simulated falling from the seed point. The sensitivity analysis involved changing individual parameters before simulating the falling rocks.

The results of this modelling (presented in Appendix C) indicate that rockfall blocks come to rest within 40 m of the toe of the debris slope. Many blocks are contained within the debris apron and do not reach the highway corridor.

Sensitivity analysis has been undertaken as part of the modelling and involves holding all but one variables constant, and varying this to evaluate the resulting rockfall distribution. This analysis indicates which parameters the modelling is most sensitive to. The sensitivity analysis indicates that the roughness of the debris apron is the parameter that most affects rockfall runout distance.
