**WCRC written evidence for TTPP Hearing – High Coastal Natural Character Overlay**

## West Coast Regional Council Written Evidence on TPP High Coastal Natural Character Overlay

**Appendix 1: Maps showing locations of the 3 areas where the High Coastal Natural Character Overlay is sought to be removed**

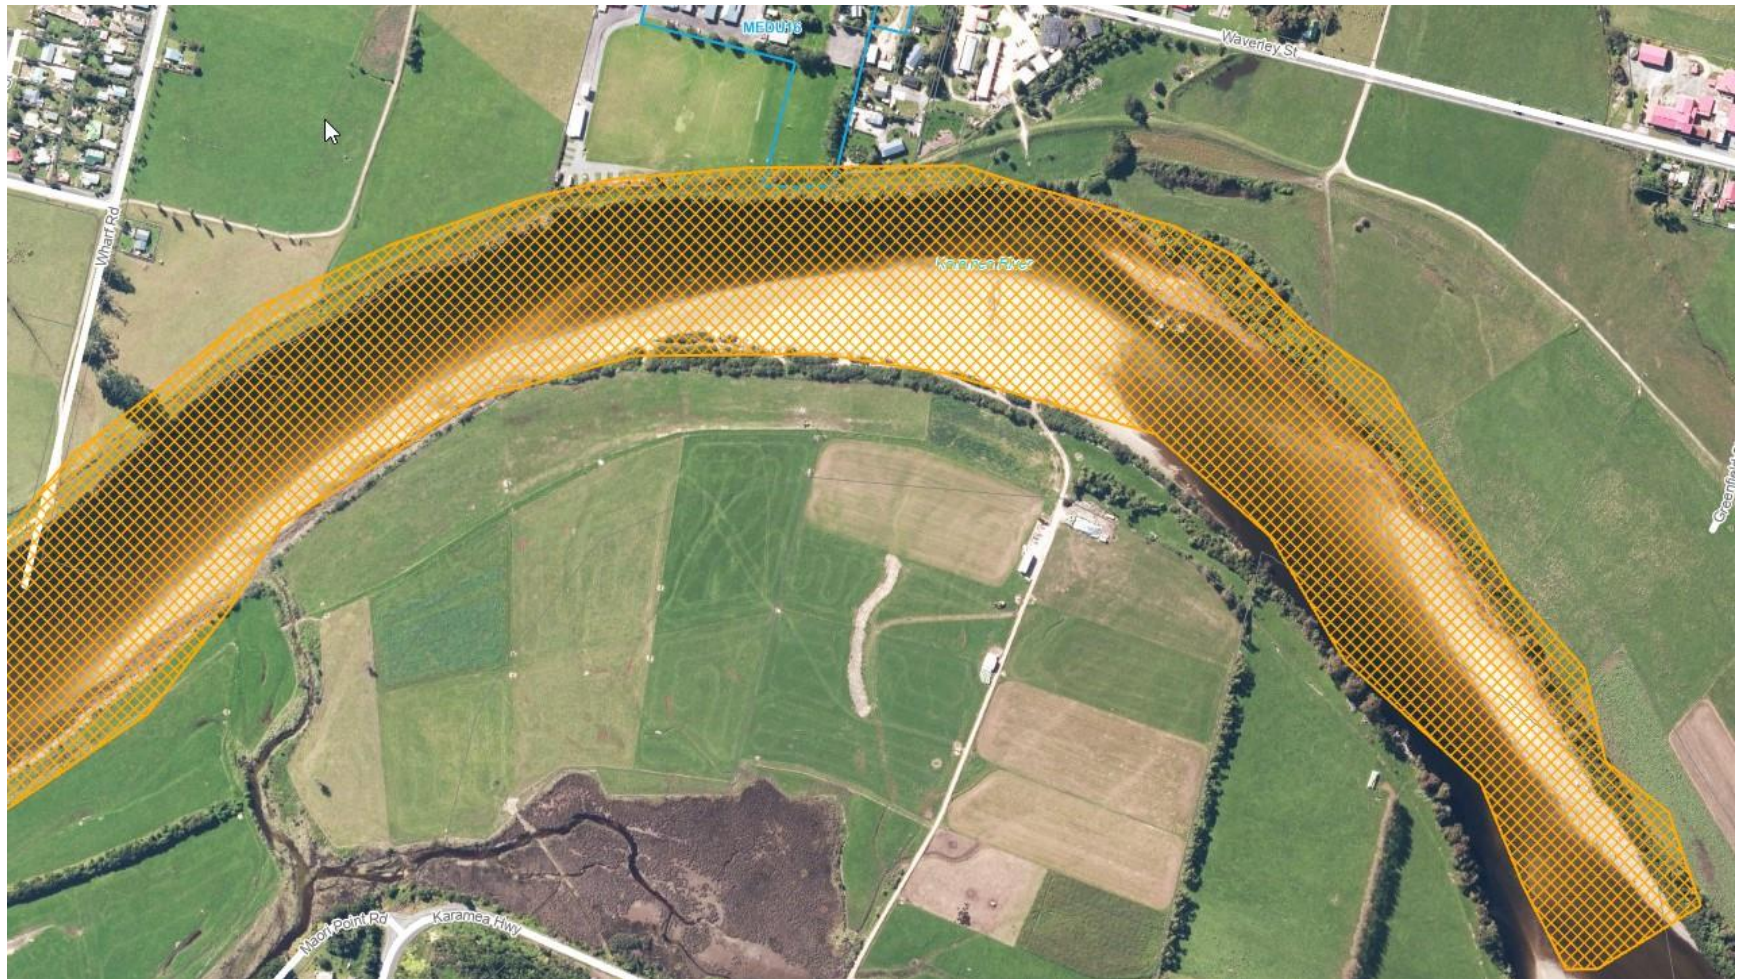
**Map 1: Banks of Karamea River by township area, with High Coastal Natural Character area in orange hatch**

Map 2 shows where the Rating District stopbanks and rock protection are along the true right bank of the Karamea River, and on the true left bank further upstream. This infrastructure has the HCNC Overlay over it as seen in Map 1. The protection works are to avoid or mitigate flooding of the settlement and farmland. These Rating District structures are existing Regionally Significant Infrastructure, and were lawfully established before the TPP was publicly notified.

The Overlay also extends into adjoining farmland, a camping ground and marginally into a residential property. These land uses in the river margins have made the land very modified, and there is very little remaining natural character.

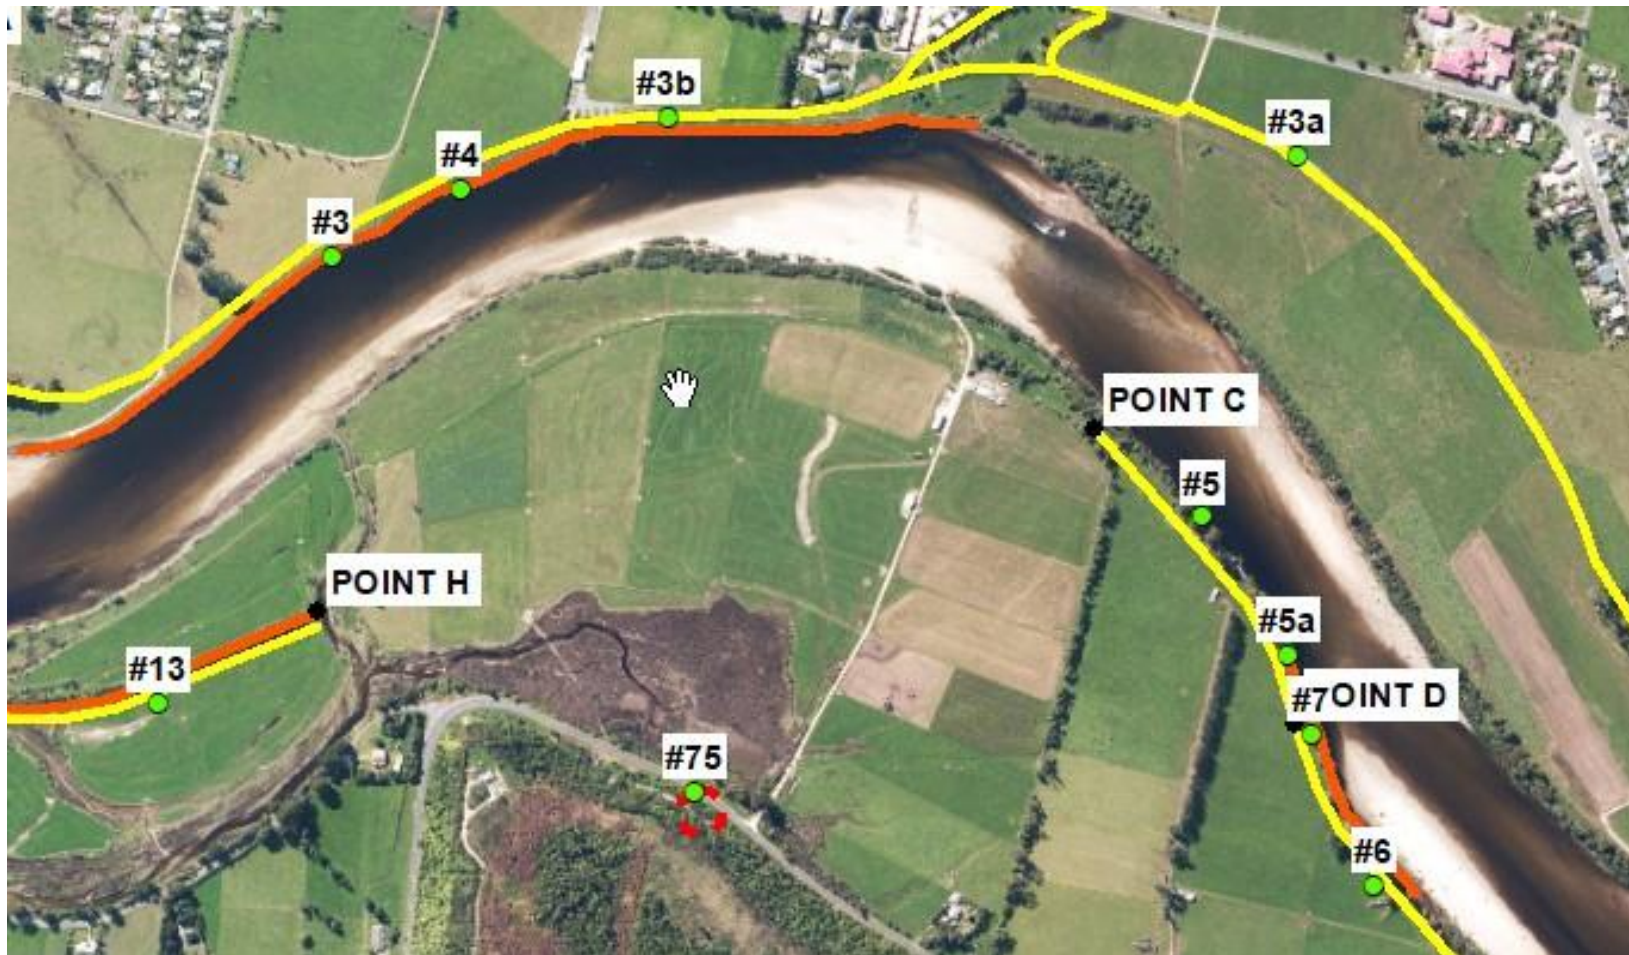
Map 2: Banks of Karamea River by township area, with Rating District stopbanks in yellow, and rock protection in red

The Council is renewing its Floodwall Protection Bylaw which does not allow planting on the stopbanks (other than pasture grass), as tree and bush roots can make the protection structure unstable and potentially fail to provide protection for the community. This means that the natural character of the river banks in these places is not likely to be restored.

Additionally, resource consents have been granted for gravel extraction from the larger gravel bed on the bend in the River, which is also within the HCNC Overlay. Removal of gravel assists with reducing the risk of harm from flooding, by stopping the River bed from building up and potentially exacerbating flooding of adjoining land.

- No #5 to Point C on the true left bank in Map 2; and
- The eastern end of the orange line showing the rock protection work, to the western end of the rock protection work, on the true right bank in Map 2.

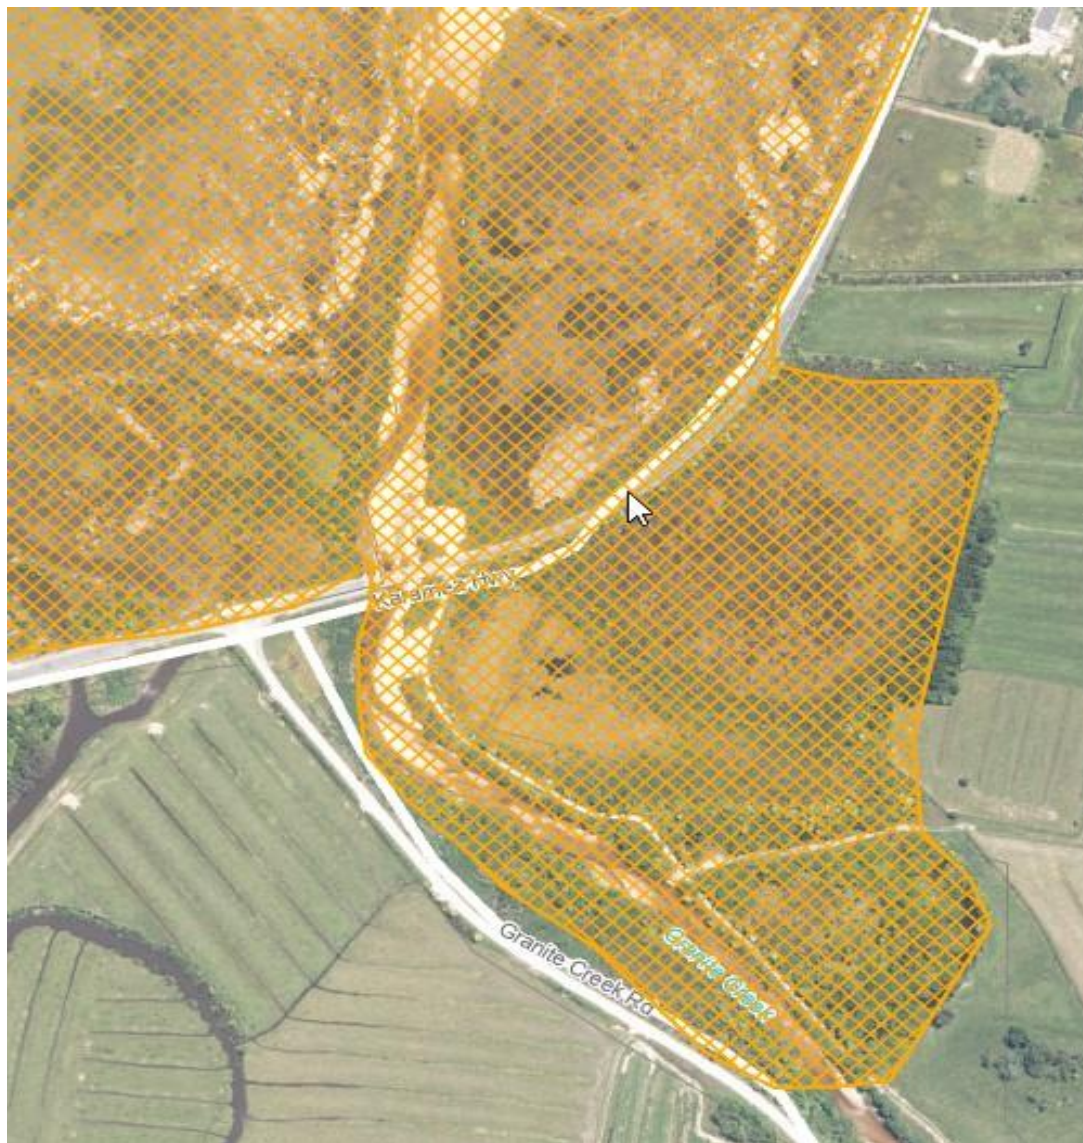
**Map 3: Downstream end of Granite Creek entering Otumahana Estuary at the road bridge, with High Coastal Natural Character overlay in orange hatch**

Maps 3 and 4 show the HCNC Overlay over the Creek bed and its margins upstream of the road bridge, and within the Otumahana Estuary. Map 4 shows the two areas adjoining the right bank of the Creek channel where the slip debris and gravel is placed when it is removed from the Creek and Estuary. Willows are also occasionally cleared from the Creek margins.

Because of the clearance work involved with removing slip debris and gravel, and exotic plants, the Creek's margins have been modified in the area covered by the Overlay. There is also an unsealed access road upstream of the bridge, parallel to the true right bank of Granite Creek which DOC, the Council and contractors use to monitor and clear debris and gravel.

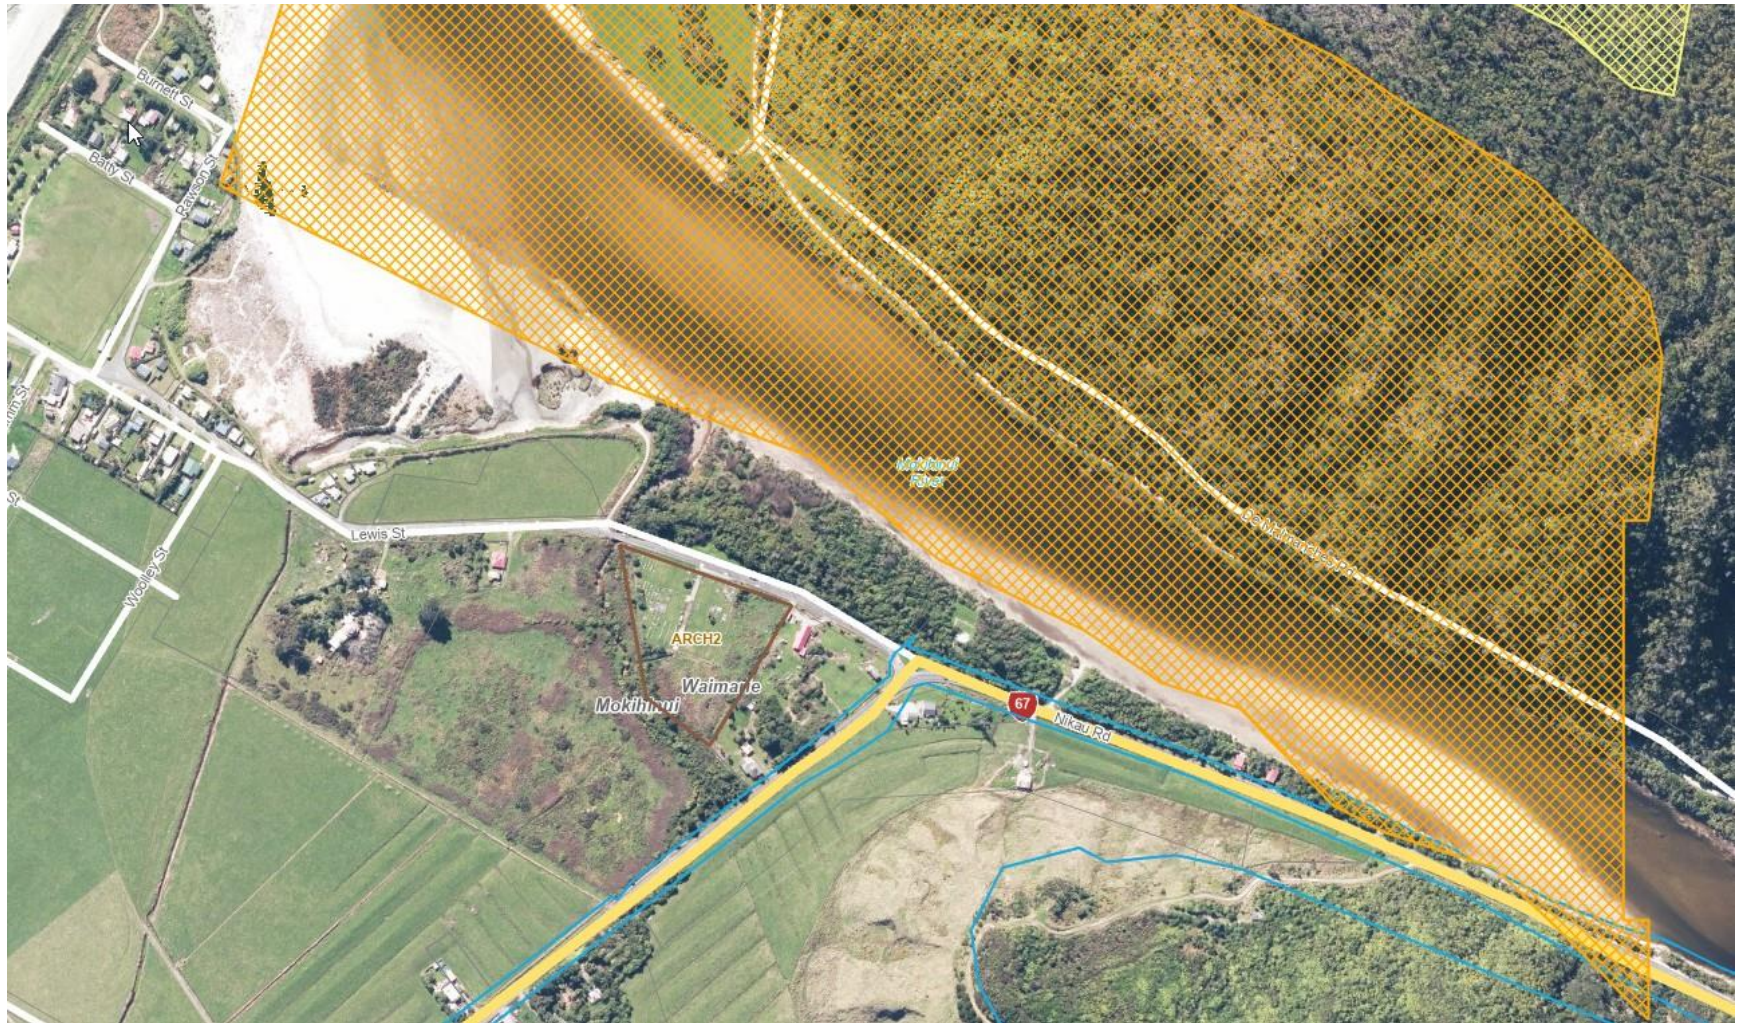
**Map 5: High Coastal Natural Character overlay in orange hatch, over 3 small parts of the south bank of the Mohikinui River, just upstream from the mouth**

Maps 5 and 6 show that small areas of the HCNC Overlay include, from downstream to upstream:

- a residential property on the corner of Rawson and Burnett Streets with adjoining Rating District stopbank next to the River,
- Rating District culverts and rock work at Nos #3-#5 in the vicinity of the residential property,
- an old groyne extending into the River at No #7,
- and a hardfill and dump site in a bush area near the landward end of the No #7 old groyne.

Map 5 also shows a small area of the Overlay further upstream on the true left side of the River, which covers the main road and vegetation in the river margin, in an unusual shape. This appears to be a mapping error, as the strip of river margin vegetation downstream is not in the HCNC Overlay.

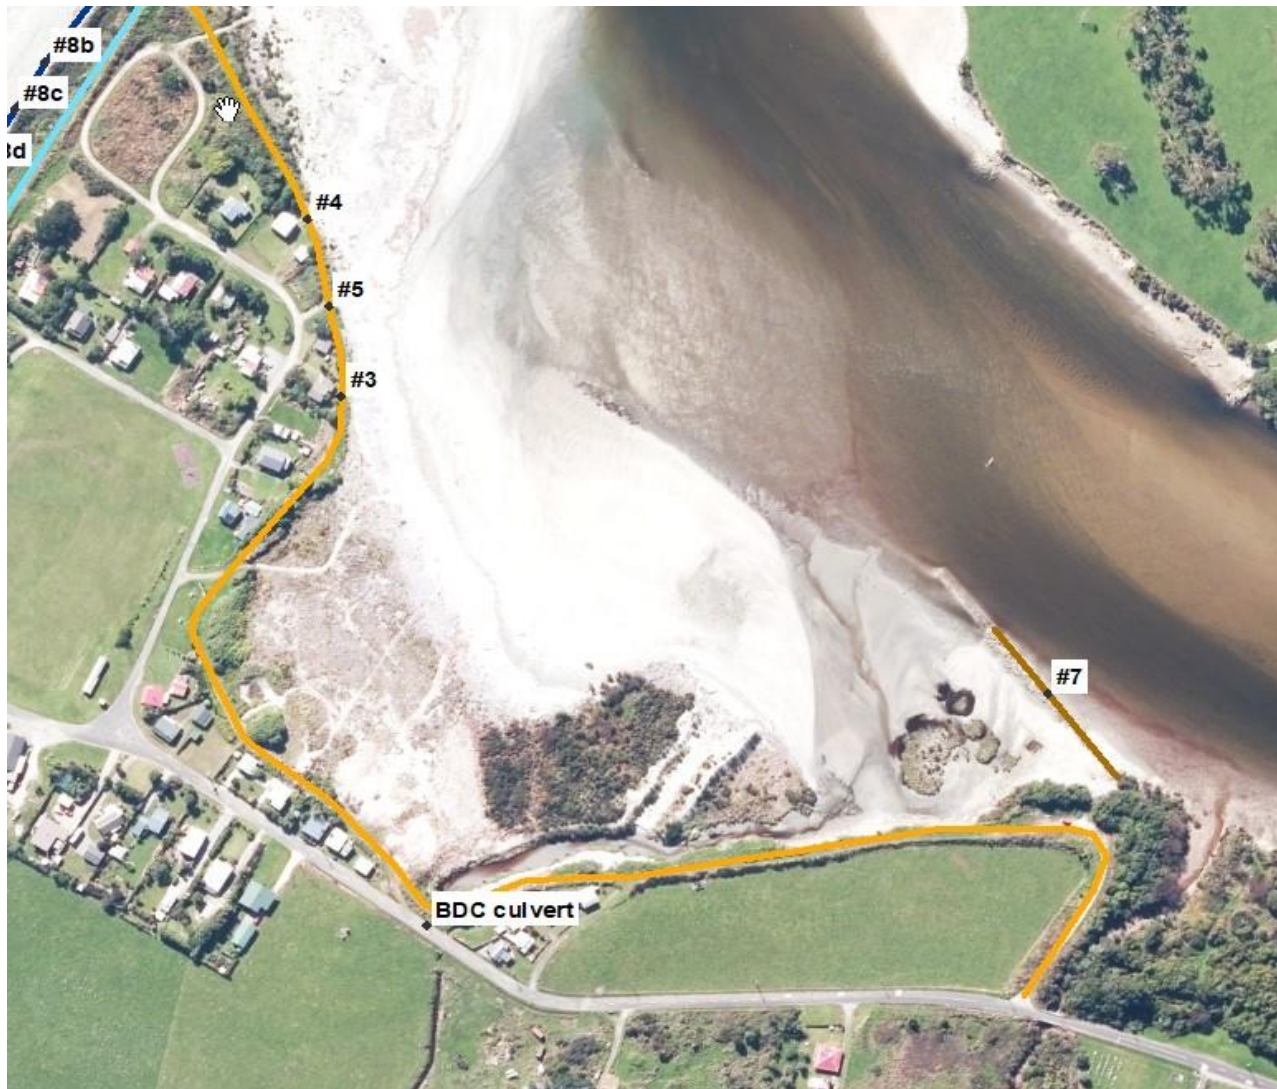
Map 6: Rating District stopbank (yellow line), culverts and rock work at Nos #3-#5, old groyne at No #7, and hardfill and dump site at bush area near landward end of old groyne - south bank of the Mohikinui River
