REPORT

Preliminary Site Investigation

Tauranga Bay Quarry

1779210-7403-002-R-Rev0_PSI

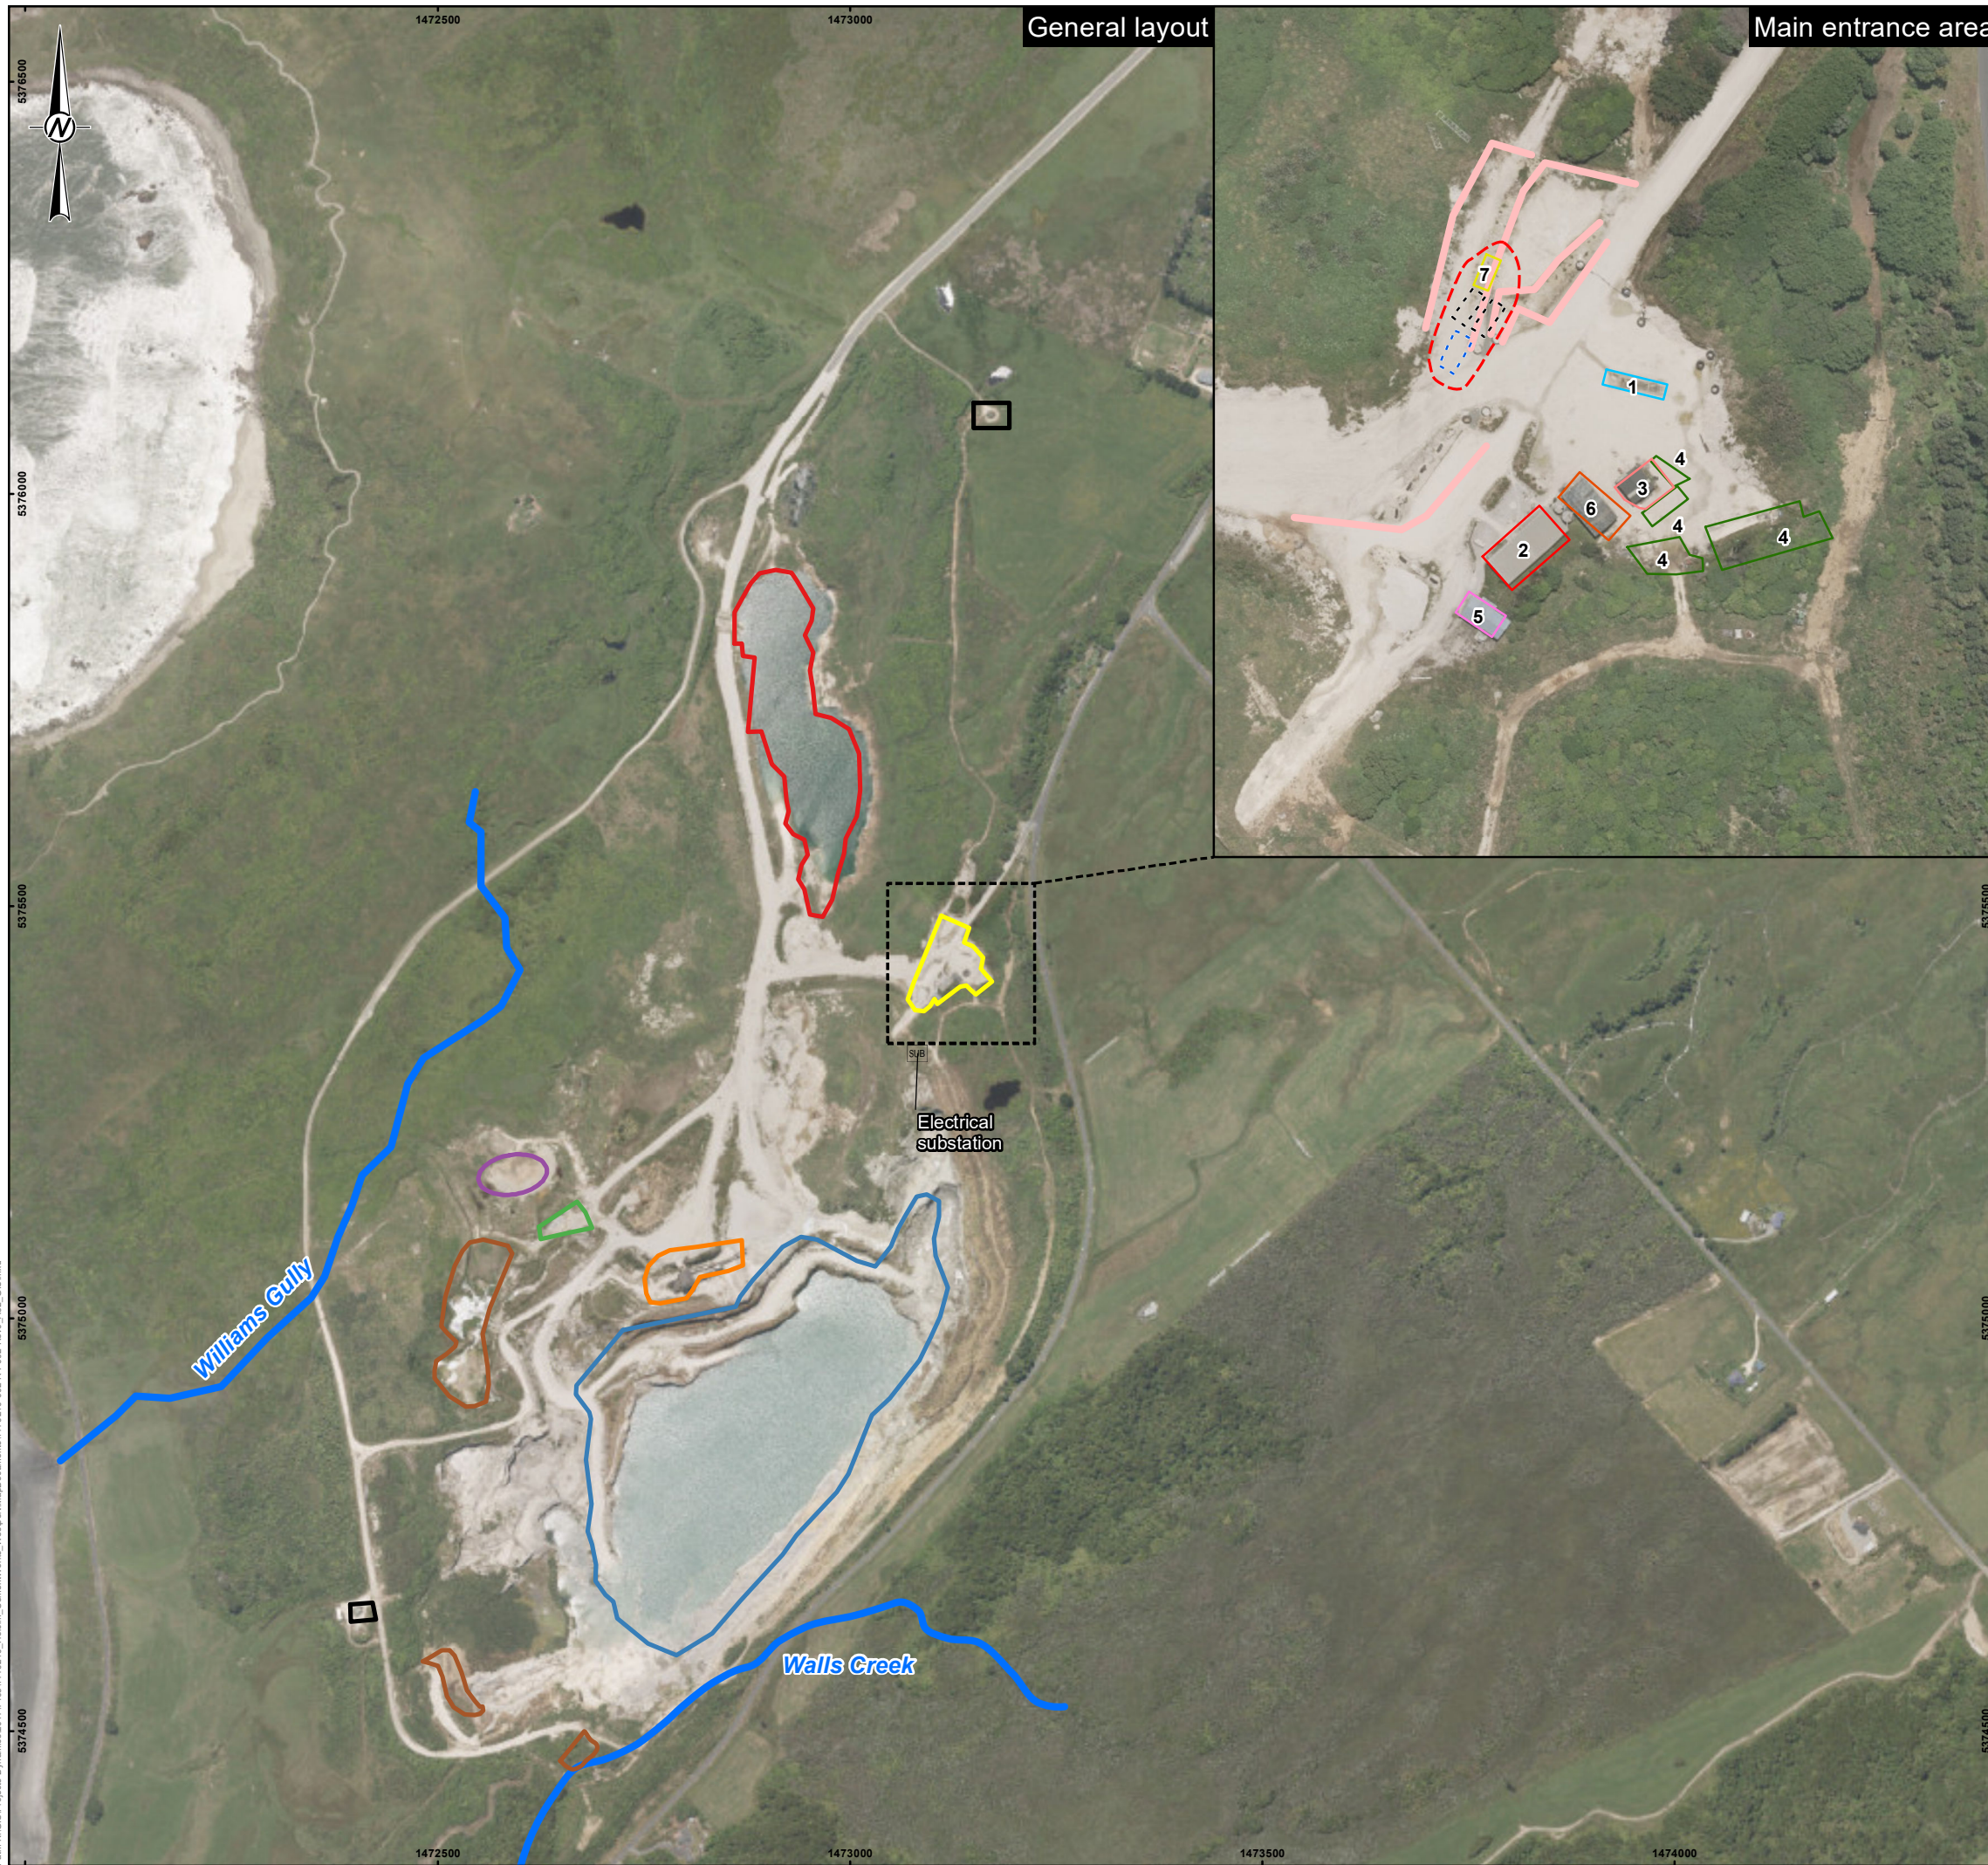
- 1 AST footprint
- 2 Canteen
- 3 Inferred core storage
- 4 Burning area / dumping ground
- 5 Office
- 6 Workshop
- 7 Building footprint - former vehicle maintenance shed
- Refuelling area
- Inferred former UST (13,600L)
- Inferred former UST (40,000L)
- Windrows

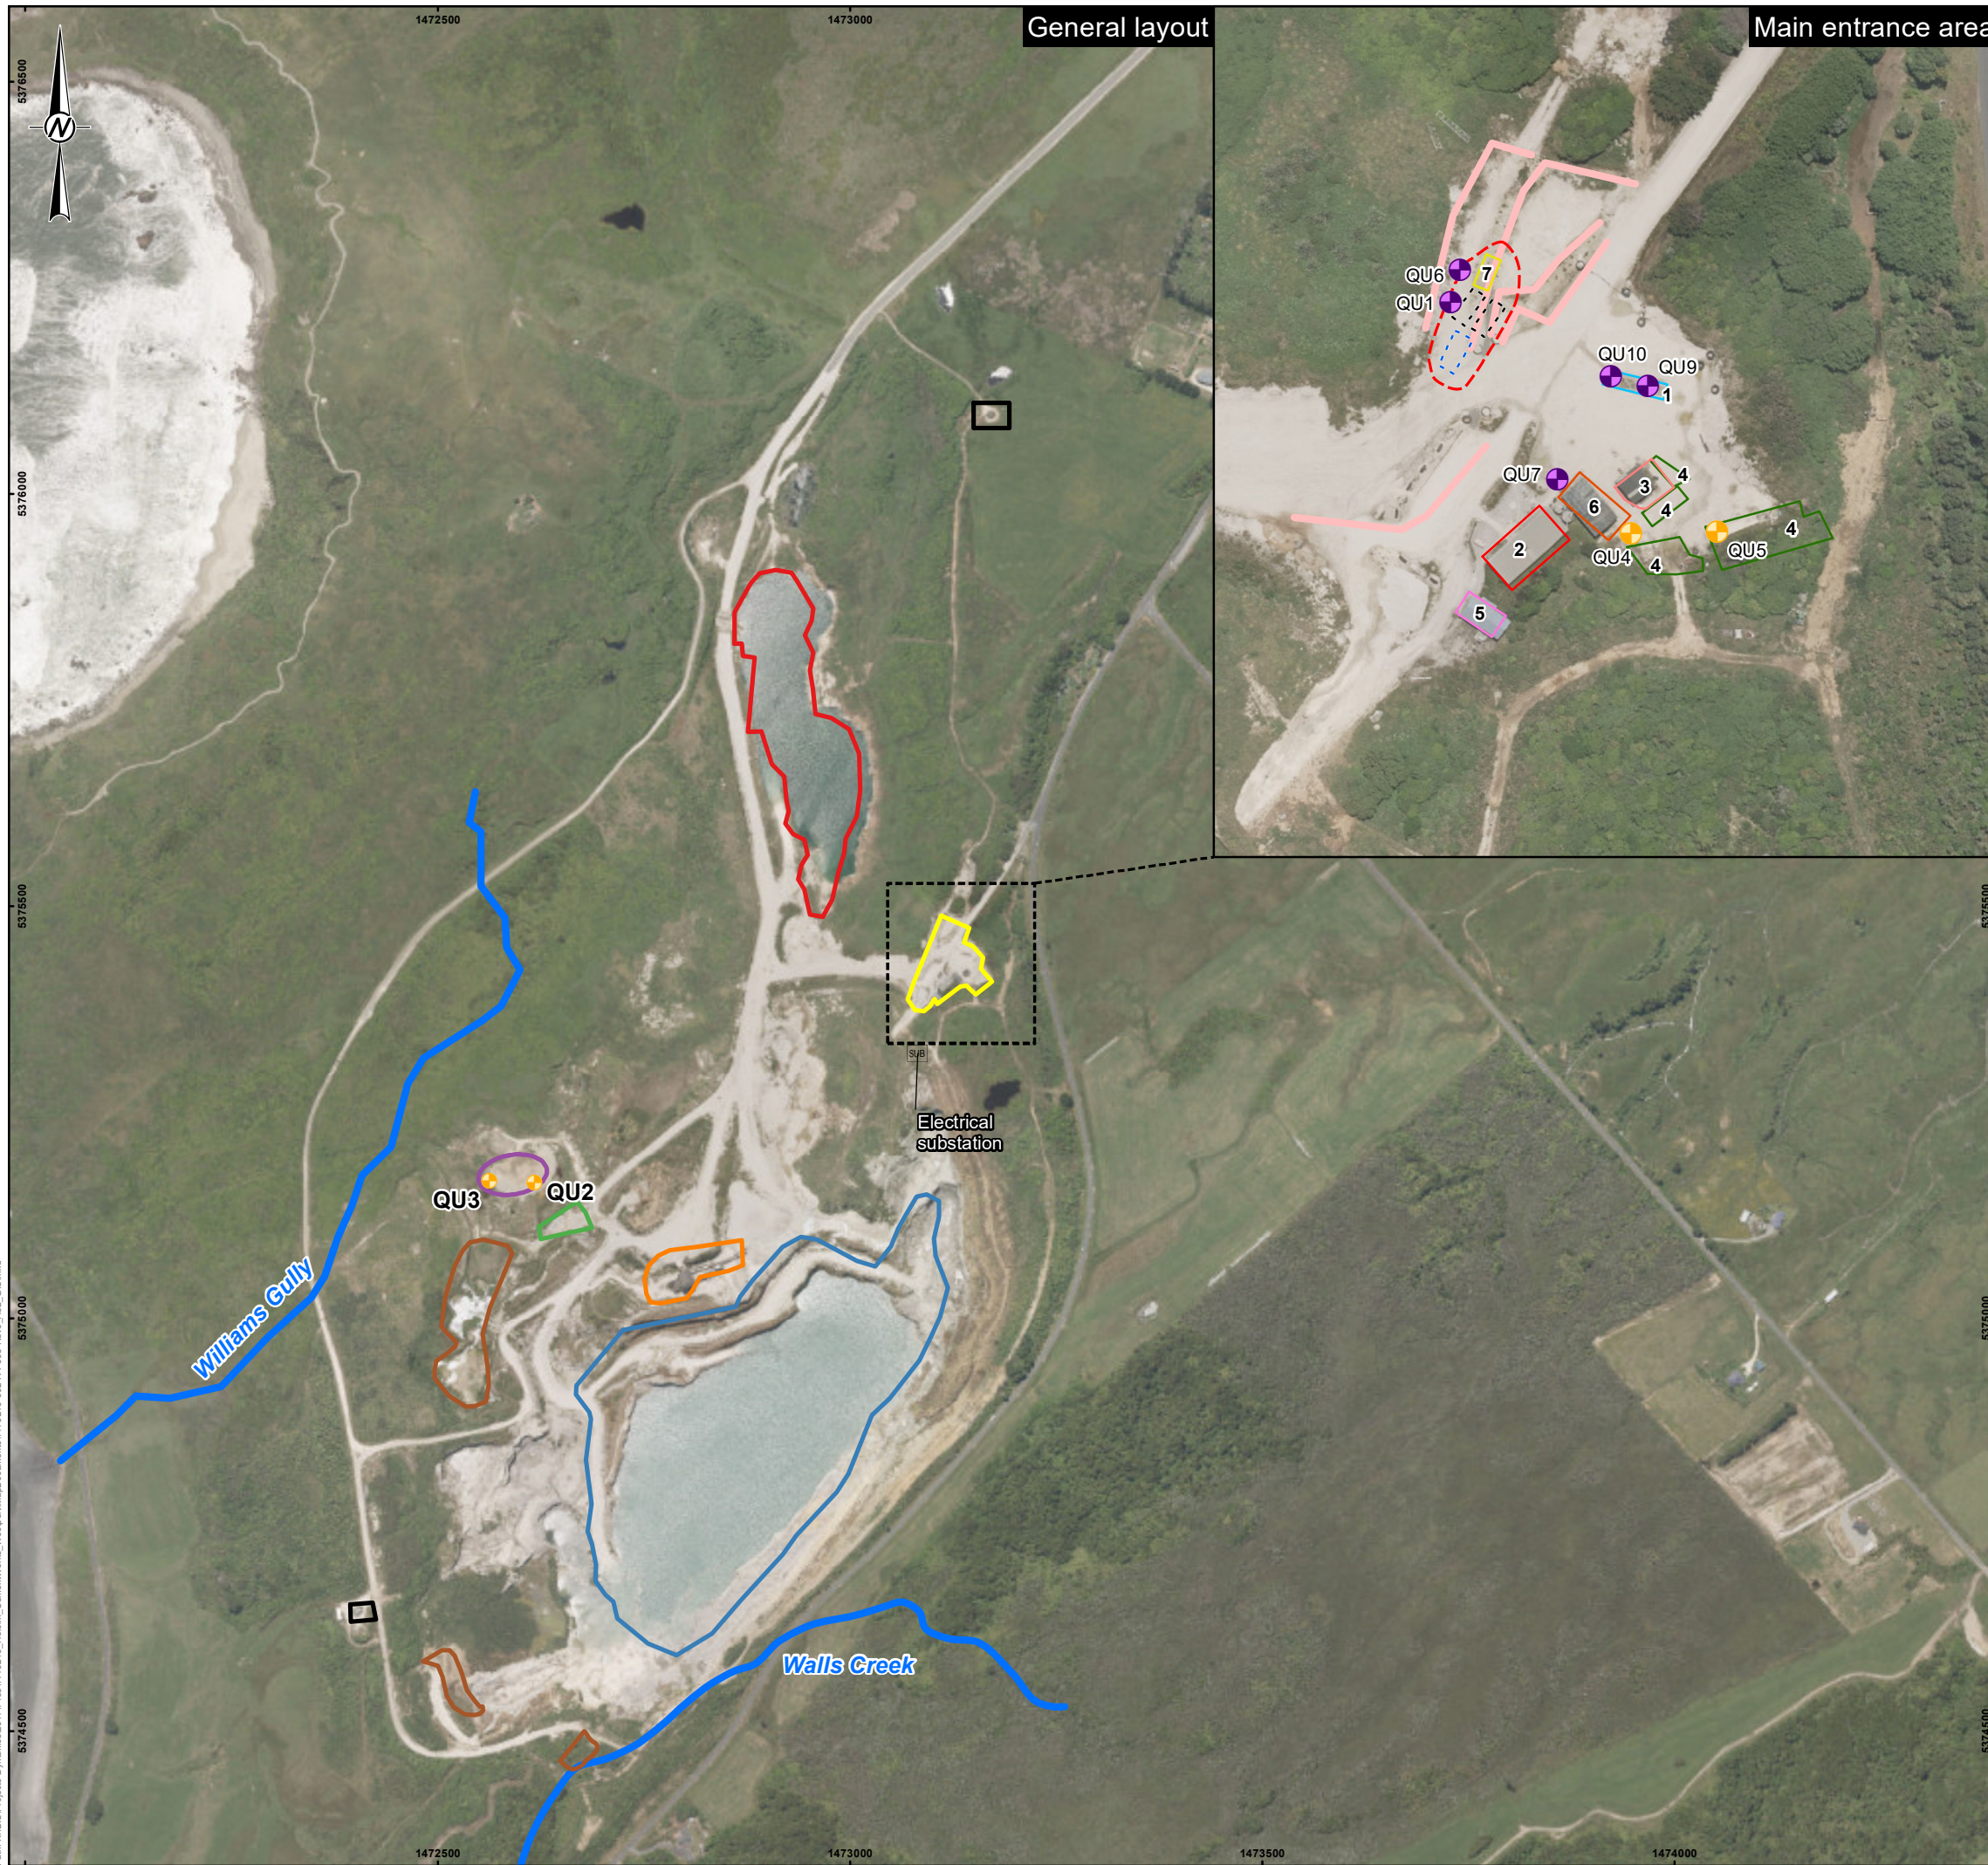
A programme of limited soil sampling was undertaken by Golder on 14 and 15 June 2017 during the Quarry site walkover, see Figure 3. The soil sampling was targeted at selected areas of interest (re-fuelling area, burning/dumping ground, former AST, and the Quarry Landfill) where evidence for possible contamination was observed during the site walkover.

- Hand excavation
- Test pit excavation

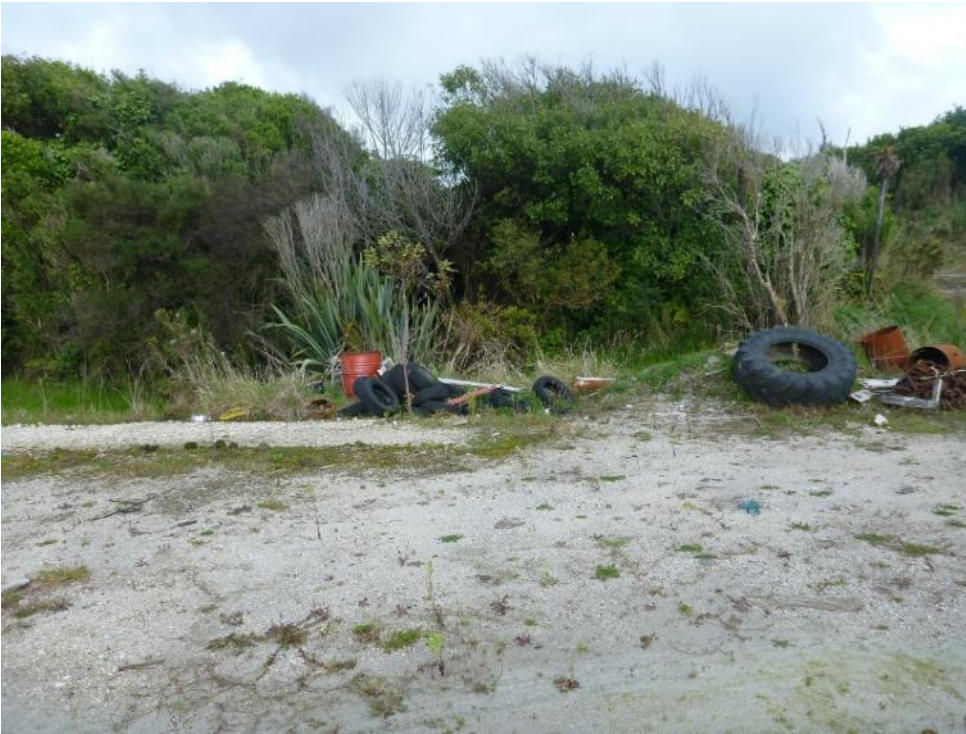
Photograph 7: Burning area and dumping ground.

Laydown and waste storage (dumping ground on Figure 2) was evident in the south-east car parking area. Materials observed to be present included an empty open top plastic 1,000 L intermediate bulk container (IBC), scrap metal and wood, wooden pallets, rope, vehicle tyres, several old and rusted 40 gallon drums (former contents unknown), and polyvinyl chloride (PVC) piping. Surface evidence of burning was also observed.

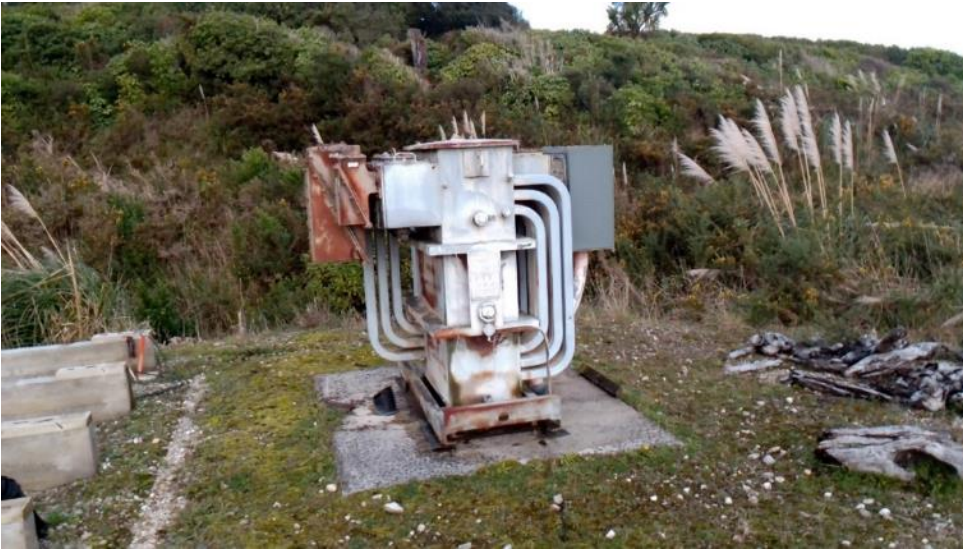
Photograph 9: Transformer.

- A refuelling area comprising a former vehicle maintenance shed (only the concrete floor slab remains) and USTs (now removed). This area is considered to be the location of the two 13,600 L and one 40,000 L USTs referred to in Section 4.3.
- Footprint of former above ground storage tank (AST).
- Core storage shed – no longer present.
- A workshop/garage (black staining was observed on the concrete pad at the front of the workshop).
- A canteen (including wash rooms).
- Offices.
- A transformer on a concrete pad.

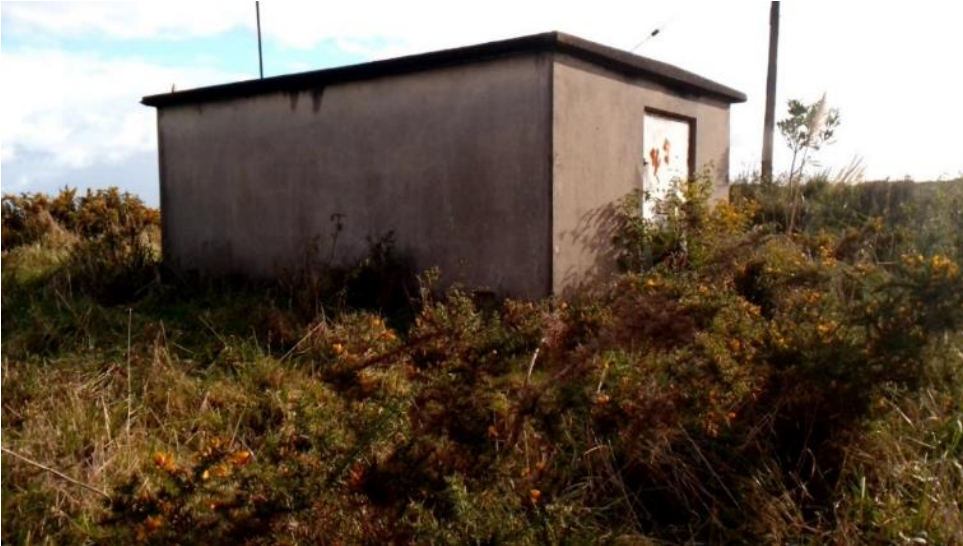
Photograph 14: Electrical substation.

Immediately to the south of the Main Entrance Area, a small shed-like structure was present, which appeared to be a former electrical substation. The shed was constructed of concrete panels. Cable trenches were present in the concrete floor slab and redundant wiring was observed in one trench.

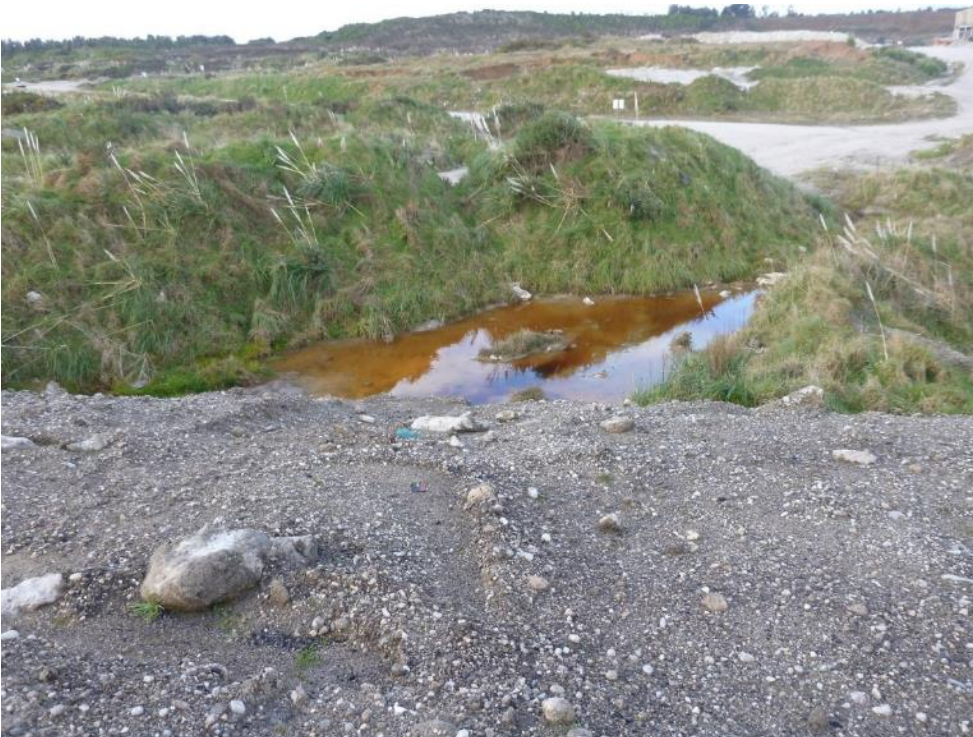
Photograph 19: Discoloured water around base of landfill.

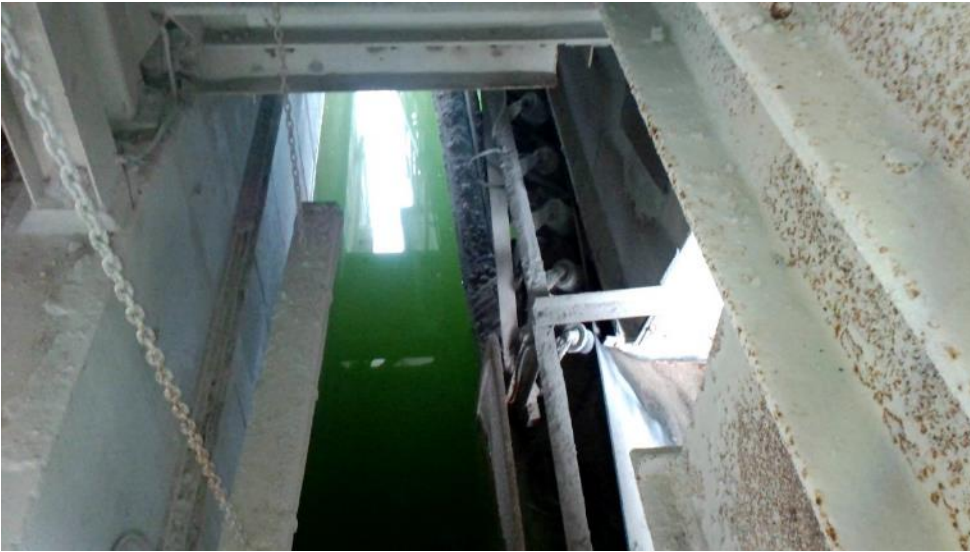
Photograph 23: Crusher – flooded basement.

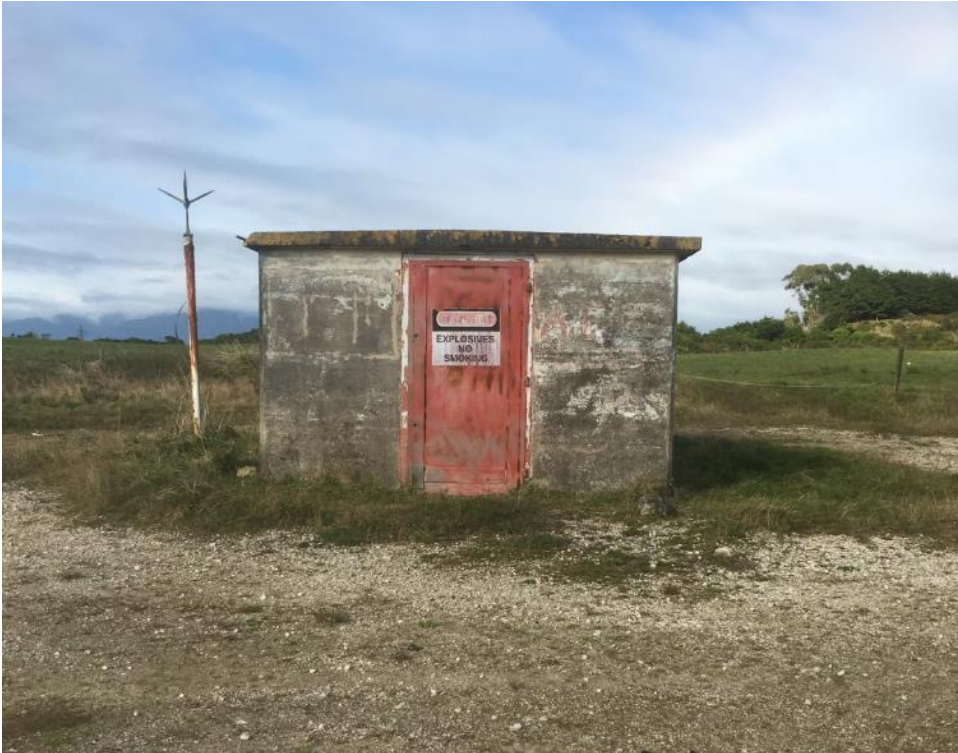
Photograph 25: Explosives store (near main entrance).

Two explosives stores are known to be present at the Quarry, though they were not observed during the walkover as the local HNZN staff did not know where they were located. Since the walkover was undertaken, local HNZN staff have located and photographed one of the explosives stores (close to the Main Entrance) and taken photographs. The photographs (Appendix F) indicate that the store comprises a square building of concrete construction.

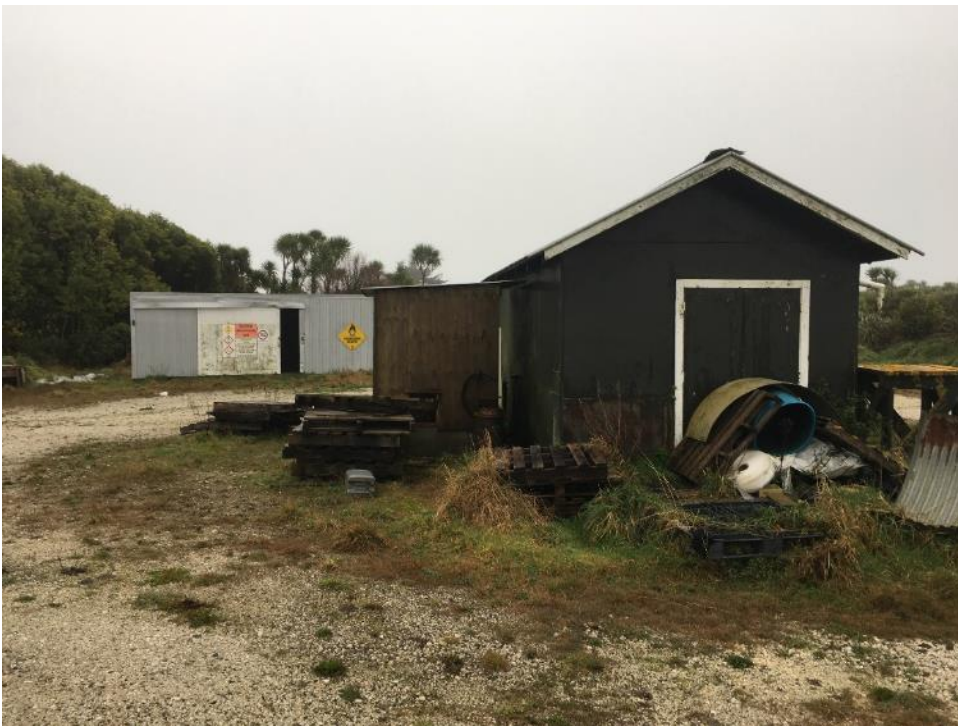
Photograph 26: Explosives store (south-west of 'M' Quarry).

- Two buildings (sheds) of wood and corrugated metal sheet construction which were used to store materials used in explosives manufacture (ammonium nitrate and diesel). We understand from HNZN that the components of the explosives were mixed on site by HNZN staff.
- Within and surrounding the sheds were pallets, cardboard boxes, polythene wrapping and bags, plastic drums, and corrugated metal sheets.
- An area close to the sheds appeared to be a general waste dumping area containing timber, metal grills, bricks, pipes (plastic and metal), polythene sheets, and possible evidence of waste burning.

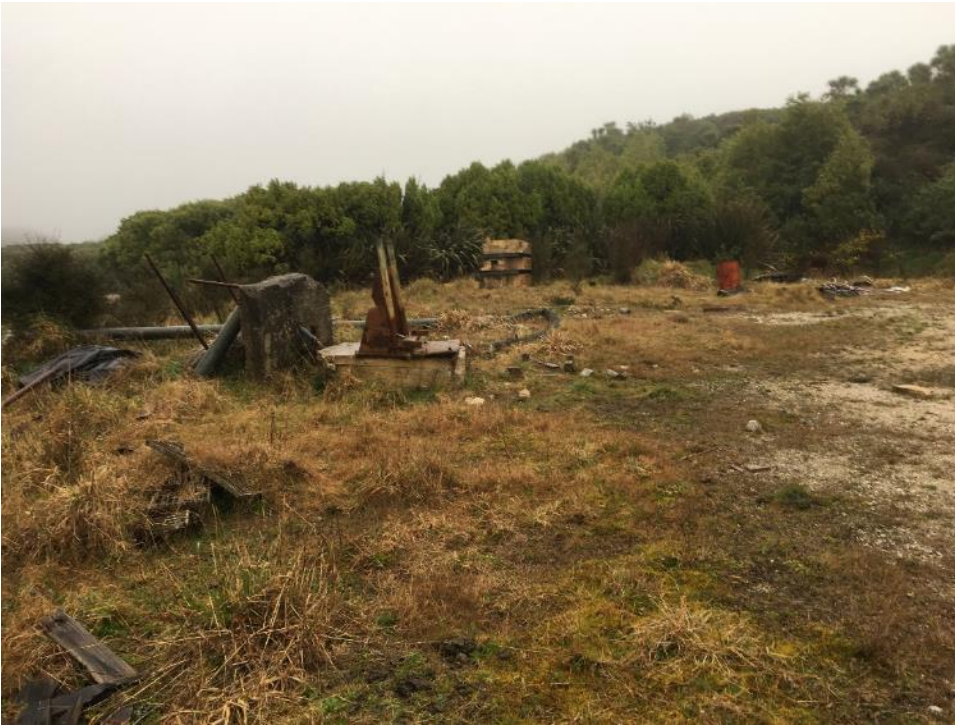
Photograph 27: Explosives store (south-west of 'M' Quarry) - general dumping area.

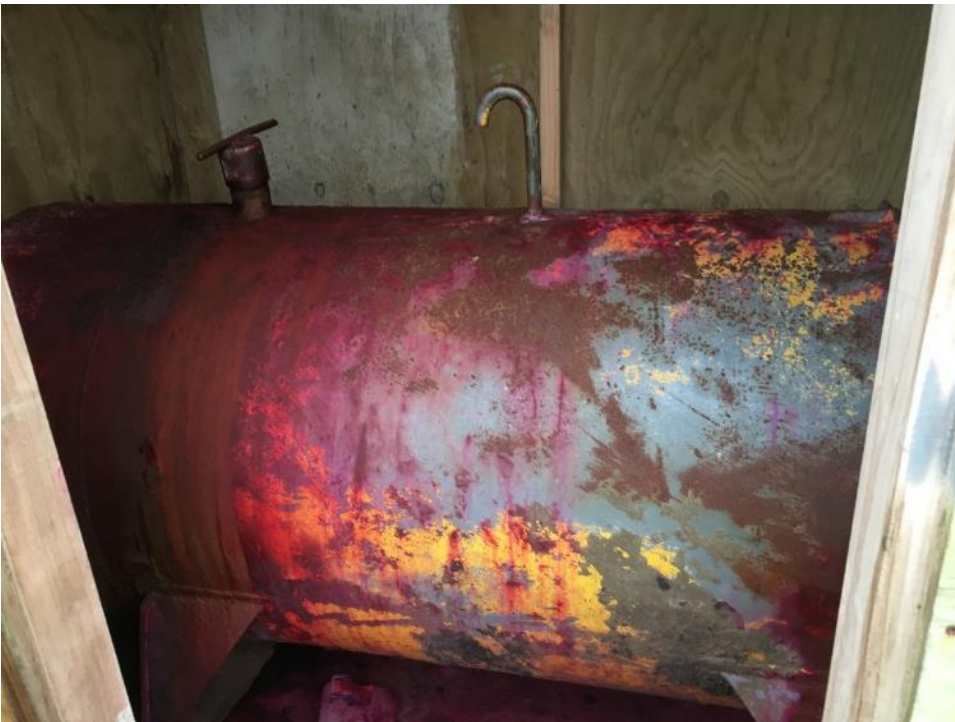
Photograph 28: Explosives store (south-west of 'M' Quarry) – diesel AST.
