Submission to Variation 2 Te Tai o Poutini Plan

Ken Wiltshire

Initial Submission 16 Dec 2024

Ngakawau Straight SH67 - A Case in Point.

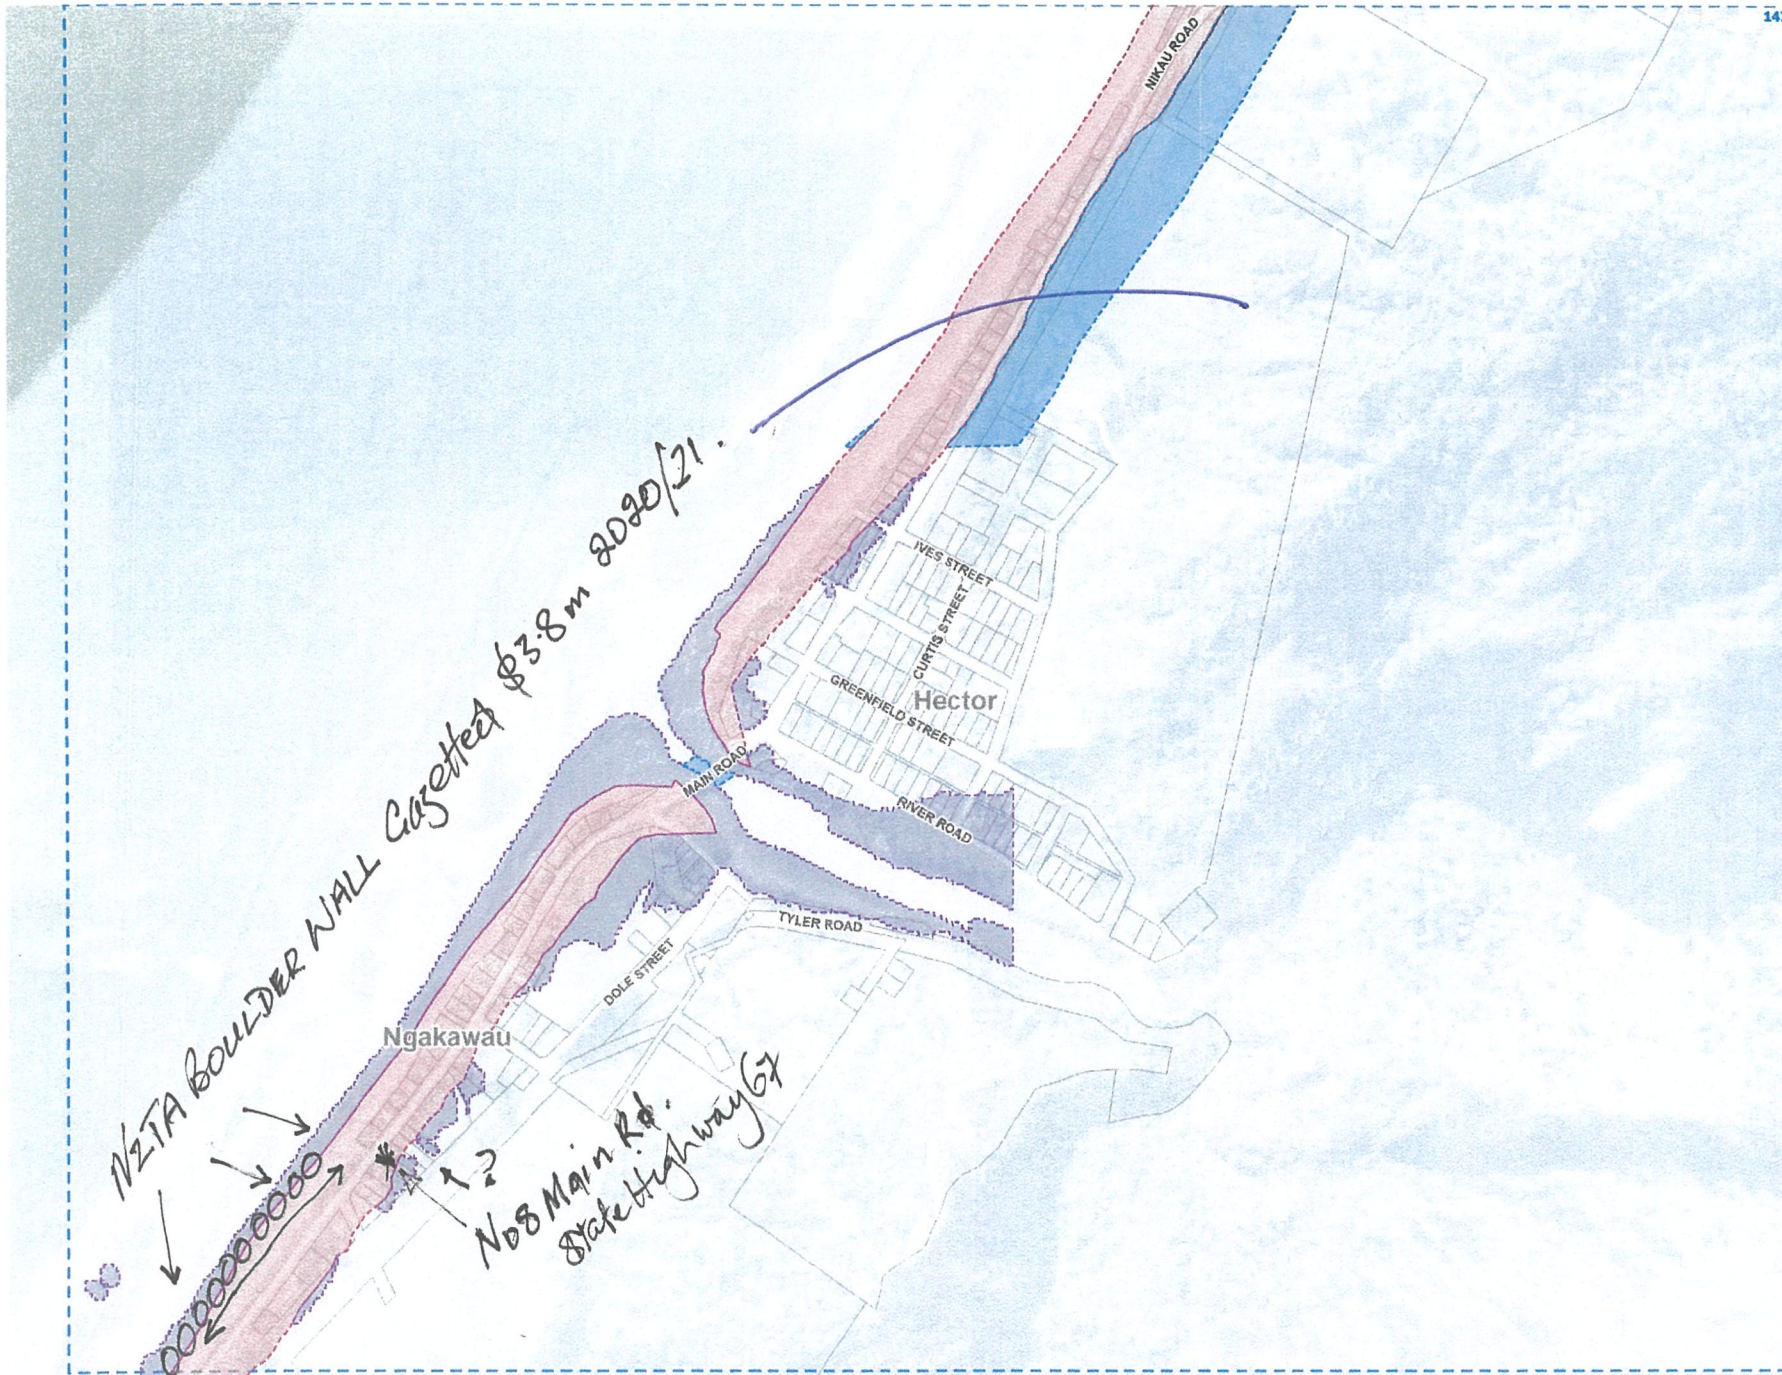
Ngakawau-Hector

Coastal Hazard Variation
Updated Mapping

- Coastal Hazard Severe
- Coastal Hazard Alert
- Coastal Hazard Setback

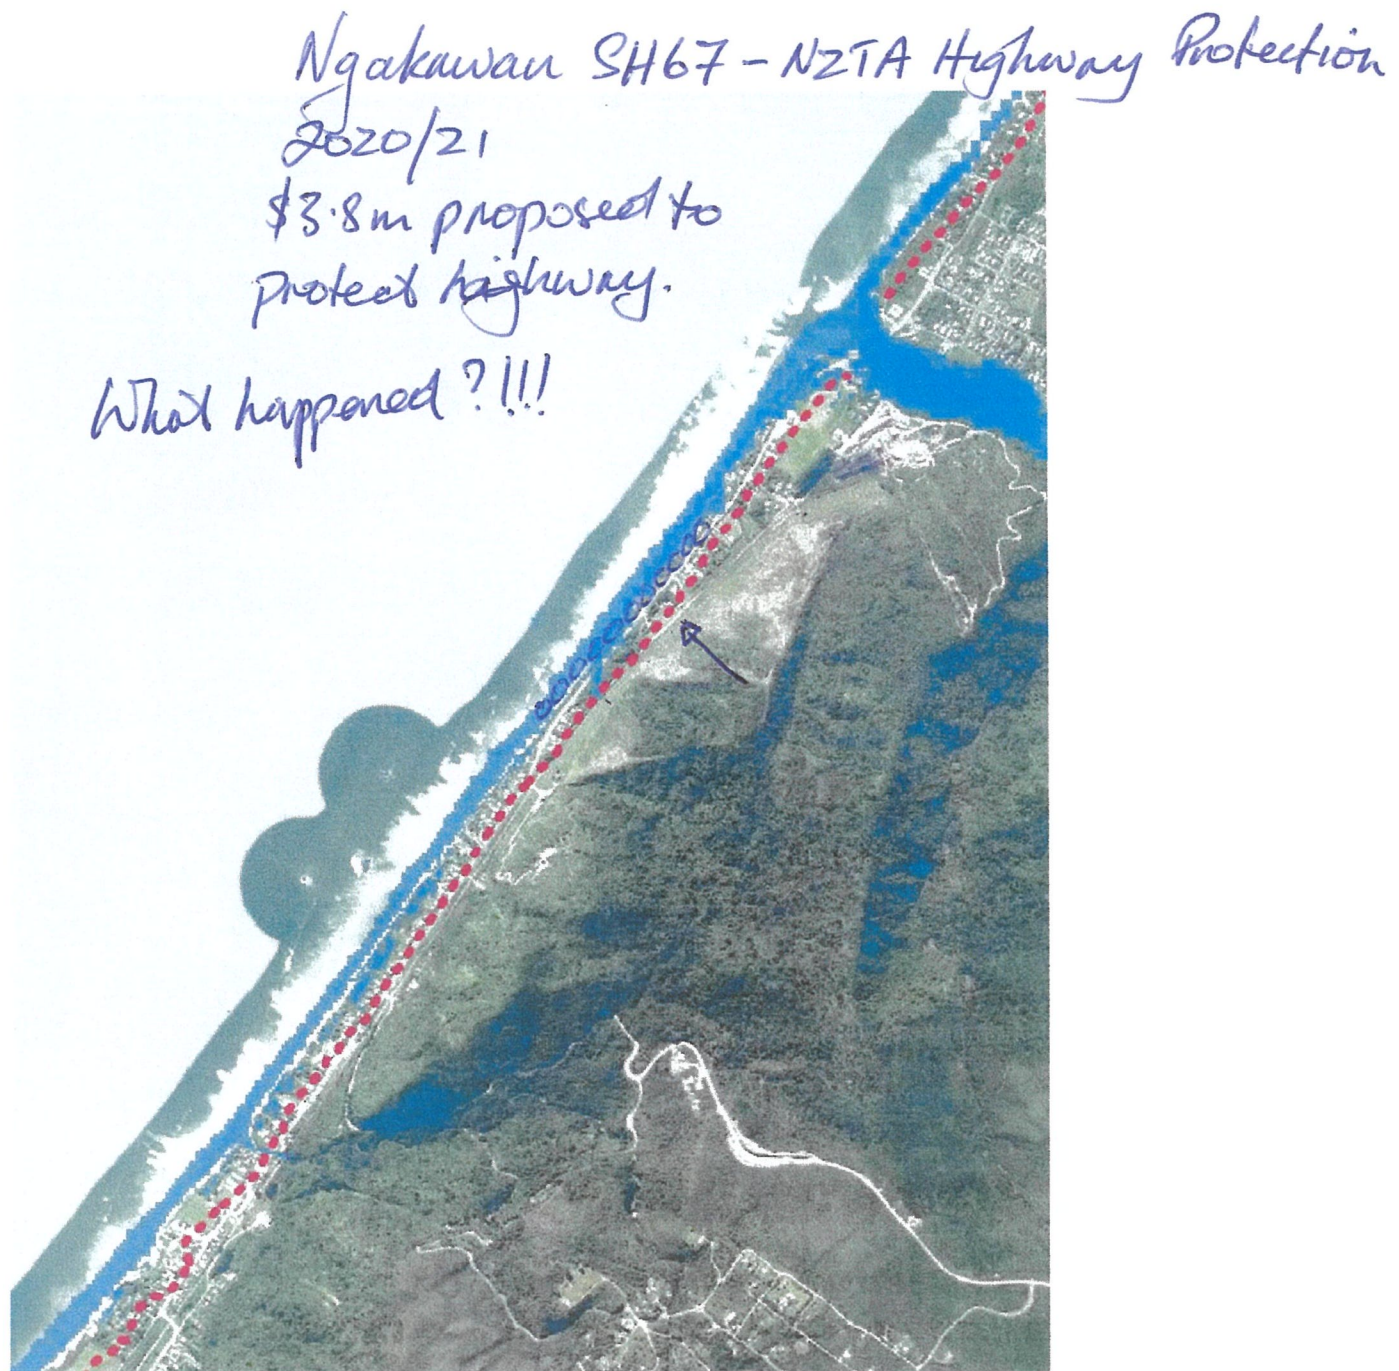
Figure 4-8: 1% AEP storm-tide+wave setup for present sea level in Granity Hector and Ngakawau . Blue shading shows areas at risk of inundation. The dash red line show the area of coastal erosion hazard for a 100-year outlook.

It should be noted that the multiple river/lagoon/beach systems can experience complex interactions between hazards. The interaction of river and coastal flooding and erosion are not covered in the static inundation assessment.

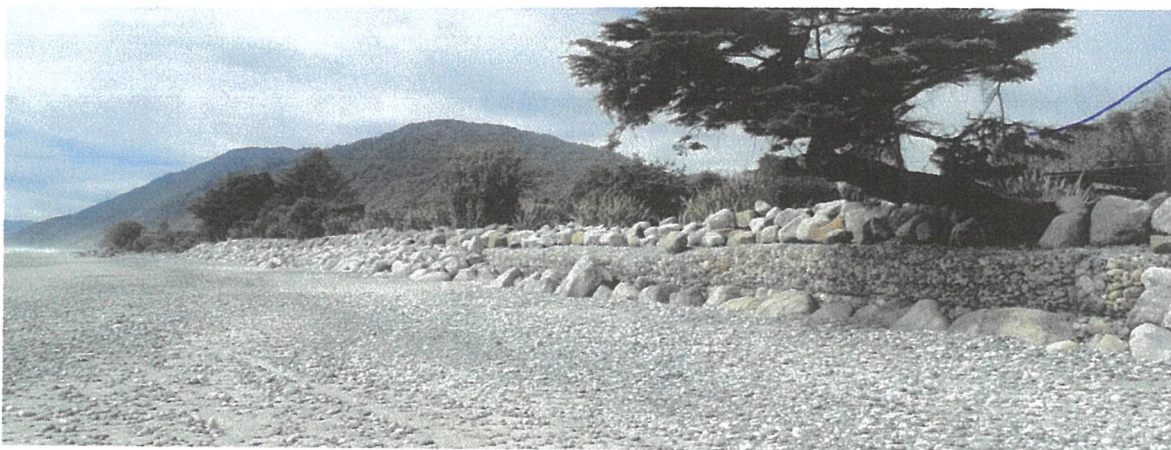
N1 - The privately built rock and gabion structure from 11 - 14 Main Rd (referred to as Merrett's wall, Figure 3-8, see also DTEC 2007) is an example of cooperative defence construction which has so far been successful in defending the properties and has a small gravel fillet beach at present. Merrett's wall also wraps around the south side of Morris Creek exit. The revetment size (rock diameter, crest height) is adequate for moderate storms, but is likely to be damaged by large coastal storms. The combination of rock and gabions is not good practice for revetment design/construction due to lack of gabions-rock interlocking when compared to rock-rock interlocking, along with the eventual corrosion and slumping of gabion baskets. There is evidence that the storms experienced have caused some undermining, outflanking and occasional overtopping. At the creek mouth, the streambed is infilling with sand and erosion of the upper foreshore has caused the shoreline to retreat on its northern side where several protection attempts have been made (Figure 3-9). This erosion and infilling will continue to cycle between streambed flushing by strong runoff events or large waves on a high tide and sediment accumulation by wind and wave coastal processes during lower wave conditions. Dwellings are within 5-10 m of the active beach face, behind the revetment and a narrow vegetation buffer.

Figure 3-8: Coastal defence "Merrett's wall" along 11-14 Main Rd, Ngakawau. Privately funded structure built in 2007. Photograph looking north east along Ngakawau frontage from 11 Main Rd, Ngakawau. [22 September 2015].

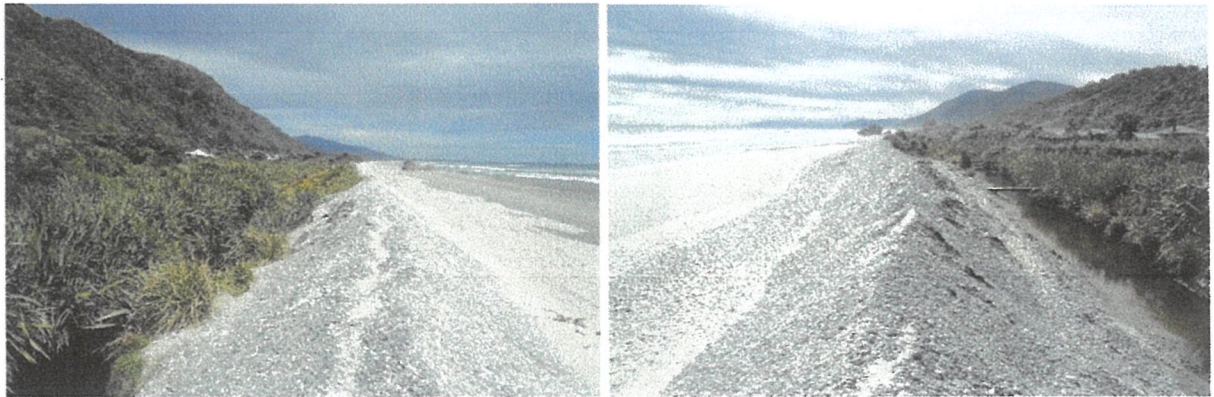
G3 - Along the stretch of coastline north from Granity Stream to Chair Rock, the beach is presently in a healthier state with a larger volume of gravel on the upper beach compared to adjacent beach sections. The gravel berm is regularly topped-up by BDC drain clearance (approx. 2.5 m above beach level at time of inspection) and there is a 40-60 m wide vegetation/swamp buffer to the dwellings (Figure 3-5). Barrier washover will still occur, particularly along sections where residents have cleared the natural vegetation up to the back of the beach crest.

Figure 3-5: Example gravel barrier and wide vegetation/swamp buffer between beach and houses between Granity Stream to south (left, not visible) and Chair Rock (right, visible at centre). Photographs looking south (left) and north (right) at about 138 Torea St. [22 September 2015].
