# Opening Statement on Coastal Hazards

Hearing of Te Tai o Poutini Plan. Variation 2 -Coastal Hazards

Cyprien Bosserelle

NIWA Taihoro Nukurangi

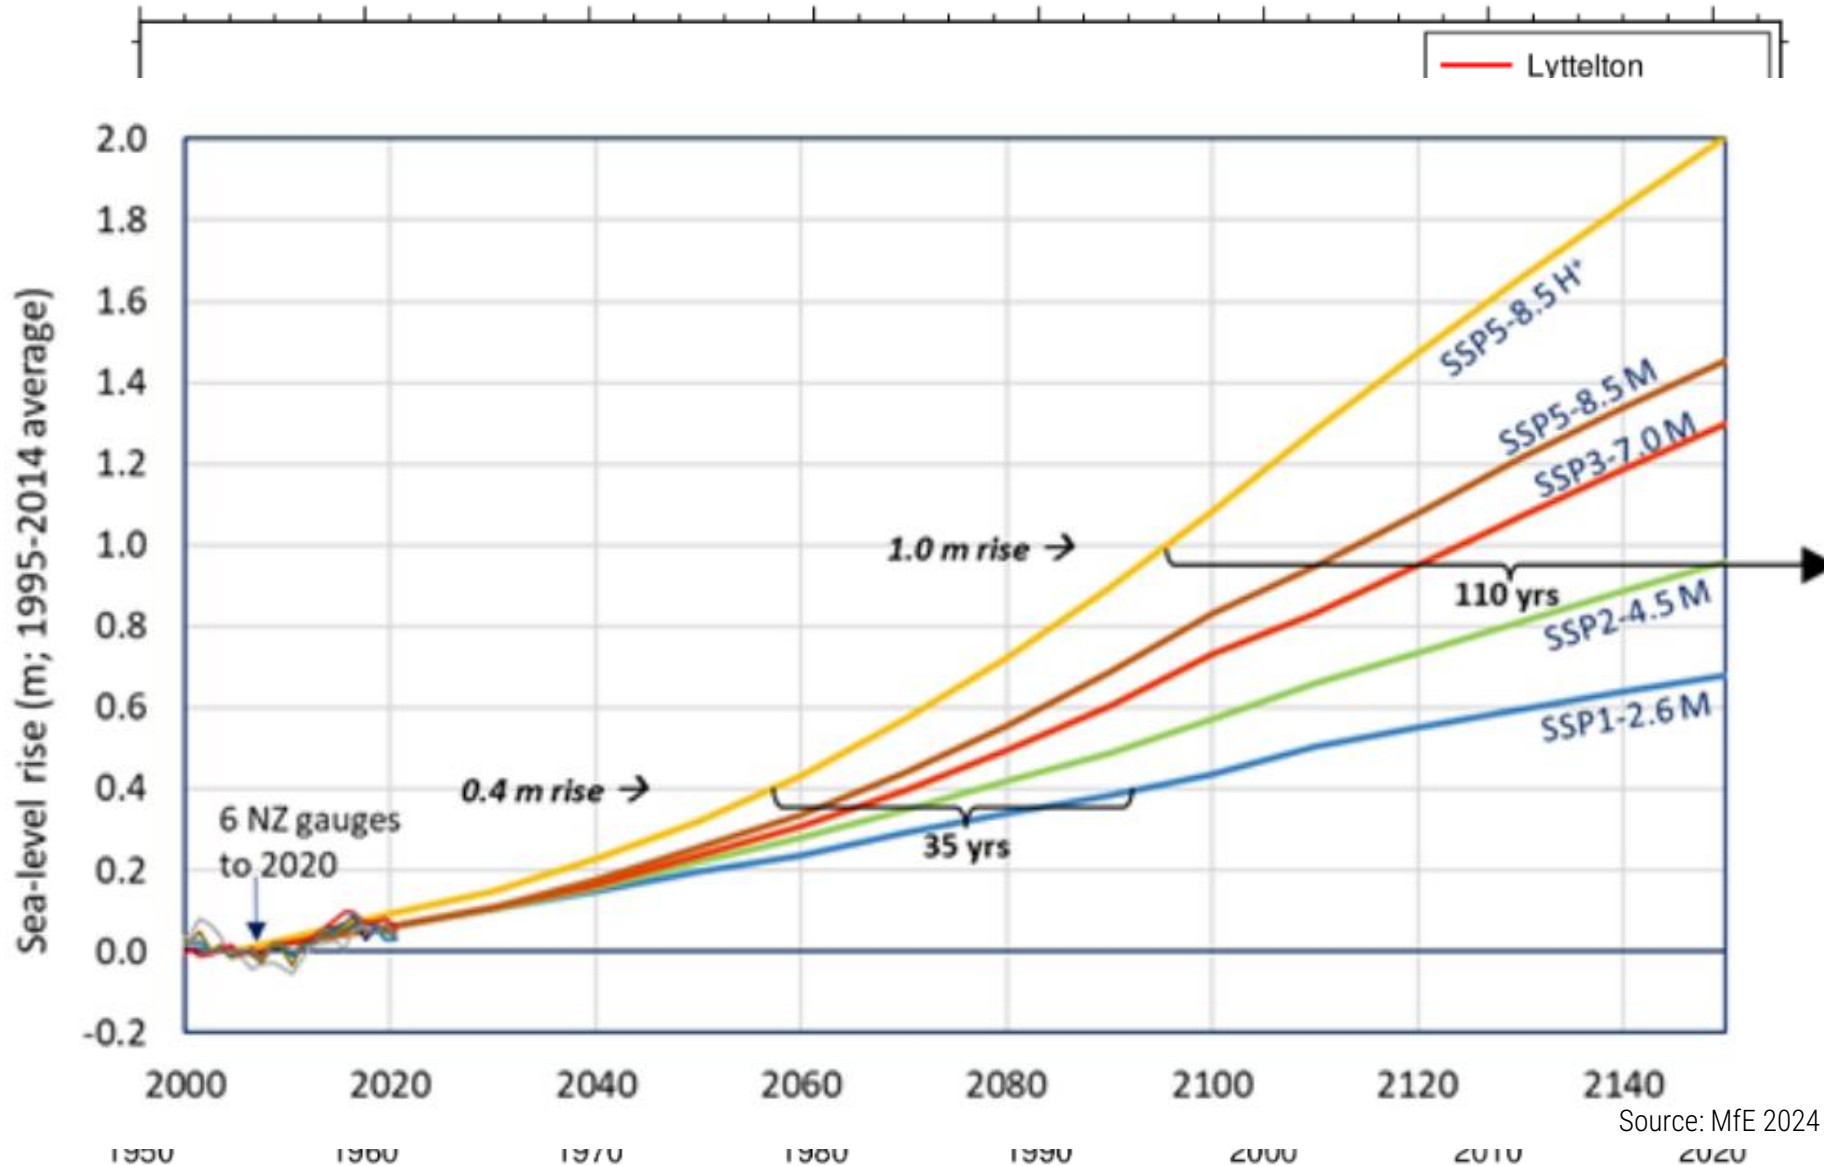
# Sea level is rising on the West Coast

Historical rate: 2.7 mm/year  
Since 1980: 3.2 mm/year

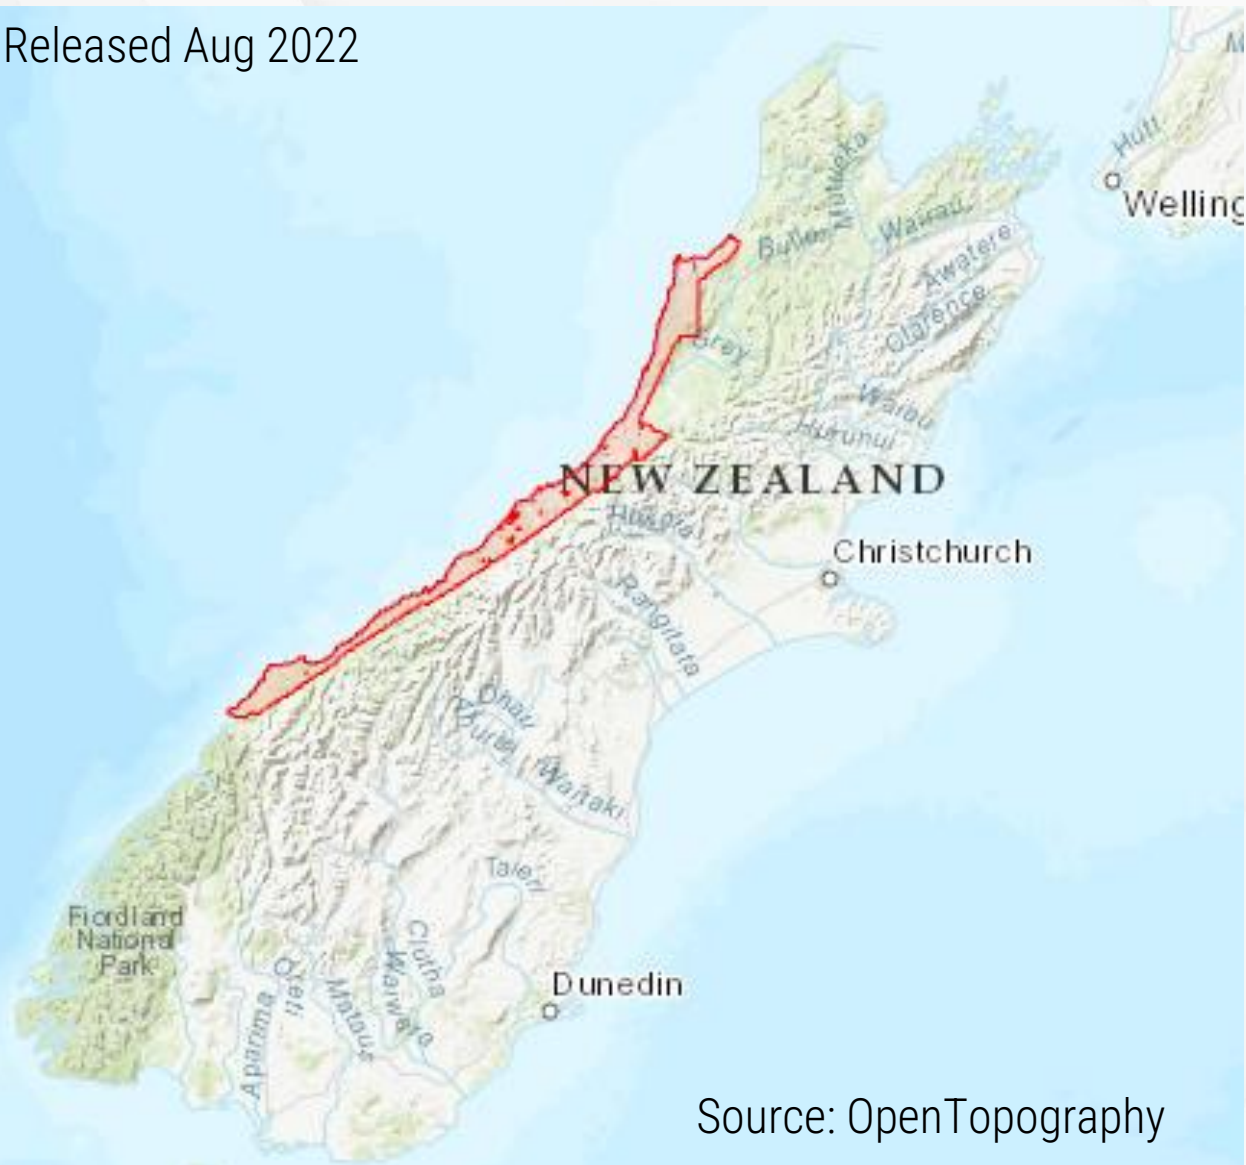
# LiDAR record

Released Aug 2022

Source: OpenTopography

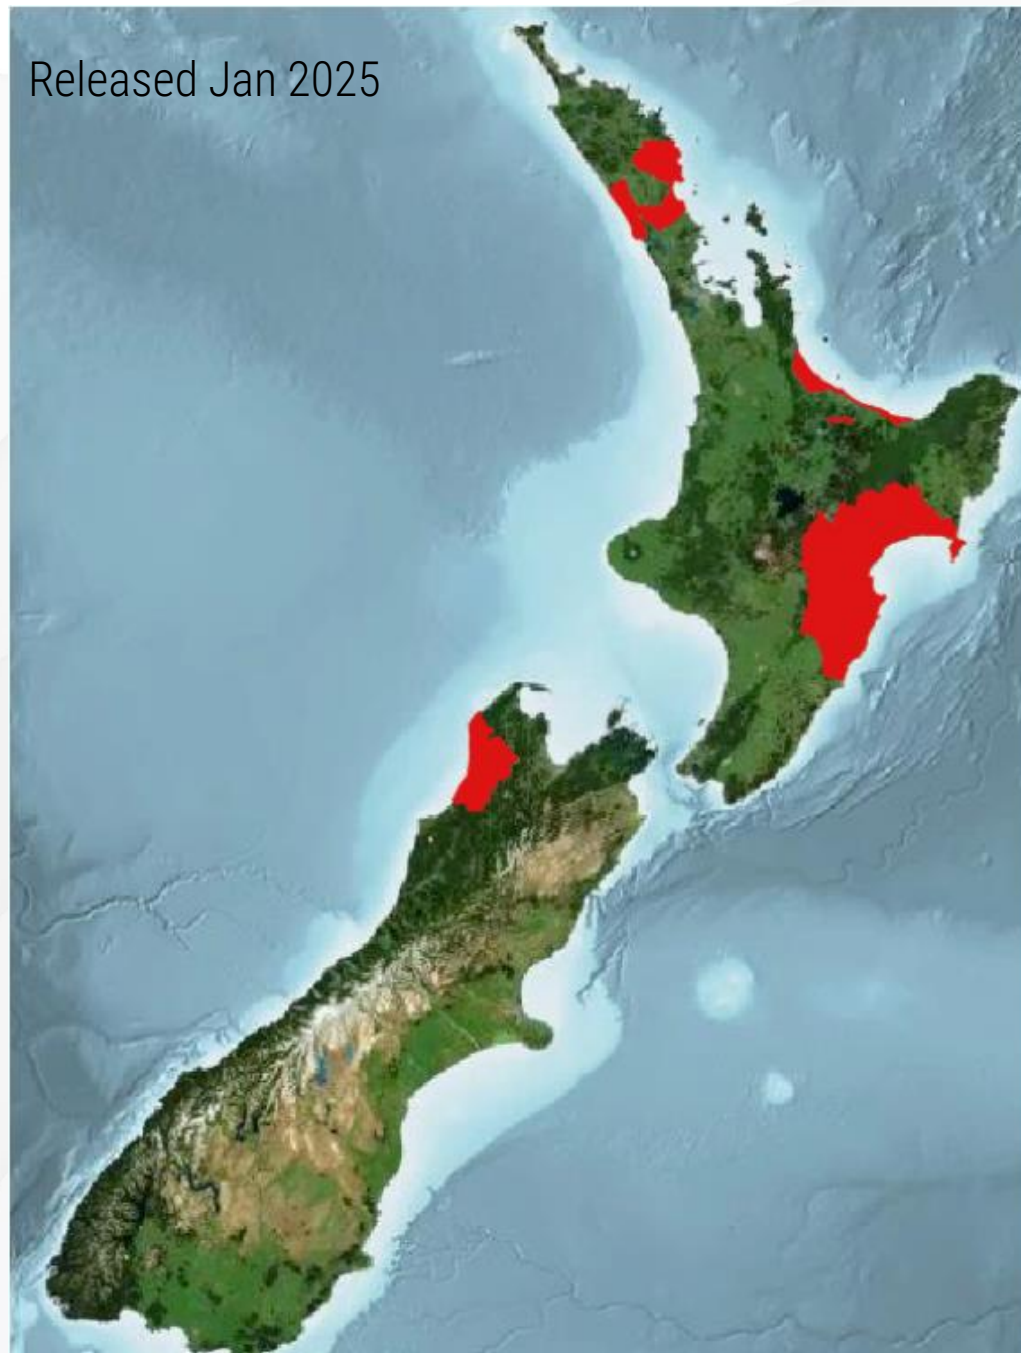
Released Jan 2025

Spatial coverage of additional regions of LINZ datasets highlighted in red.

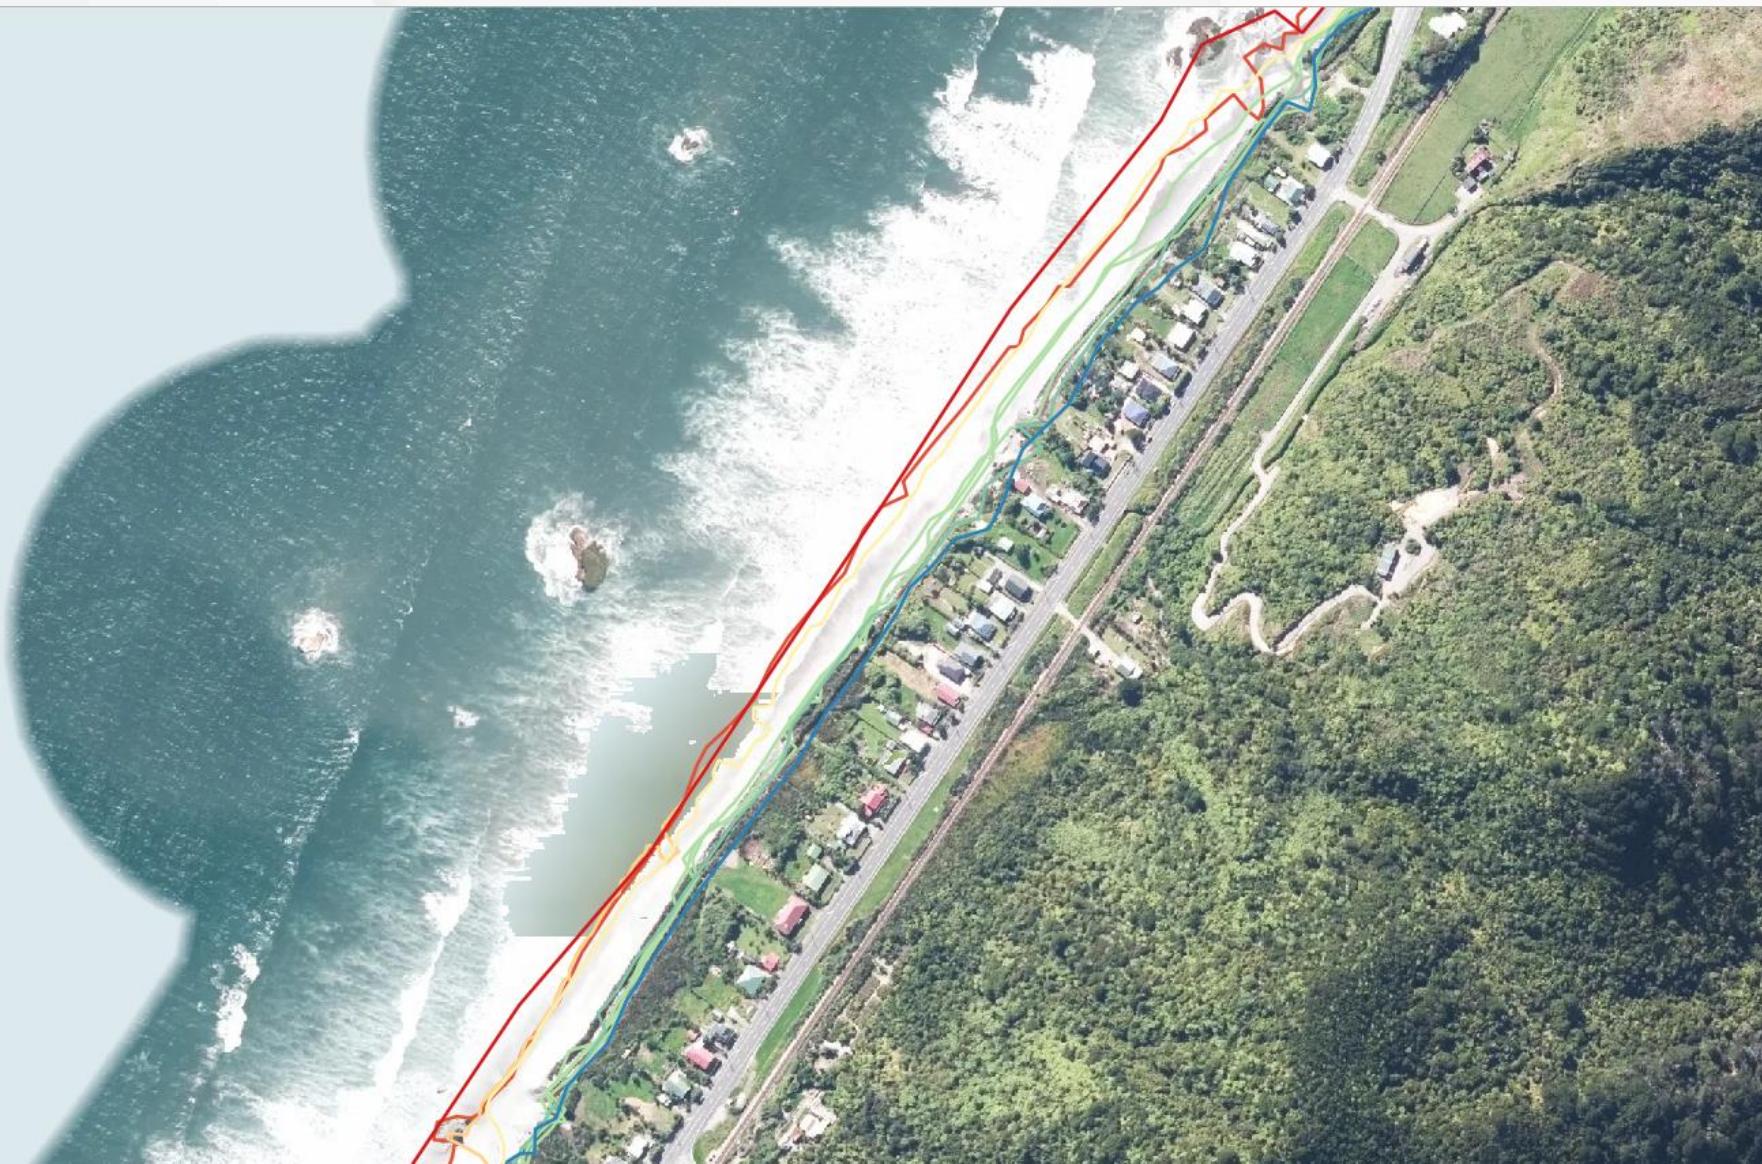
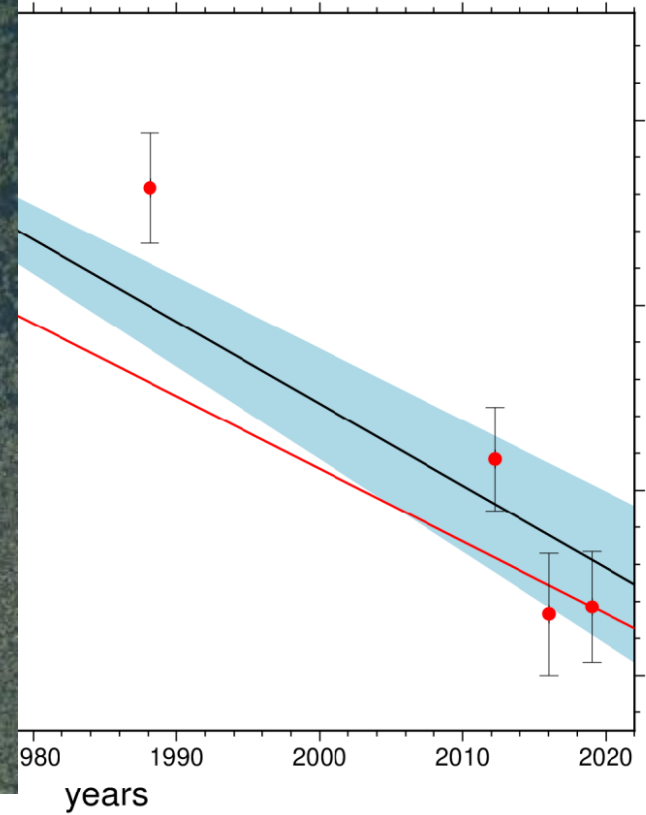
# Coastal erosion: historical rates

- 1876 - 1939
- 1939 - 1943
- 1943 - 1943
- 1943 - 1950
- 1950 - 1968
- 1968 - 1988
- 1988 - 1988
- 1988 - 2003
- 2003 - 2012
- 2012 - 2016
- 2016 - 2016
- 2016 - 2019

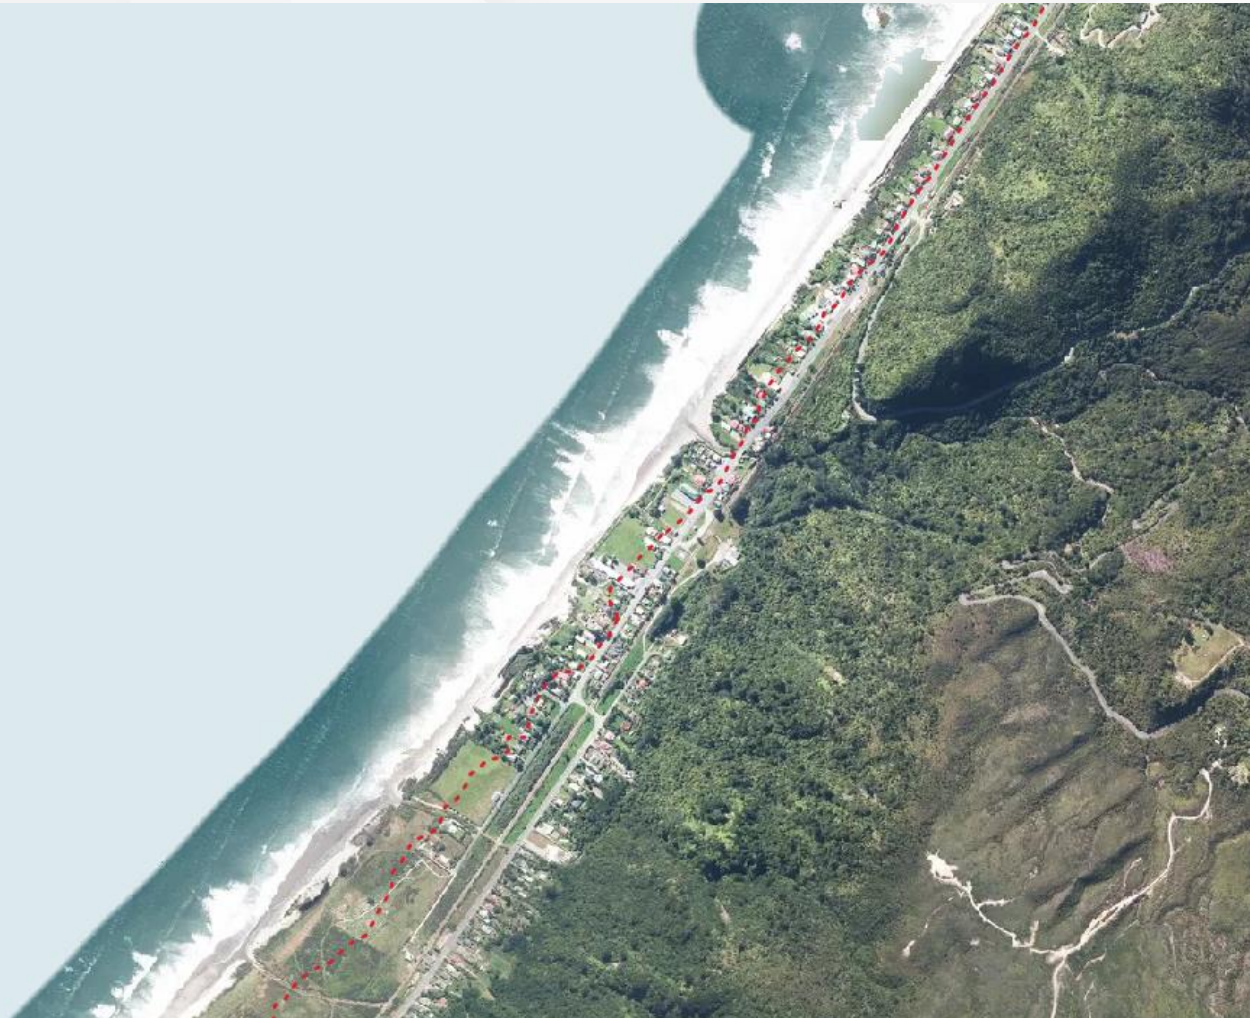
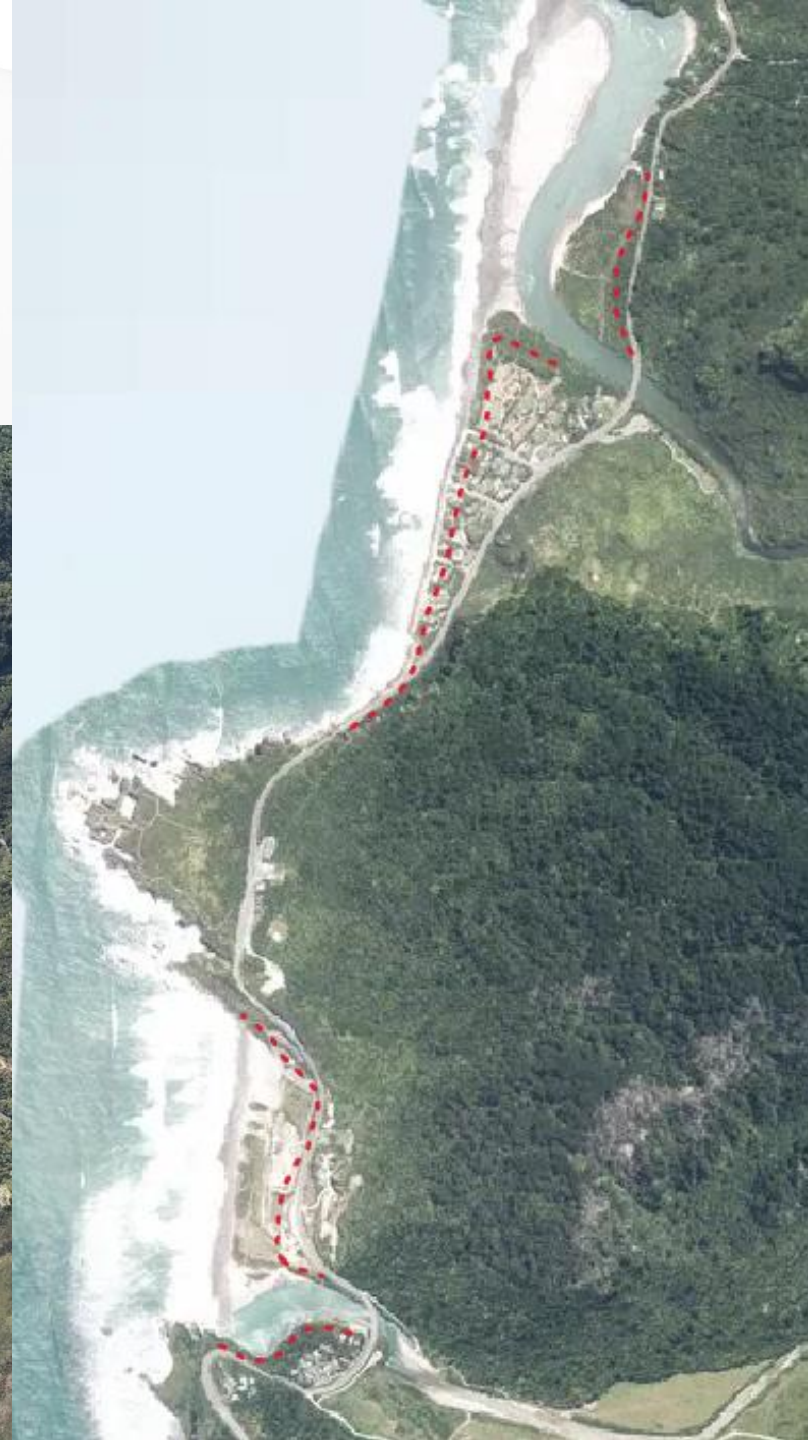
# Erosion hazard lines

Landward extent limited to known hard/consolidated rocks

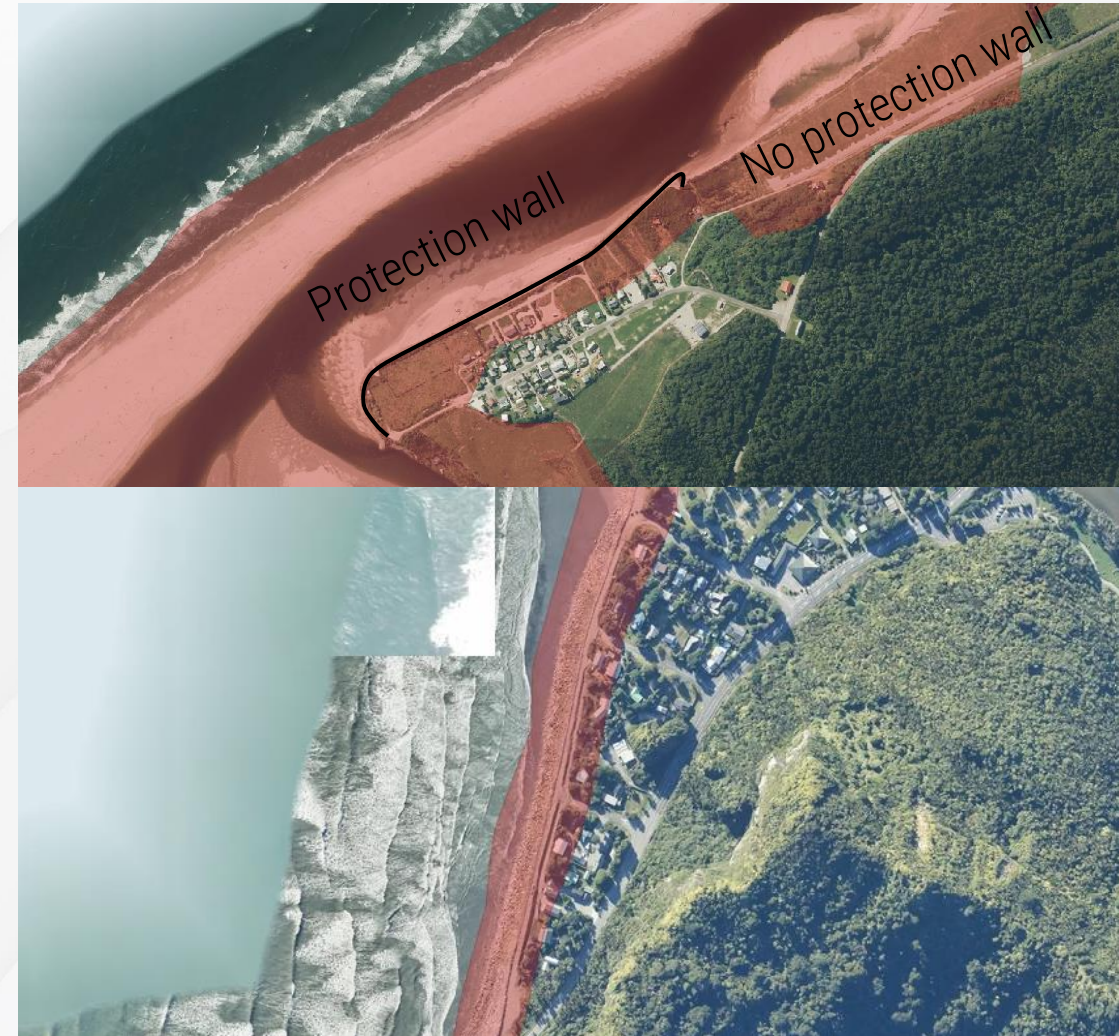
# Accounting for existing coastal structures

- Accounted-for :
  - Granity school
  - Orowaiti
  - Punakaiki
  - Okuru
  - Jackson Bay
- Not used for
  - Soft structures (likely to disappear; e.g. gravel bund )
  - Smaller structures = private seawall
  - Newer than 2020-2022 (e.g. Hannahs Clearing)

Structures do not remove the hazard

- Seawall can fail
- Typically designed to be “topped-up”

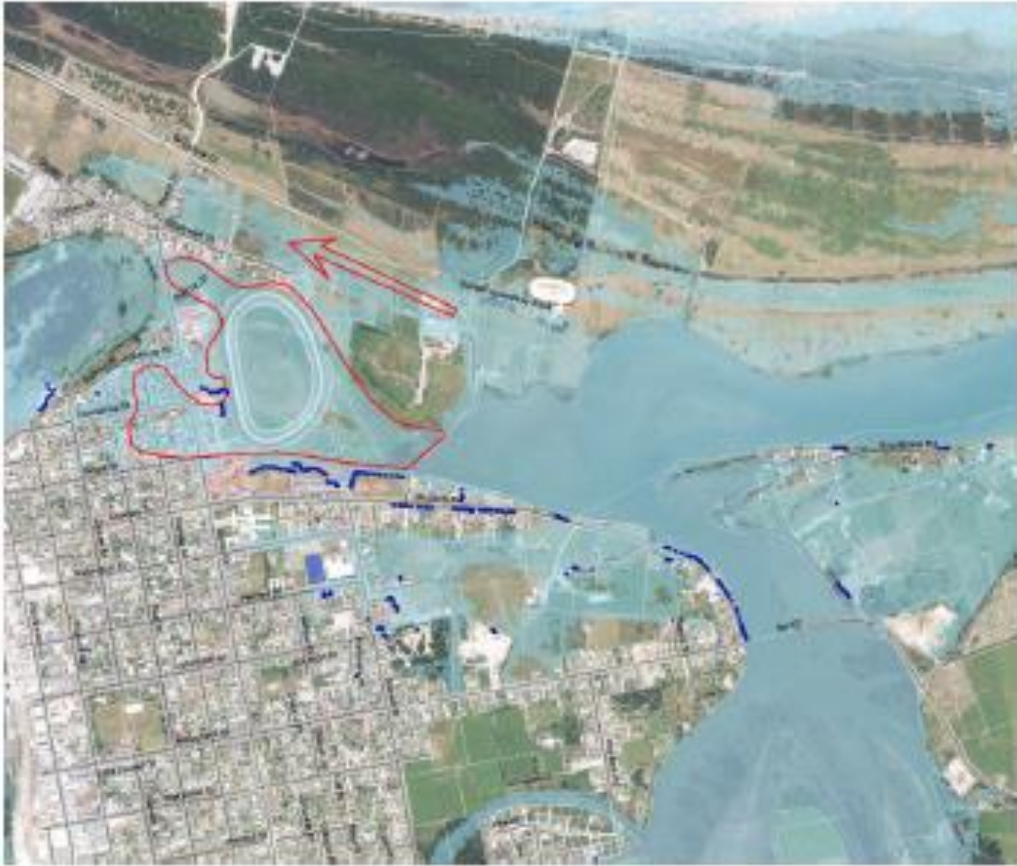
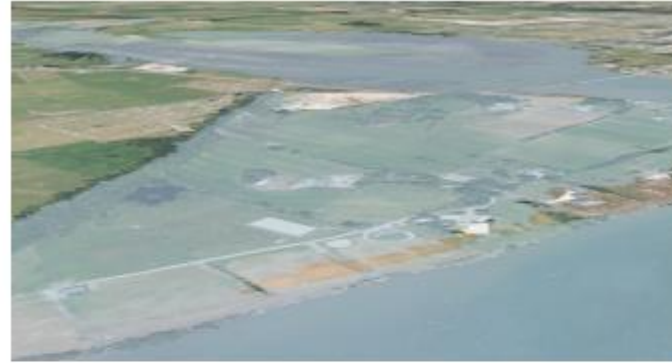
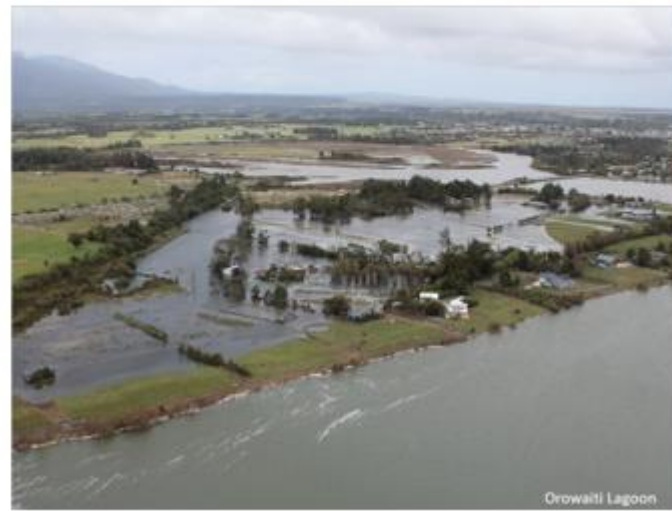
# How do we know the dynamic inundation model works?

Mean error = 0.01 m abs mean error 0.08 m (within measurement error)

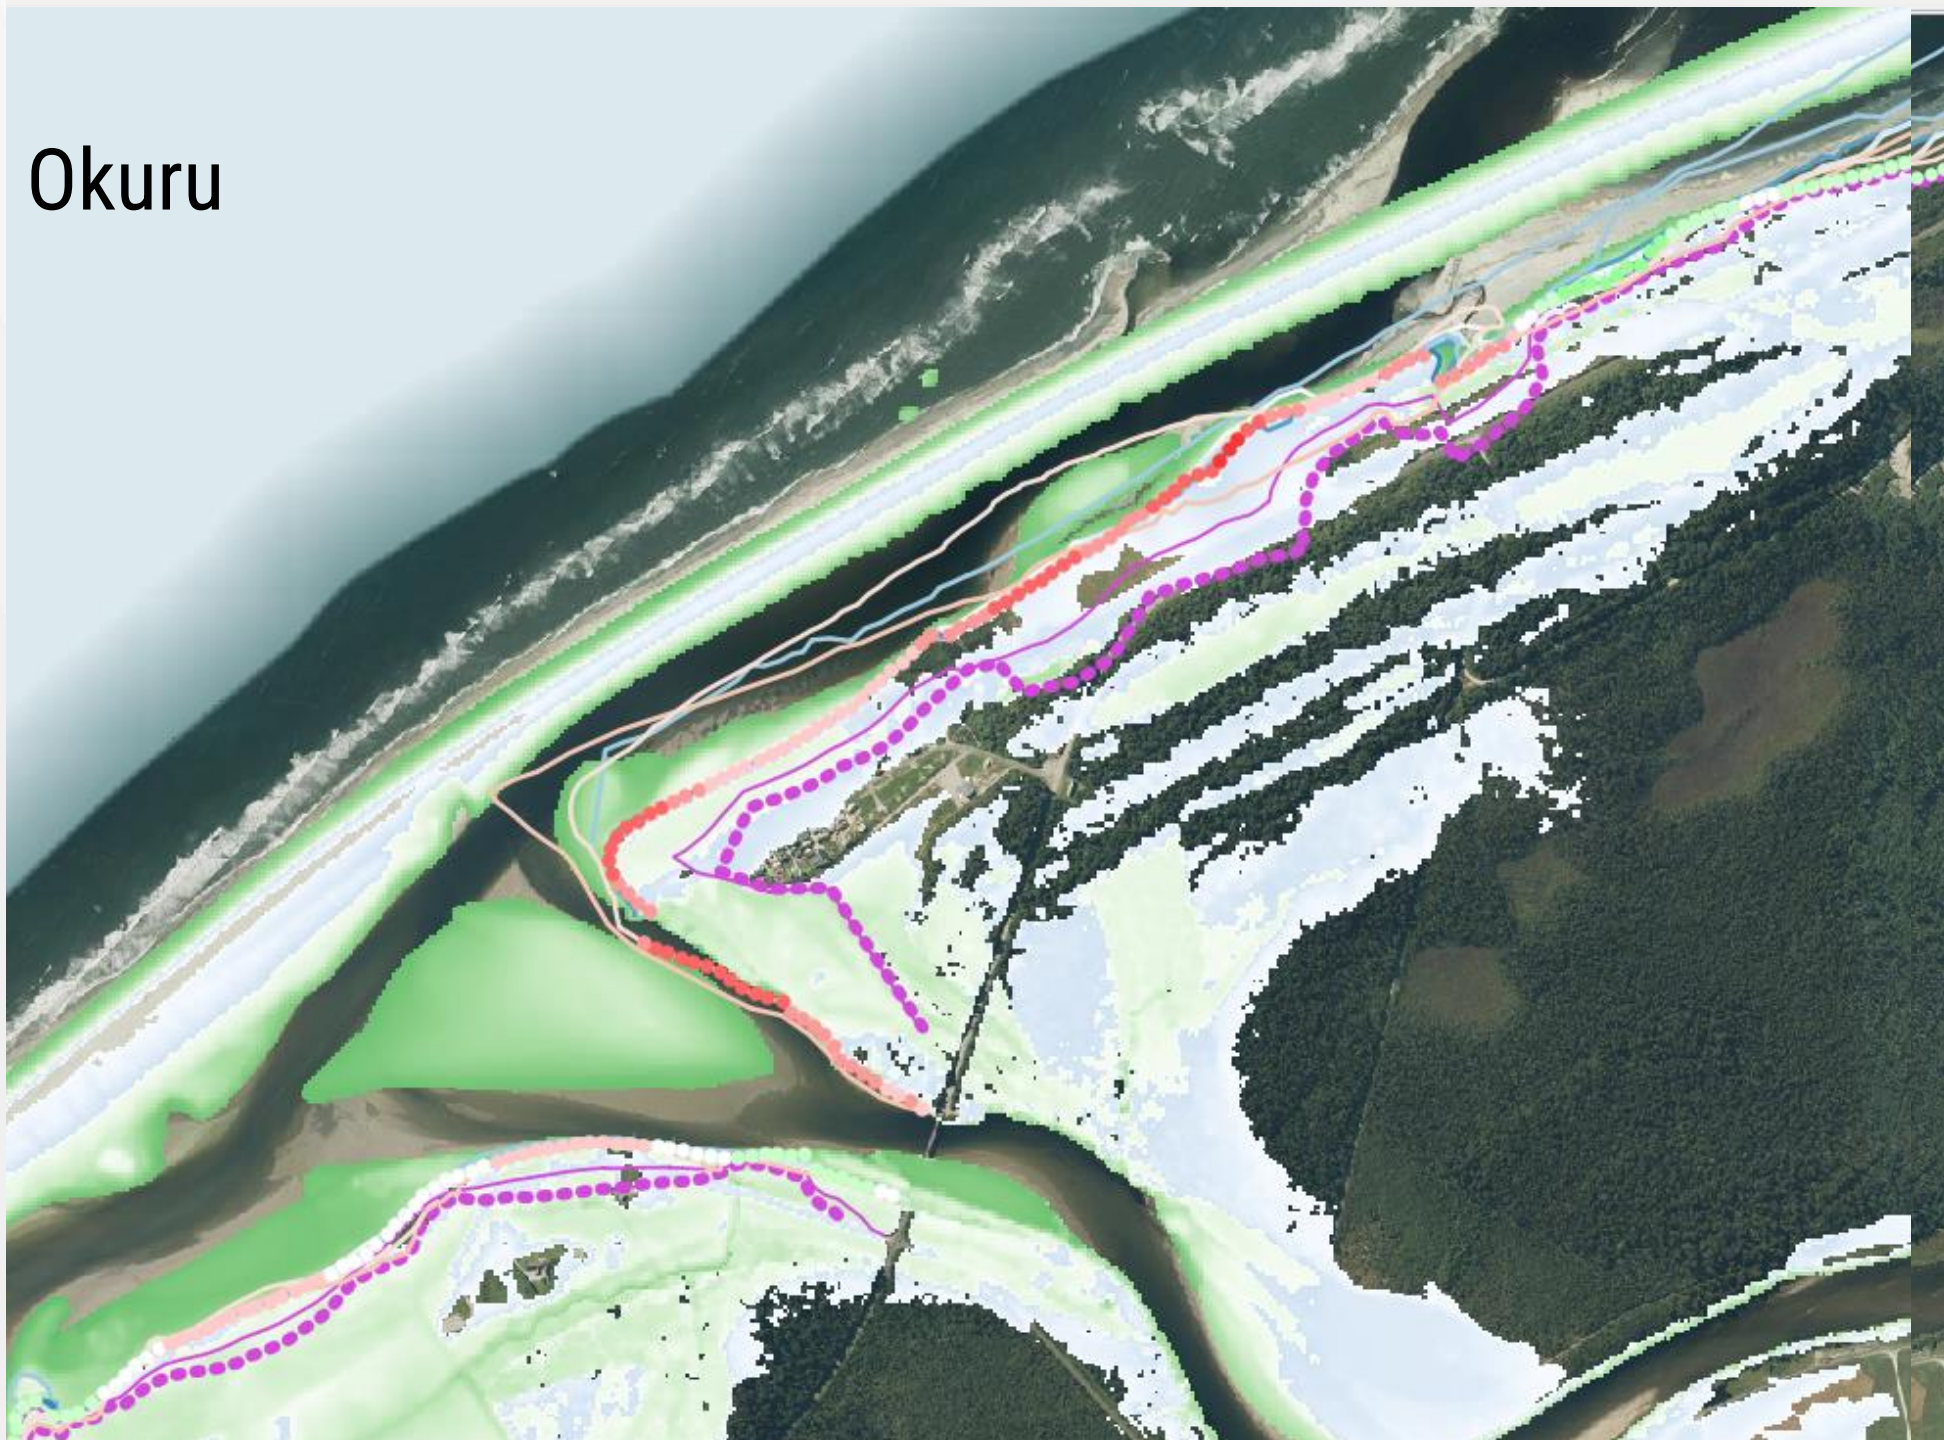
# Okuru

- 1876
- 1878
- 1939
- 1943
- 1948
- 1950
- 1951
- 1964
- 1965
- 1968
- 1969
- 1970
- 1988
- 2000
- 2003
- 2005
- 2006
- 2007
- 2010
- 2011
- 2012
- 2013
- 2015
- 2016
- 2017
- 2018
- 2019
- 2021
