Project Number: 6-WCAP0.02 035GG

Omau Cliffs Subdivision Geotechnical Assessment Report

20 August 2021

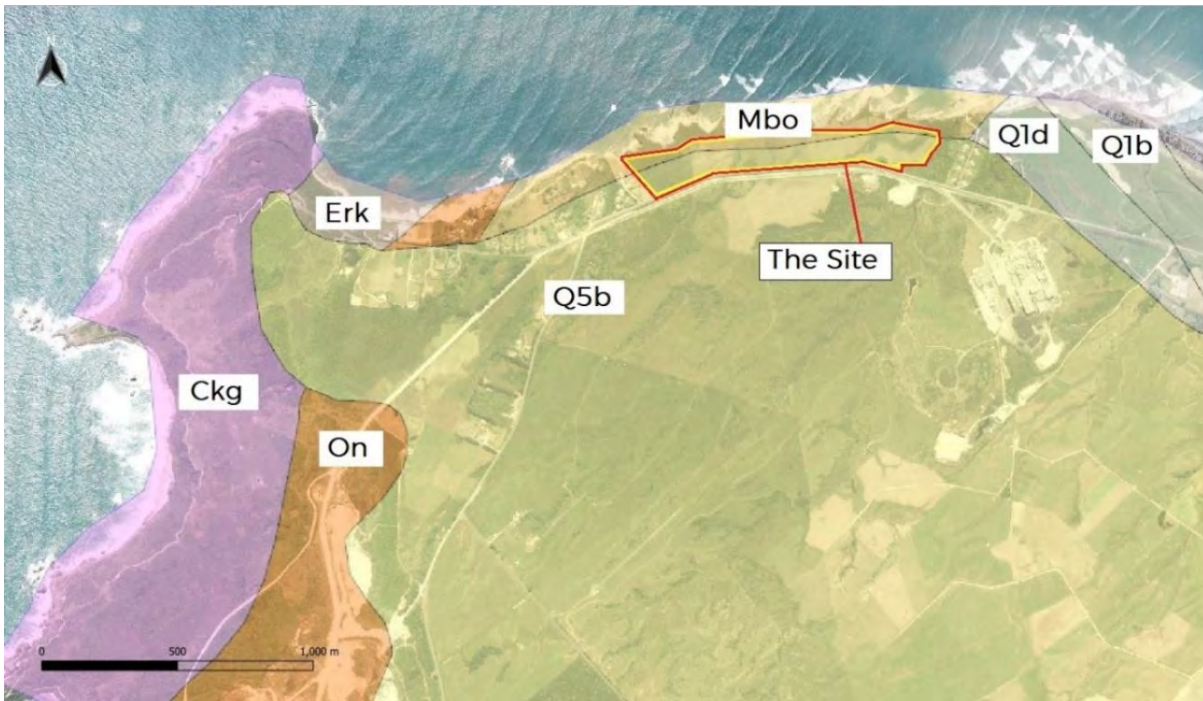
Figure 3 Geological map of the Cape Foulwind area, which indicates that the site (outlined in yellow) is dominated by Miocene age blue-grey, micaceous muddy sandstone of the O'keffe Formation (Mbo) overlain by a thin cover of Quaternary marine sands and gravels of the Waites Formation (Q5b).

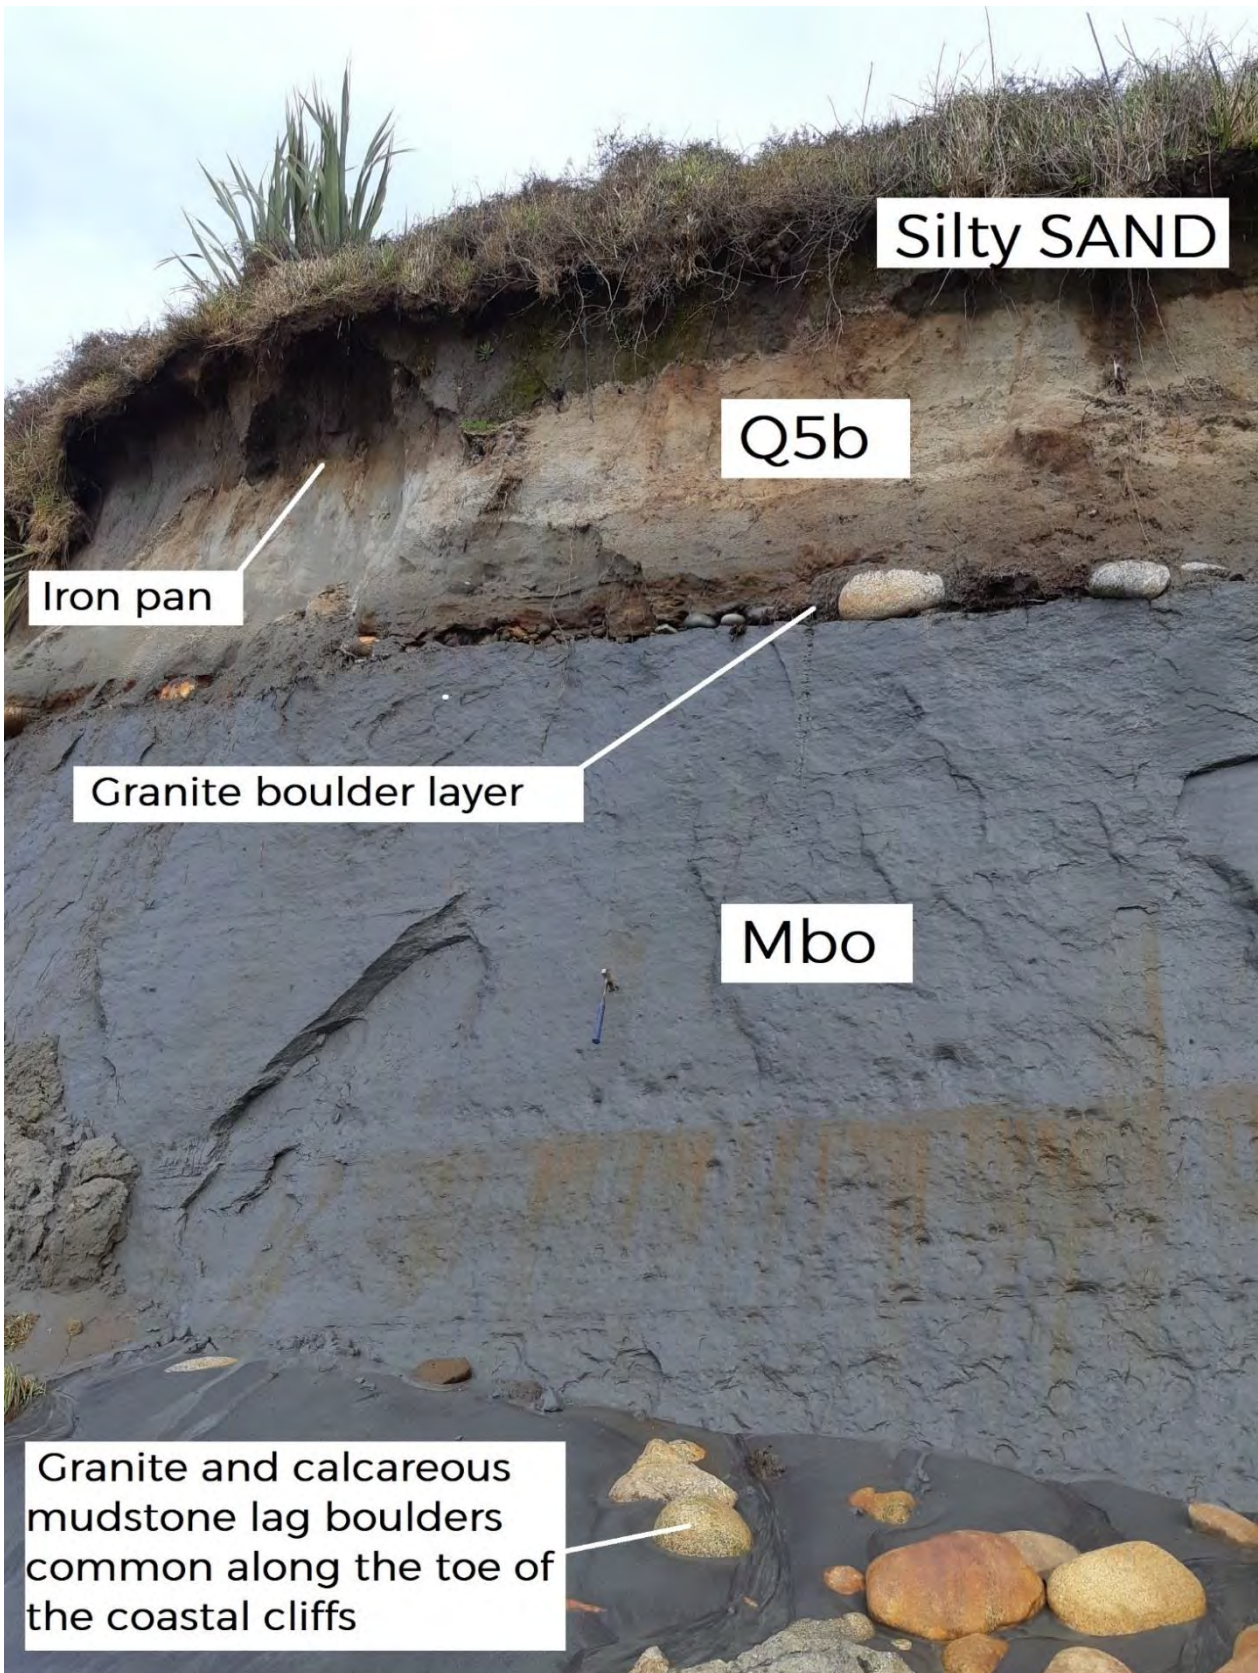
Figure 4 Typical cross section of geological units present at the site including blue-grey, micaceous muddy sandstone of the O'keffe Formation (Mbo) overlain by a thin cover of marine sands and gravels of the Waites Formation (Q5b). Surficial silty SAND are likely residual soils from weathering of the Waites Formation.

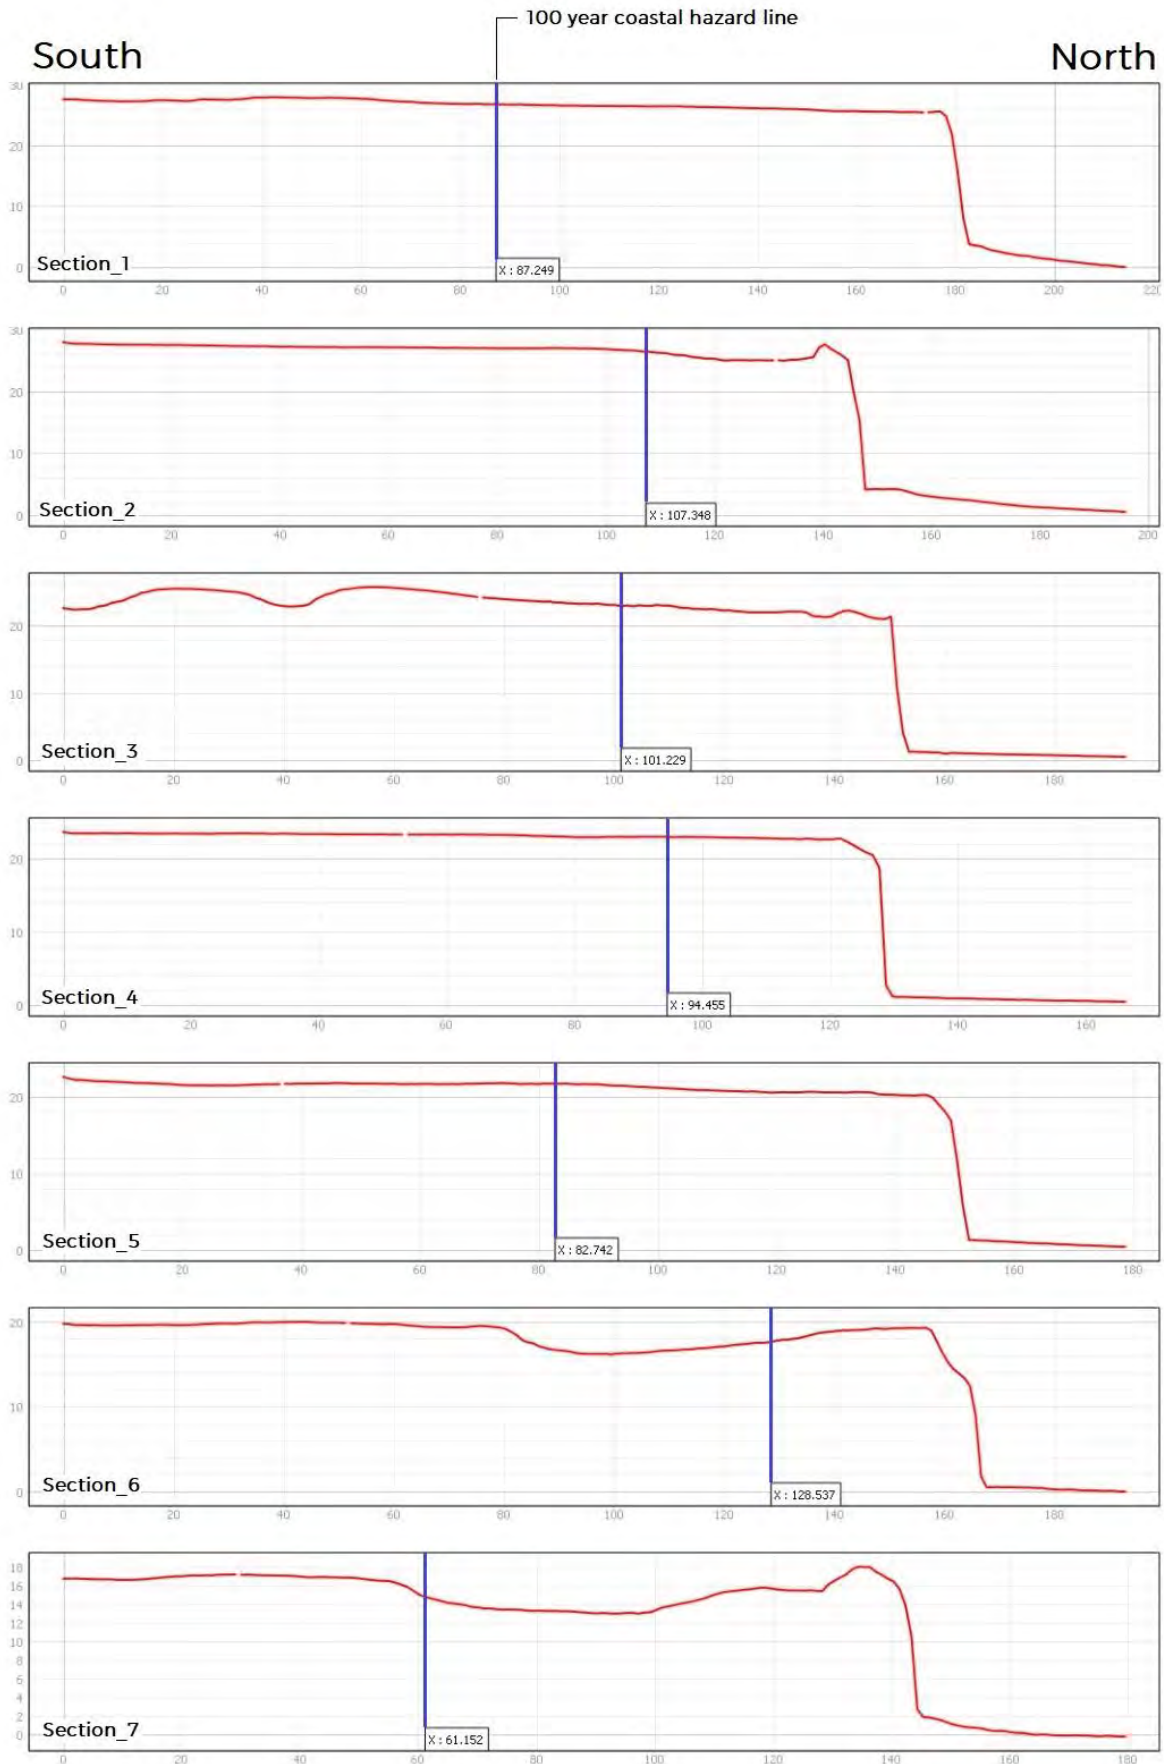
The land is bounded towards the north (Buller Bay) by the near vertical coastal Omau Cliffs with crest heights of 27m in the west and 15m in the east above Gibsons Creek, refer to Figure 6. Slope gradients of the coastal cliffs typically vary between 60° to 90° to horizontal in mudstone of the O'keffe Formation and 40° to 90° to horizontal in sand and sandstone of the Waites Formation.

Figure 6 Topographical sections (South-North) from LIDAR Digital Elevation Model (DEM). The 100-year coastal hazard line is marked in blue line, discussed in section 2.6.

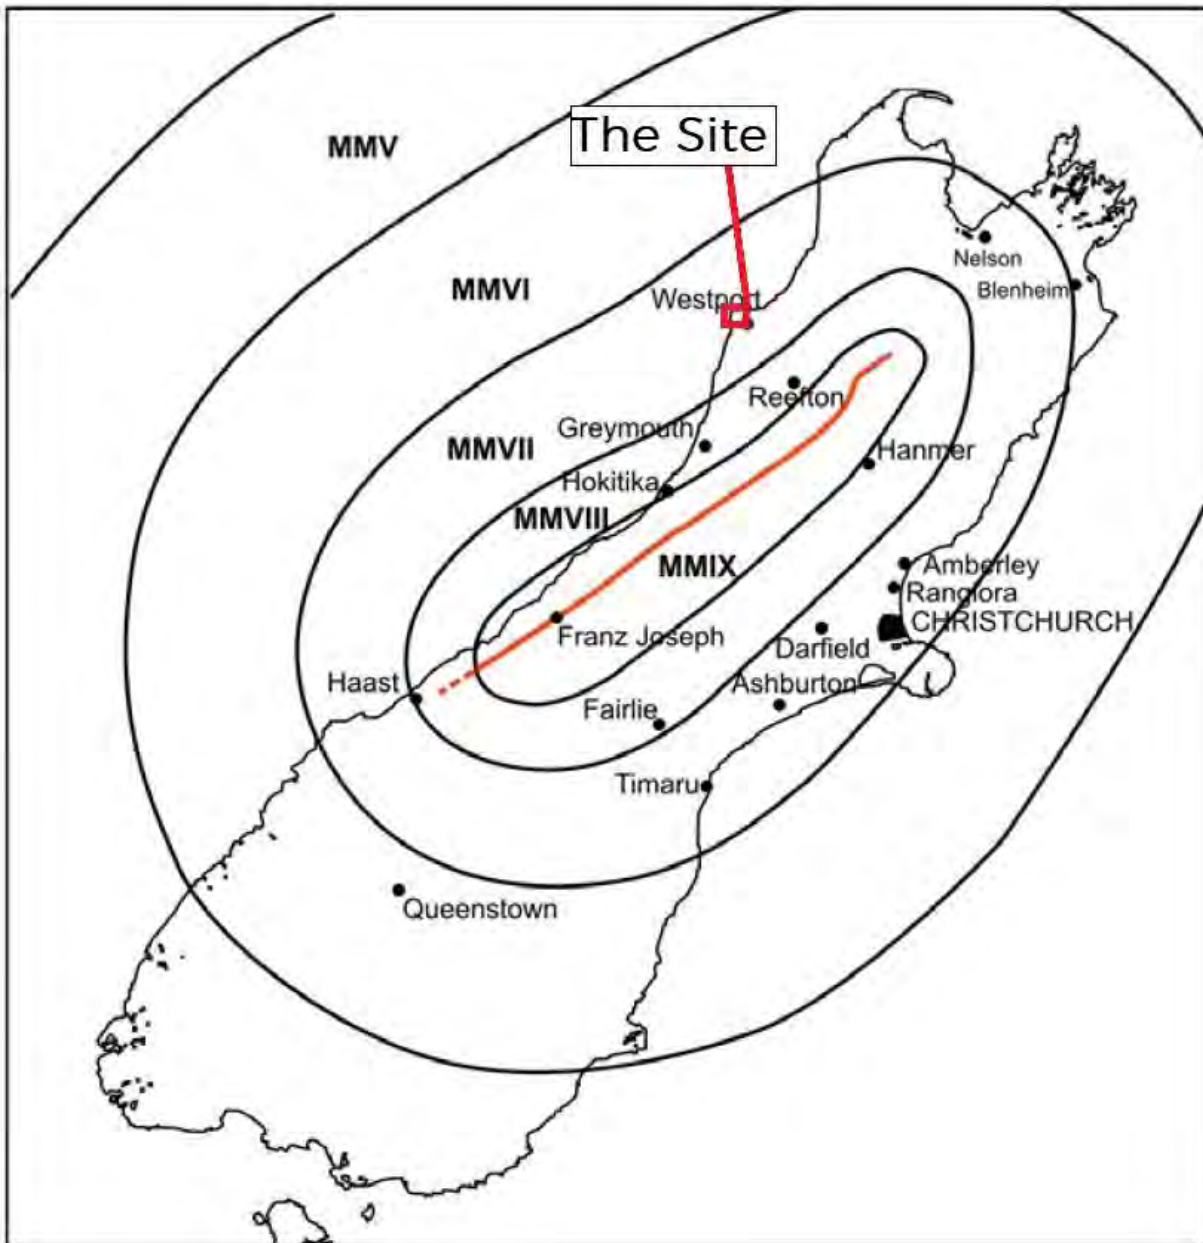
Figure 8 Estimated Modified Mercalli intensity isoseismals (lines defining equal shaking intensity) for the Alpine Fault earthquake scenario indicating an intensity of MM VII for the Westport area (BDC, 2006).

Although the distance to the Alpine Fault is relatively significant (90km), very strong shaking is to be expected for an Alpine Fault Earthquake Scenario with slight to moderate damage to well built, ordinary structures and considerable damage to poorly built structures, as presented in Figure 8.

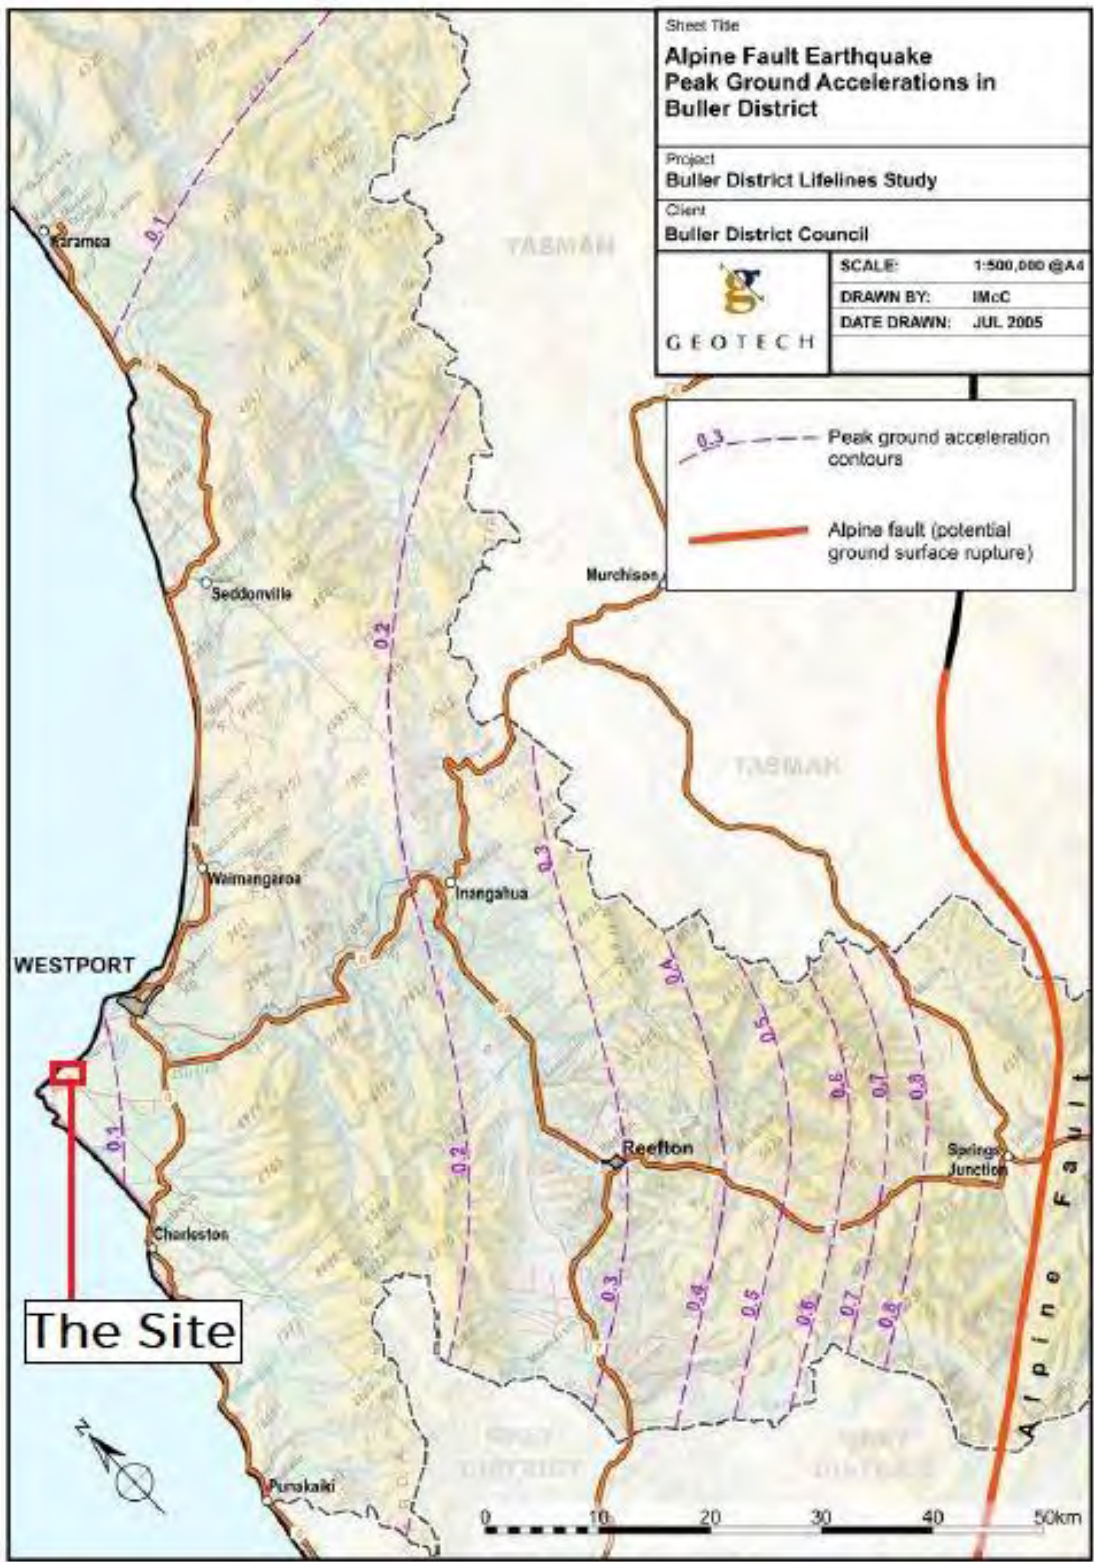
Figure 9 Map of peak ground acceleration in the Buller District for an Alpine Fault Earthquake Scenario (BDC, 2006).

A Peak Ground Acceleration in excess of 0.1g is to be expected for an Alpine Fault Earthquake for the Westport area, as presented in Figure 9.

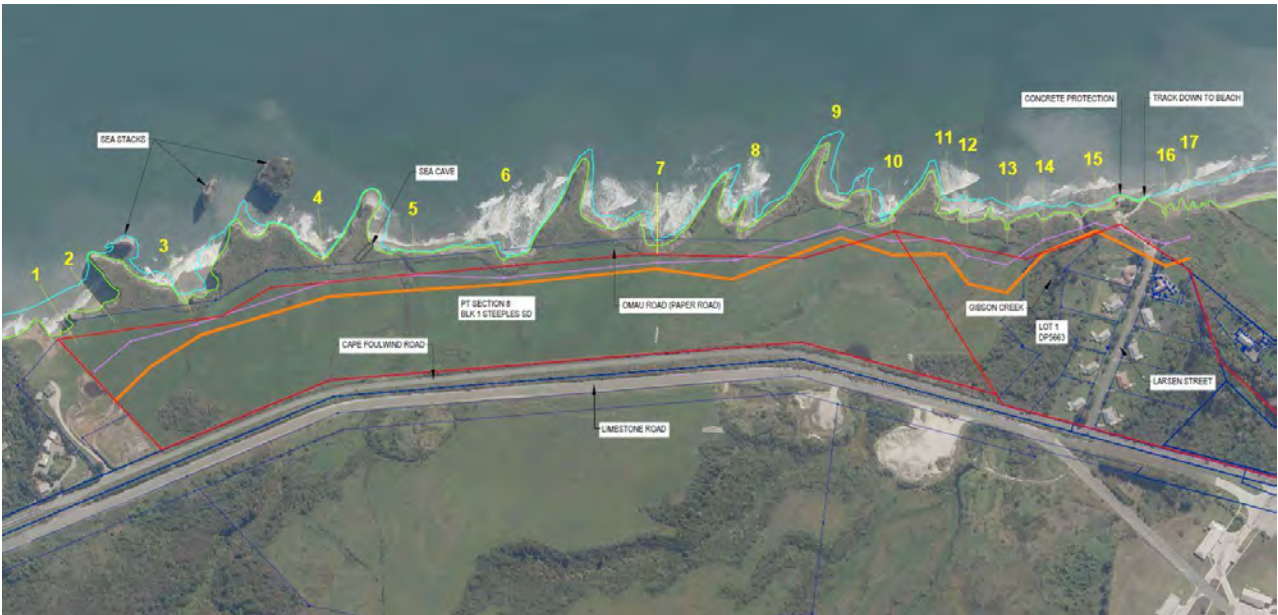
Figure 11 Map of 17 points along the existing coastline where ASCE values have been calculated, refer to Figure 12 (from Beca, 2020)

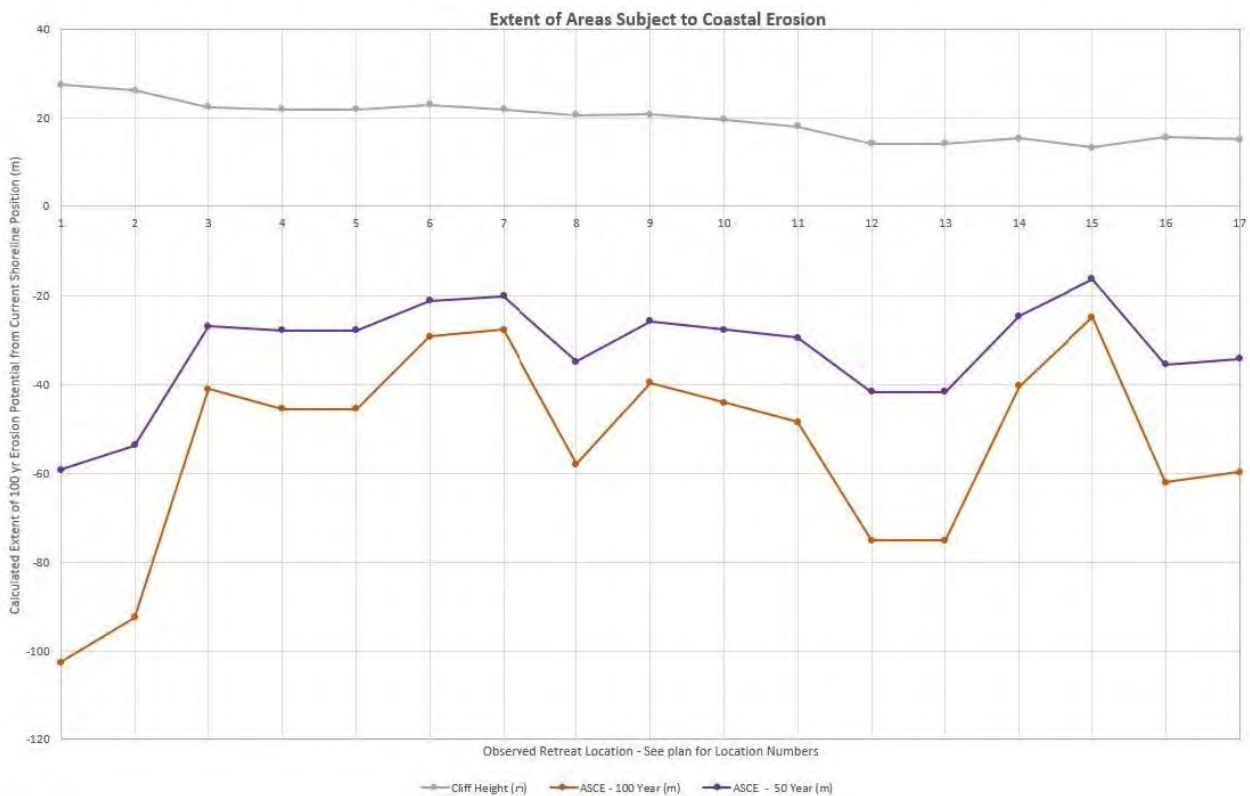
The combination of these components was used to calculate Area Susceptible to Coastal Erosion (ASCE) values for 50- and 100-year timeframes at 17 points along the existing coastline, refer to Figures 11 and 12 adopted from the Beca report. Setbacks are greatest at the western end of the site as the result of the significant localised retreat of up to 0.54m/year (Lot 1 and Lot 2).

Figure 12 Comparison of ASCE setbacks (50 year and 100 year) from existing shoreline position based on quantified historical shoreline retreat between 1938-2018 (from Beca, 2020)

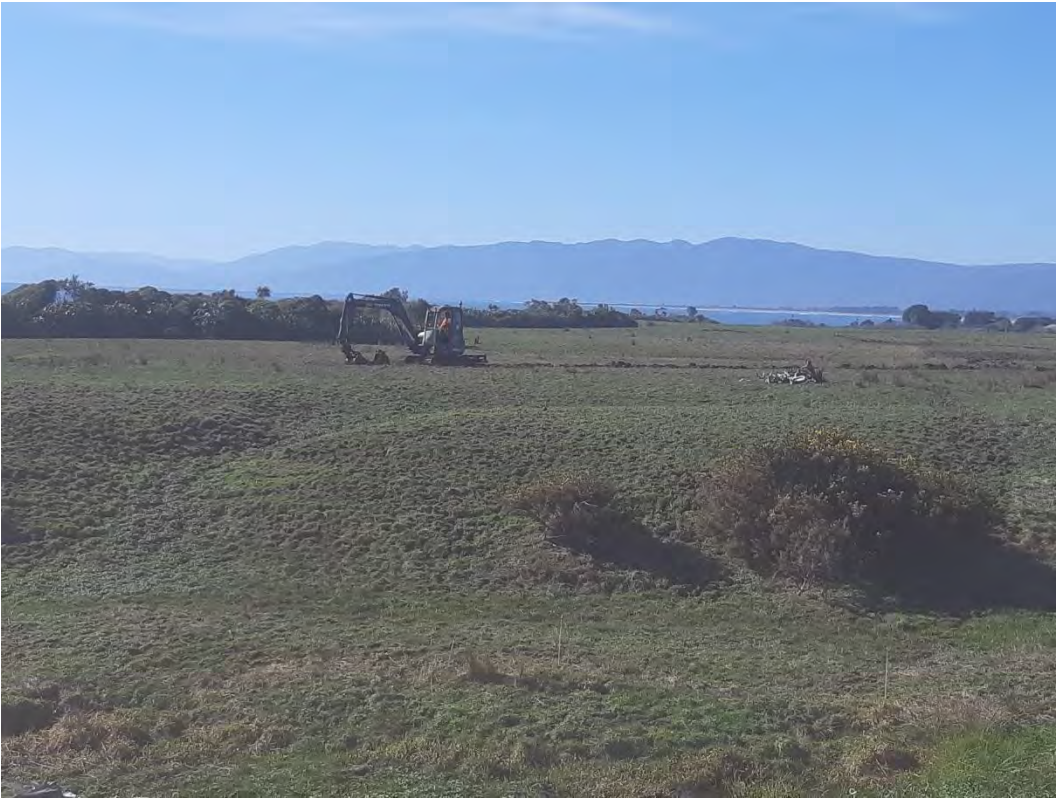
The site is a slightly undulating raised coastal terrace, which slopes very gently towards the east (overall gradient of 0.6°), refer to Figure 5 and Site Photograph 1 in Appendix B.

Site Photo 1 The proposed Omau Cliffs Subdivision is located on a slightly undulating raised coastal terrace overlooking Buller Bay.
