**GEOTECHNICAL SITE SUITABILITY
ASSESSMENT**

PROPOSED SUBDIVISION

**LAKE POERUA
WESTLAND**

R06812016-02-V2

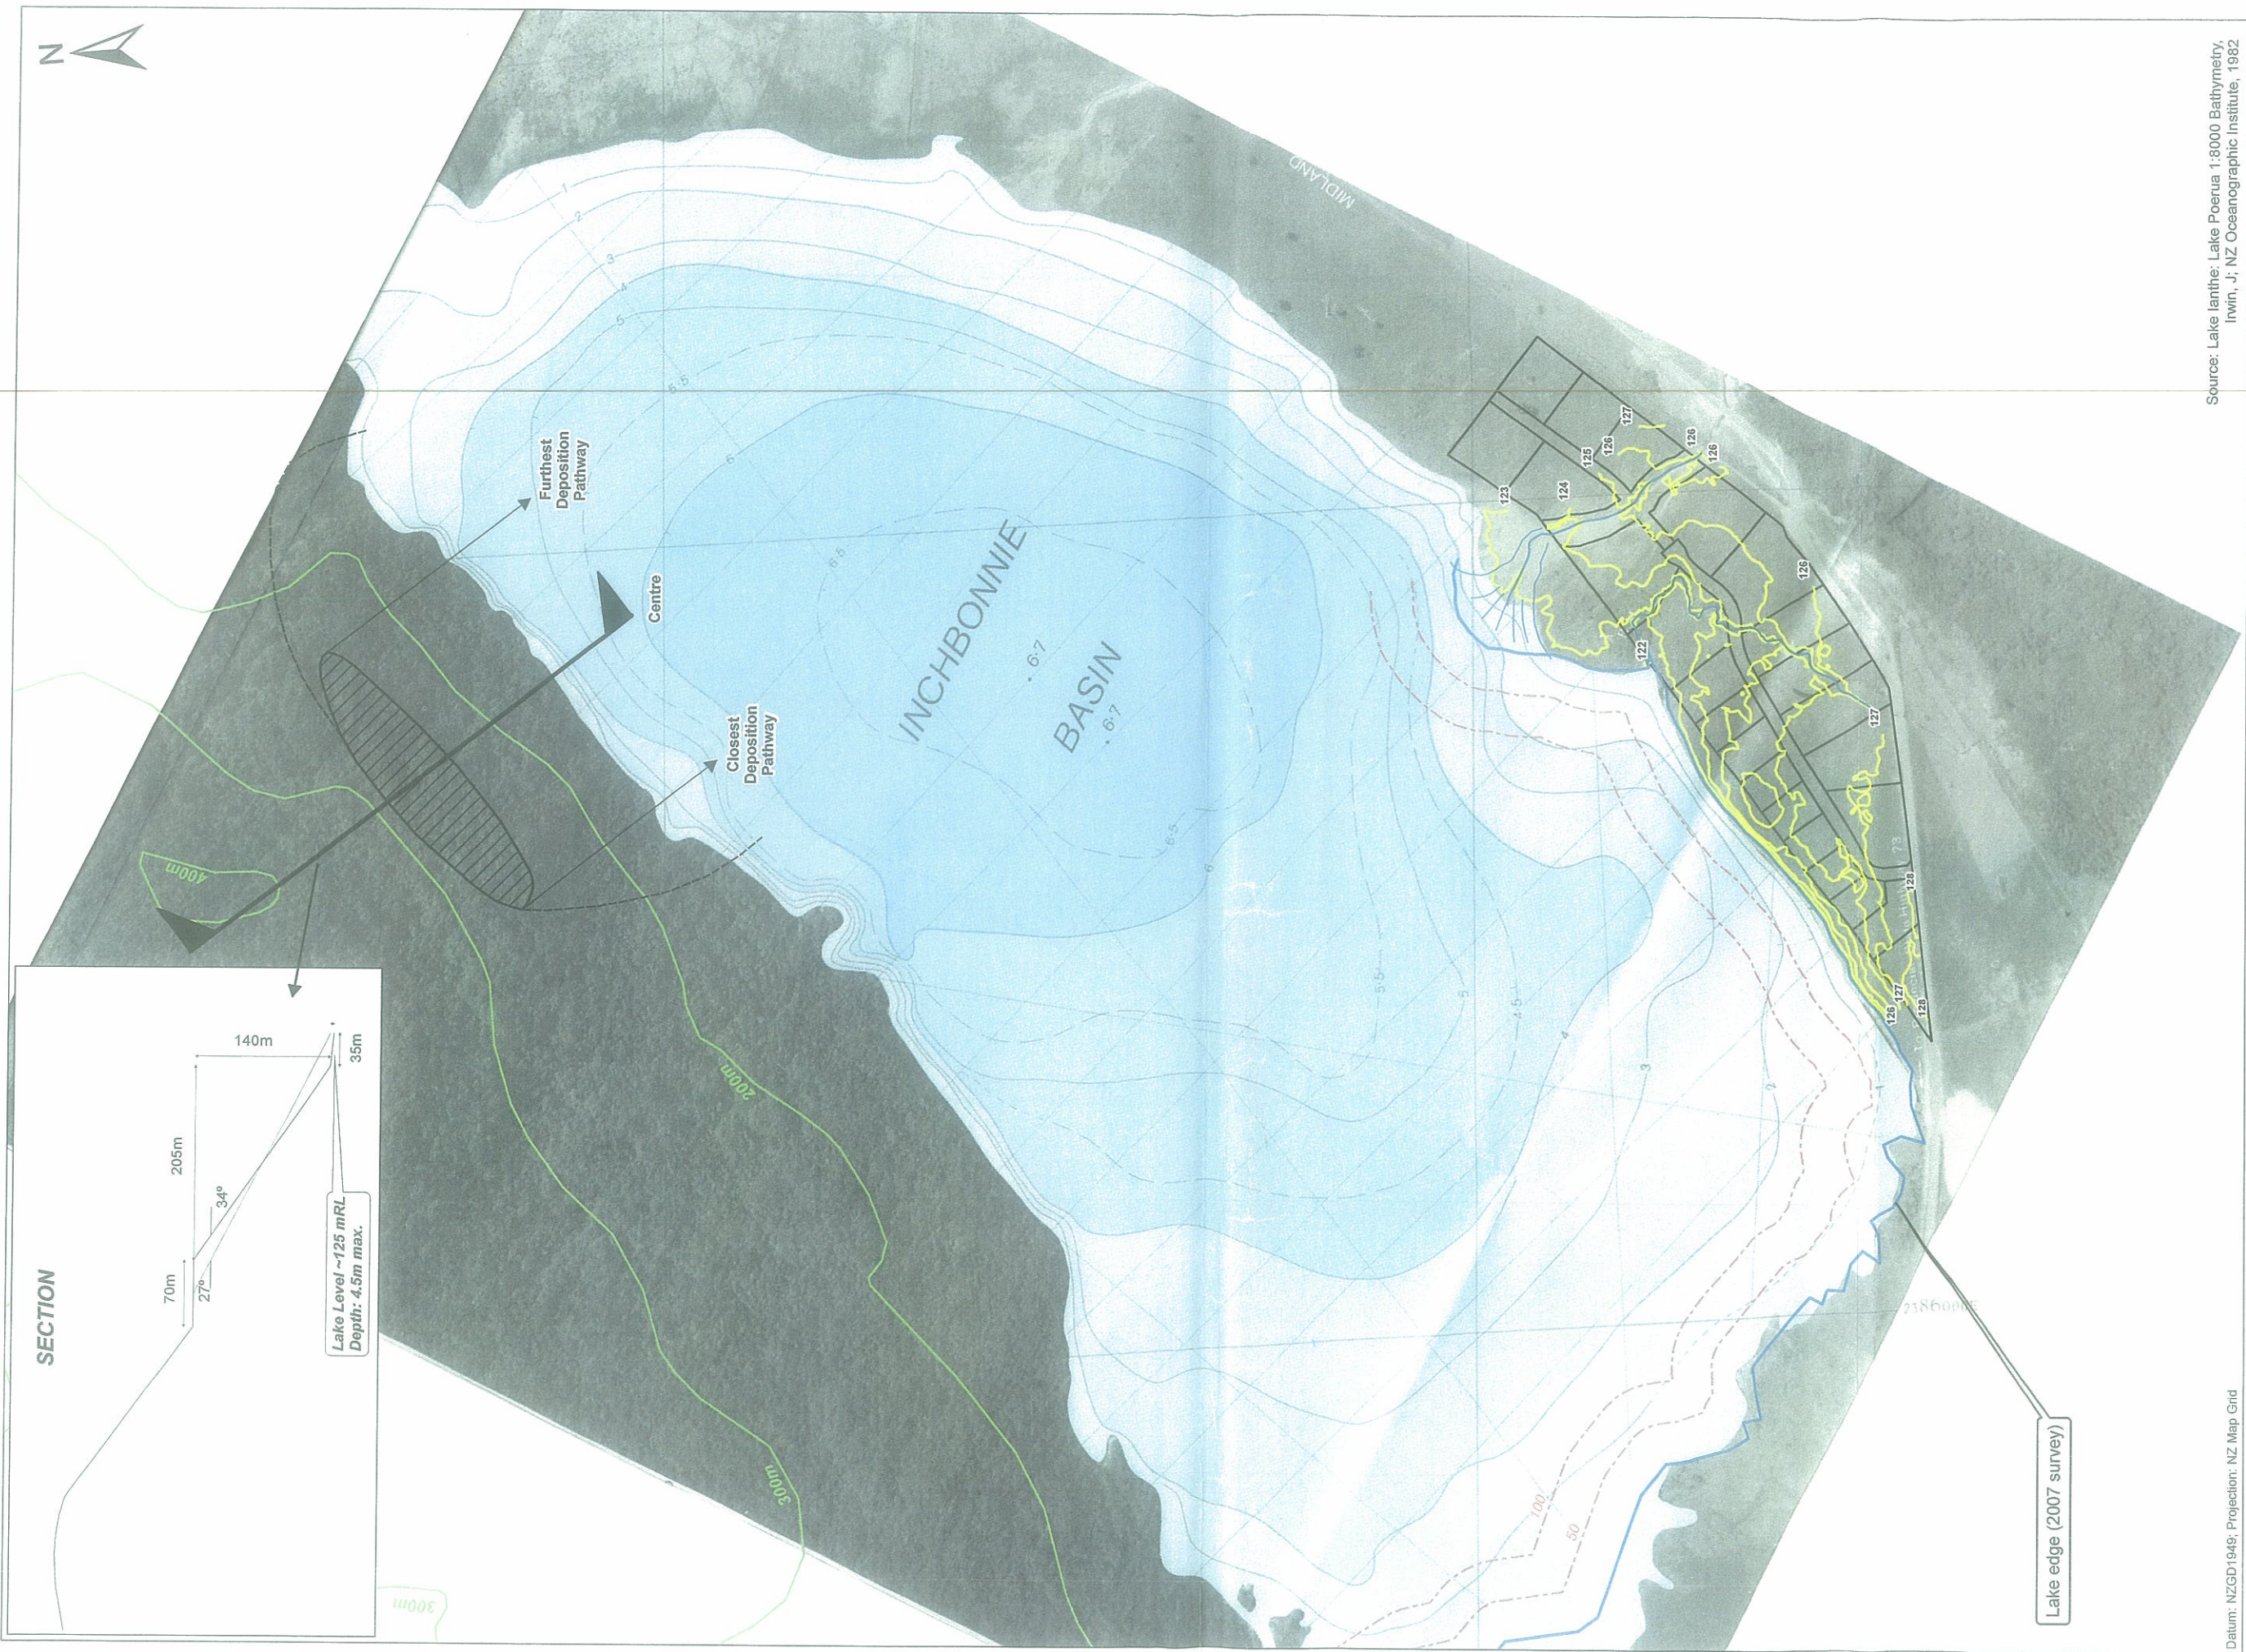
TITLE	SURGE WAVE PLAN		
PROJECT No	06812016	REV No	0
REPORT No	R06812016-02-V2	FIGURE No	6

An area, identified in Figure 6 is considered a possible source for a large and rapid landslide. The highest hill side crest near the western side of the lake is about 280m above the lake at a slope 27°. On this slope is a ledge about 70m width, 400m in length at about 140m above lake level at a slope of 34°. This steeper zone is kinematically more likely to fail for its slope is near the accepted angle of repose for loose angular gravel mass, usually about 35° to 38°. This area is at the northern end of the lake and its expected closest deposition path at the shoreline is between a 1km to the shoreline closest to the nearest boundary of the proposed subdivision to over 1.5km from the shoreline at the farthest section of the subdivision. If we assume the worst case is that this area fails to say 27° (same as the higher slope) then a wedge will fall from the top to the lake floor to form a slope at 27°. This is estimated to be about 1,225m³ per metre length of this area. A reduction of 35m in the width of this mass at the top of the slope, with a corresponding increase of 35m at the base of the slope would result in a slope of about 27°. A width of 35m gives a maximum depth of about 4.5m deep. So if this ledge came down instantly a volume of water of about 79m³ per metre length of the failure could be displaced.

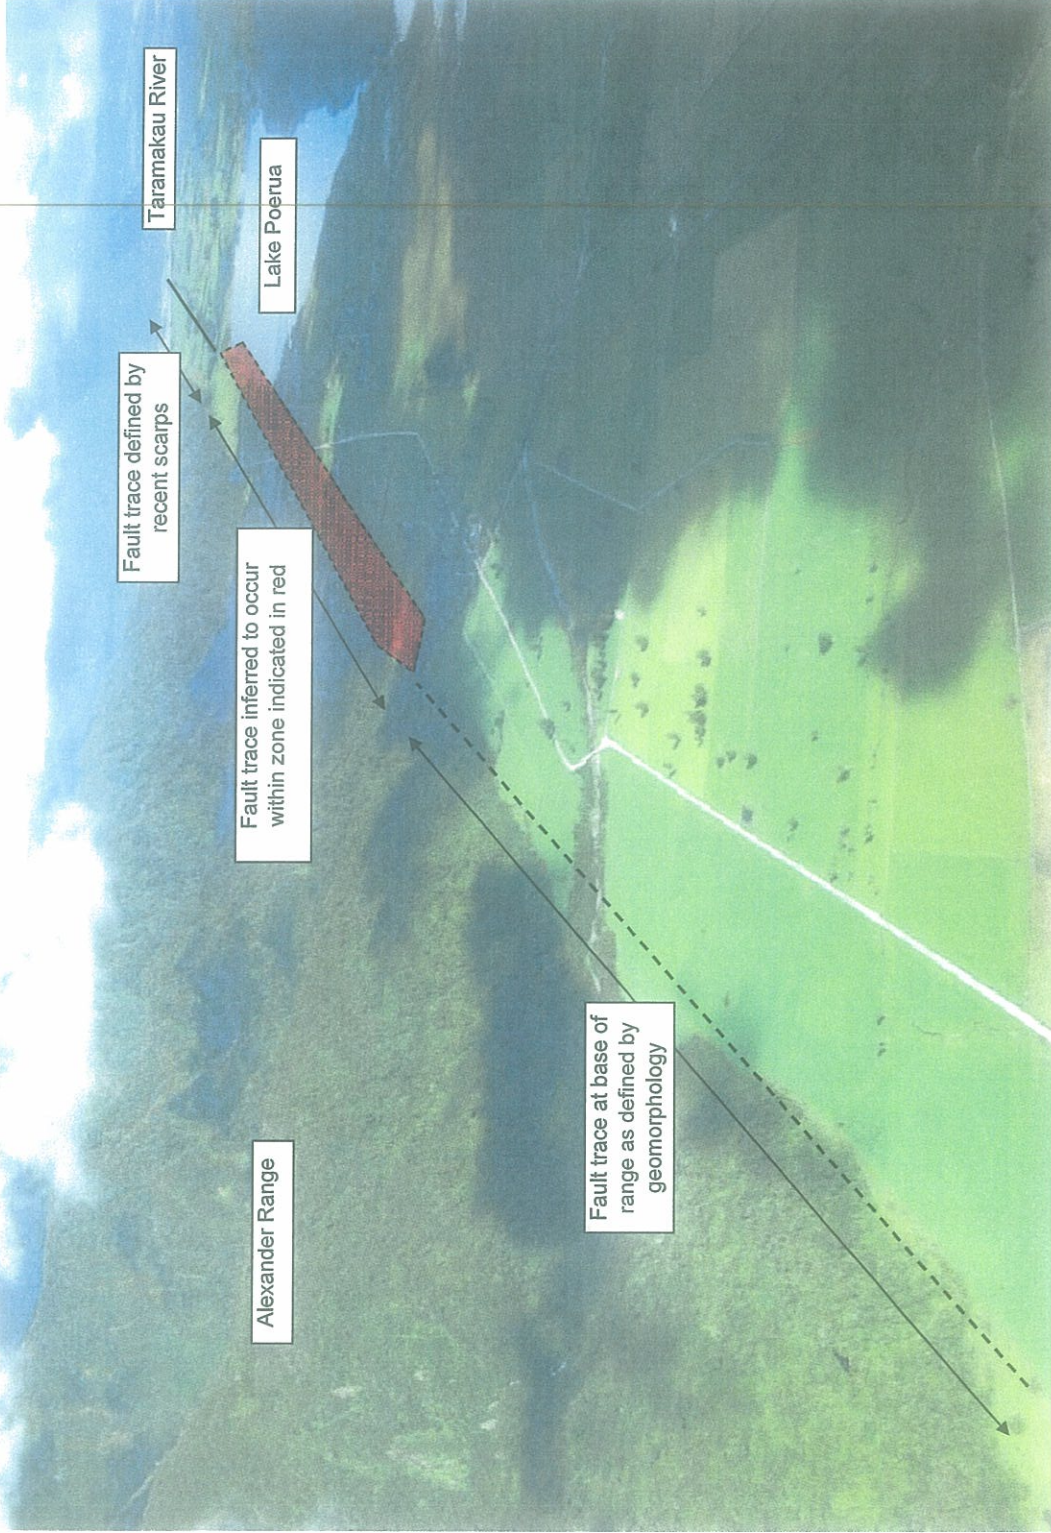
Fault trace at base of range as defined by geomorphology

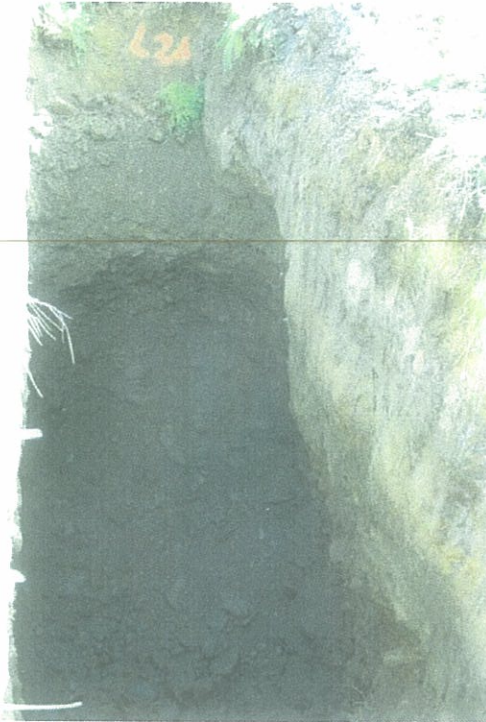
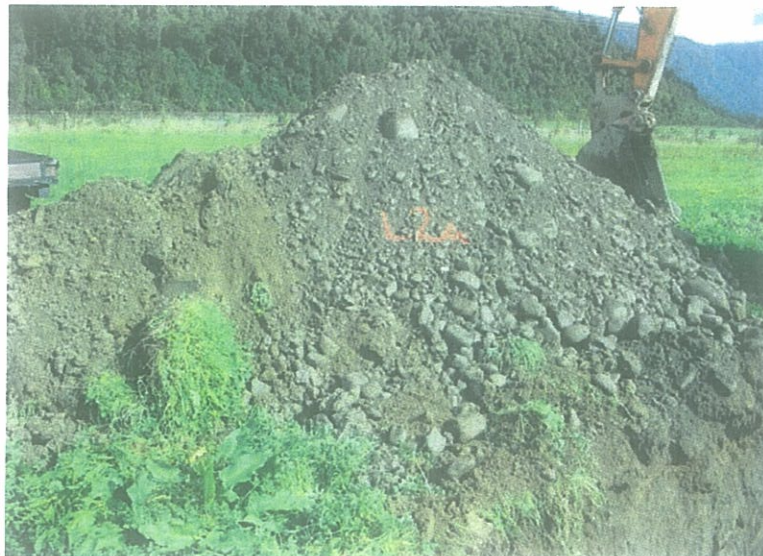
TITLE			Test Pit (GA 01) and Spoil Pile Photographs for Lot 2a		
	PROJECT			Geotechnical Assessment, Proposed Subdivision, Lake Porerua, Westland		
Comments	CLIENT		Grant Marshall		FIGURE	B1
	DRAWN	JM/RB	DATE	23/03/2006	PROJECT No.	06812016
	CHECKED	LRC	DATE	24/09/2007	SCALE	na
						A4

0.0					OL SANDY SILT dark brown sandy SILT - firm, moist (TOPSOIL)										
			0.15					ML GRAVELLY SILT light brown SILT with some gravel - firm, moist, well graded, subrounded greywacke gravel clasts (ALLUVIUM)

0.80					GW SANDY GRAVEL WITH SOME SILT dark greyish brown sandy GRAVEL with some silt - dense, moist, well graded, subrounded greywacke gravel clasts to 0.1m diameter - iron pans from 1.2m to 3.8m - boulders up to 0.35m diameter from 2.5m - pit walls caving in below 0.8m (ALLUVIUM)

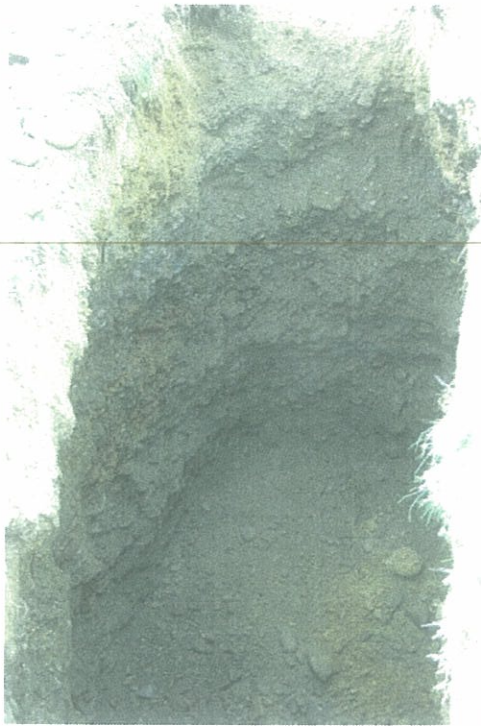
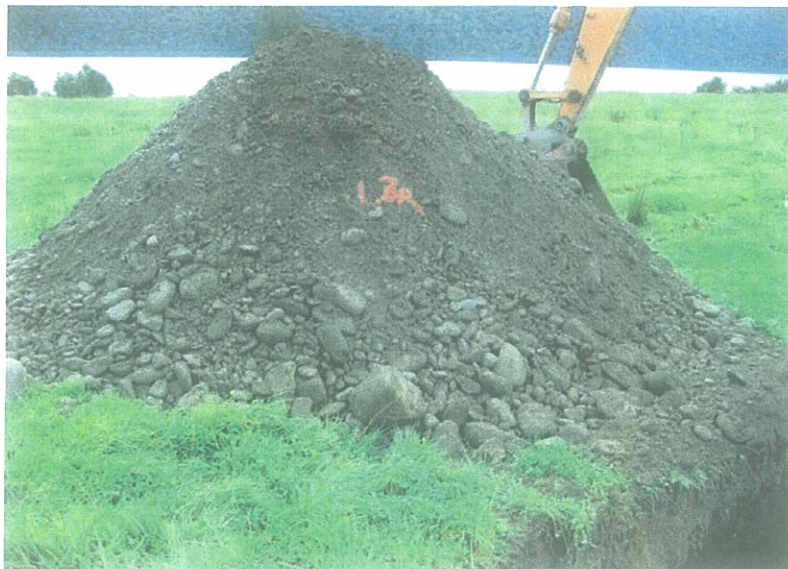
TITLE	Test Pit (GA 02) and Spoil Pile Photographs for Lot 3a		
PROJECT	Geotechnical Assessment, Proposed Subdivision, Lake Porerua, Westland		
CLIENT	Grant Marshall	FIGURE	B2
DRAWN	JM/RB	DATE	23/03/2006
CHECKED	LRC	DATE	24/09/2007
		PROJECT No.	06812016
		SCALE	na
			A4

0.0					ML	ORGANIC GRAVELLY SILT dark brown organic gravelly SILT - firm, moist (TOPSOIL)													[Bar chart showing DCP test results]				
			0.30					GW	SANDY GRAVEL orange brown silty sandy GRAVEL - very dense, moist, well graded, subrounded greywacke gravel - weakly cemented due to iron pan development (ALLUVIUM)

0.45					SP																		
			0.5					GW	SAND dark brownish grey SAND - moderately dense, moist, poorly graded medium sand (ALLUVIUM)

0.80						SANDY GRAVEL orange brown sandy GRAVEL with some silt - dense, moist, well graded, subrounded greywacke gravel clasts up 60mm diameter - discontinuous no fines gravel layer at 1m depth approximately 0.2m thick, appears on both sides of the pit - multiple iron pans from 1m to pit base (ALLUVIUM)

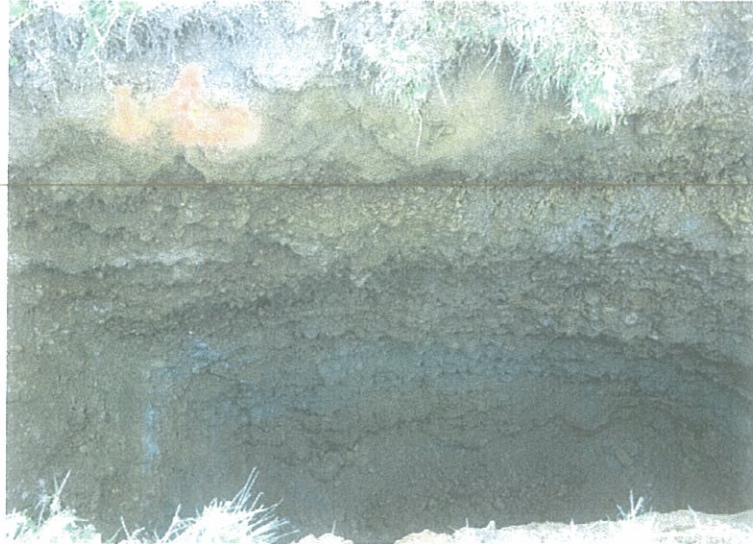
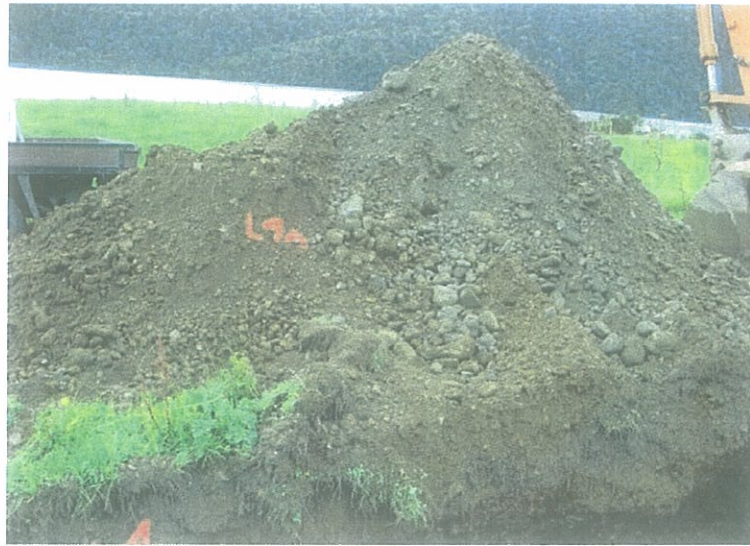
TITLE			Test Pit (GA 03) and Spoil Pile Photographs for Lot 4a					
	PROJECT					Geotechnical Assessment, Proposed Subdivision, Lake Porerua, Westland			
	CLIENT			Grant Marshall	FIGURE		B3		
	DRAWN		JM/RB	DATE		23/03/2006	PROJECT No.		06812016
	CHECKED		LRC	DATE		24/09/2007	SCALE		na
Comments

0.0	0.10			OL	ORGANIC SILT WITH SOME GRAVEL dark brown organic SILT with some gravel - firm, moist, greywacke gravel clasts (TOPSOIL)										
			0.5	0.50			ML	SANDY SILT WITH SOME GRAVEL light brown sandy SILT with some gravel - firm, moist, greywacke gravel clasts

0.90			SW	- greywacke gravel concentrated in lenses approximately 200mm thick (ALLUVIUM)										
			1.0				GW	SAND grey SAND - loose-very loose, moist, well graded - gradational change into overlying unit (ALLUVIUM)

1.5					SANDY GRAVEL grey sandy GRAVEL - medium dense, moist, well graded, subrounded greywacke gravels - several fines free gravel beds in sequence - channel infilled with grey loose sand in one wall approximately 1m deep - pit walls collapsing below 0.9m - becoming dense at 2.7m (ALLUVIUM)

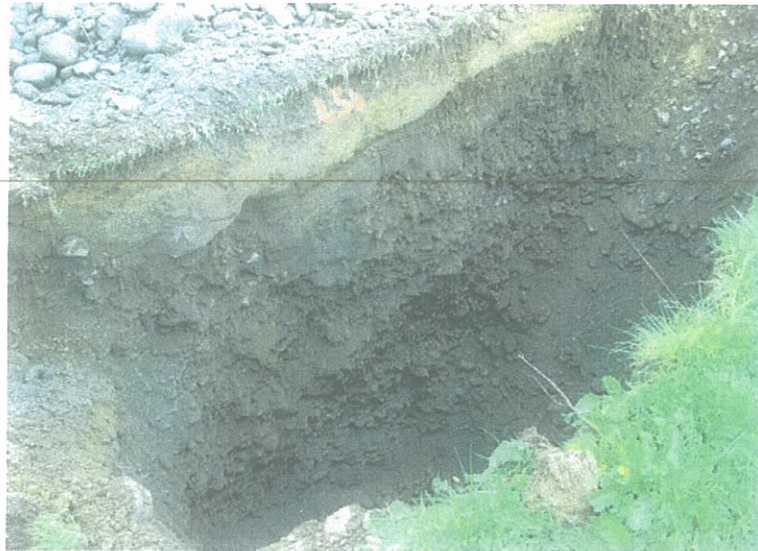
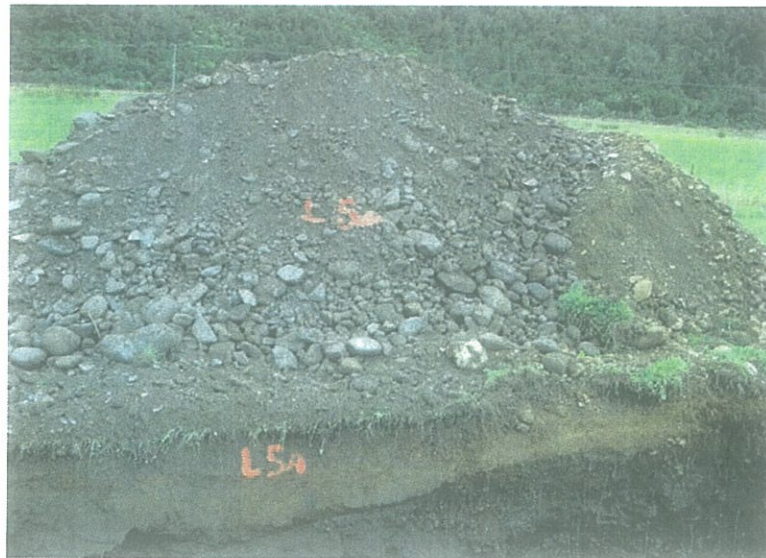
TITLE Test Pit (GA 04) and Spoil Pile Photographs for Lot 5a		
	PROJECT Geotechnical Assessment, Proposed Subdivision, Lake Porerua, Westland		
Comments	CLIENT Grant Marshall	FIGURE B4	
	DRAWN JM/RB	DATE 23/03/2006	PROJECT No. 06812016
	CHECKED LRC	DATE 24/09/2007	SCALE na
			A4

0.0					ML ORGANIC GRAVELLY SILT dark brown organic gravelly SILT - firm, moist, well graded, subrounded greywacke gravels (TOPSOIL)										
			0.15					GW SILTY GRAVEL WITH SOME SAND light brown silty GRAVEL with sand -medium dense, moist, well graded, subrounded greywacke gravel clasts (ALLUVIUM)

0.5	0.60				GW SANDY GRAVEL dark brownish grey sandy GRAVEL - medium dense, moist, well graded, subrounded greywacke gravel clasts up to 150mm diameter - fines free channelised gravel 0.2m thick 1m wide below 0.6m - minor iron pan development - pit walls collapsing below 1.8m and the sandy GRAVEL becomes dark grey (ALLUVIUM)

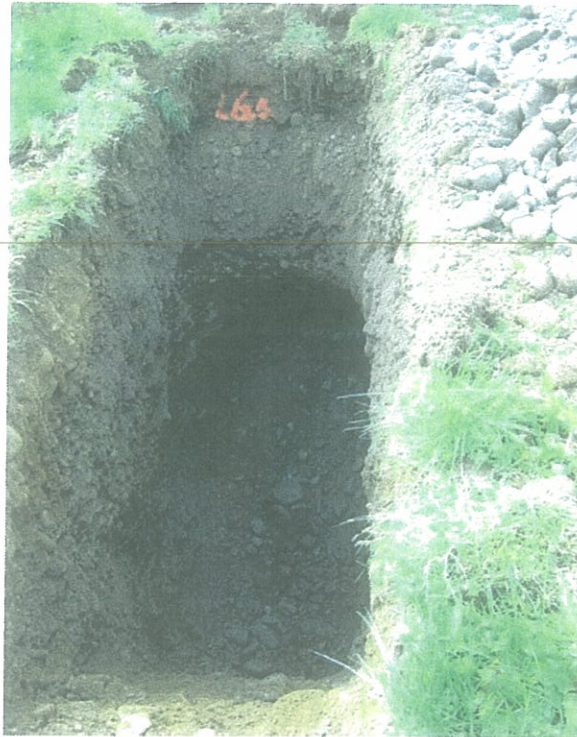
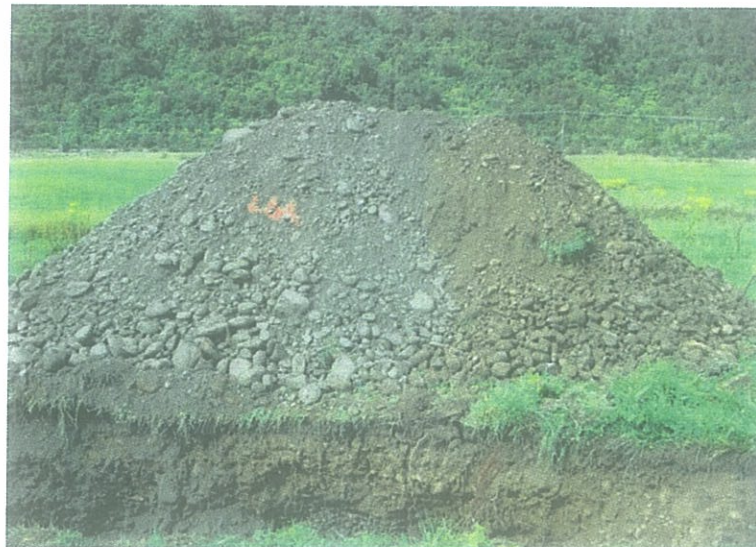
TITLE		Test Pit (GA 05) and Spoil Pile Photographs for Lot 6a	
PROJECT		Geotechnical Assessment, Proposed Subdivision, Lake Porerua, Westland	
CLIENT		Grant Marshall	FIGURE B5
DRAWN	JM/RB	DATE	23/03/2006
CHECKED	LRC	DATE	24/09/2007
		PROJECT No.	06812016
		SCALE	na
			A4

Excavation			Sampling		Field Material Description													
METHOD	EXCAVATION RESISTANCE	WATER	DEPTH (metres)	DEPTH RL	SAMPLE OR FIELD TEST	RECOVERED GRAPHIC LOG	USC Symbol	SOIL / ROCK MATERIAL DESCRIPTION	WEATHERING	MOISTURE	CONSISTENCY	DCP TEST (AS1289.6.3.2) Blows per 100 mm				STRATIGRAPHIC UNIT		
												0	5	10	15	20	5	
L			0.0	0.15			OL	ORGANIC GRAVELLY SILT dark brown organic gravelly SILT - firm, moist, well graded, sub rounded greywacke gravels (TOPSOIL)										
M			0.5				GW	SANDY GRAVEL WITH SOME SILT brown sandy GRAVEL with some silt - medium dense, moist, well graded, subrounded greywacke gravel clasts - discontinuous band of gravels at 0.7m, minimal fines and 10% voids (ALLUVIUM)

1.0	1.10			GW	SANDY GRAVEL light grey sandy GRAVEL - dense, moist, moderately well graded, subrounded greywacke gravels - discontinuous 0.2m thick grey medium-coarse SAND layer at 1.3m depth, medium dense, moist - discontinuous 0.2-0.4m thick horizon of no fines gravels at 2.5m depth (ALLUVIUM)										
EX			2.0															
M			2.5

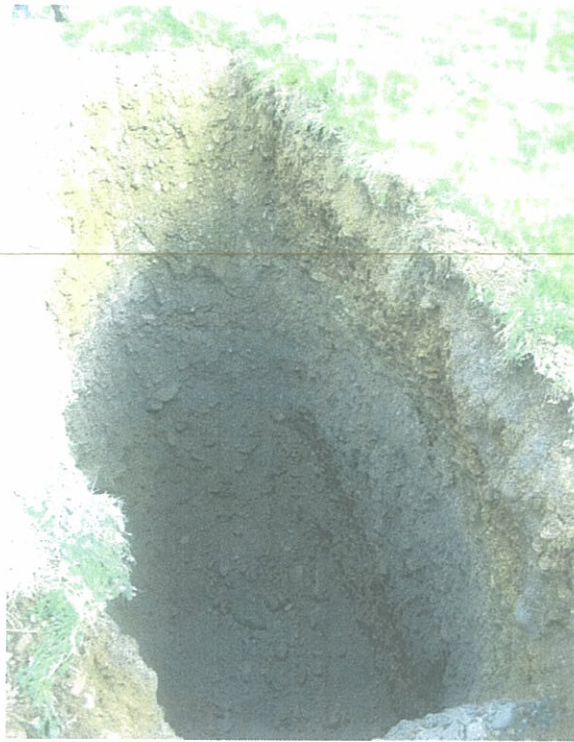
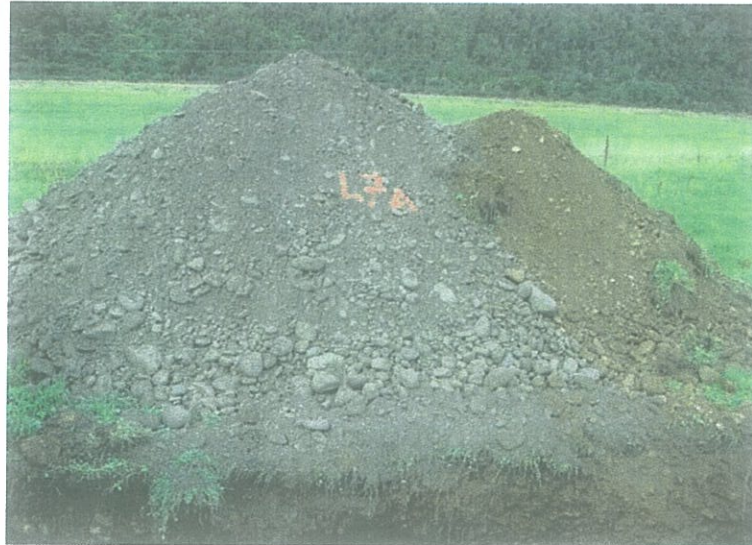
TITLE Test Pit (GA 06) and Spoil Pile Photographs for Lot 7a			
	PROJECT Geotechnical Assessment, Proposed Subdivision, Lake Porerua, Westland			
	CLIENT Grant Marshall		FIGURE B6	
	DRAWN JM/RB	DATE 23/03/2006	PROJECT No. 06812016	
	CHECKED LRC	DATE 24/09/2007	SCALE na	A4
Comments

Excavation				Sampling			Field Material Description											
METHOD	EXCAVATION RESISTANCE	WATER	DEPTH (metres)	SAMPLE OR FIELD TEST	RECOVERED GRAPHIC LOG	USC Symbol	SOIL / ROCK MATERIAL DESCRIPTION	WEATHERING	MOISTURE	CONSISTENCY	DENSITY	DCP TEST (AS1289.6.3.2) Blows per 100 mm				STRATIGRAPHIC UNIT		
			DEPTH RL									0	5	10	15	20	25	
EX	L		0.0			ML	ORGANIC SILT WITH GRAVEL brown organic SILT with gravel - firm, moist, uniformly graded, subrounded greywacke clasts, coarse gravel (TOPSOIL)

0.40			SW	COARSE SAND WITH GRAVEL dark brown coarse SAND with gravel - dense, moist, well graded, subrounded greywacke clasts (ALLUVIUM)											
			0.80			GW	COARSE SANDY GRAVEL grey coarse sandy GRAVEL - medium dense, moist, subrounded greywacke gravel clasts - becoming dark grey at 1.4m (ALLUVIUM)											
	M		1.0

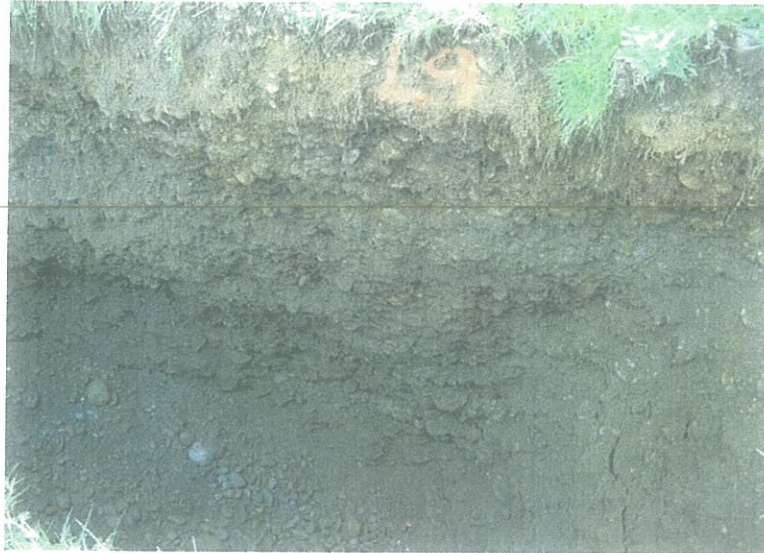
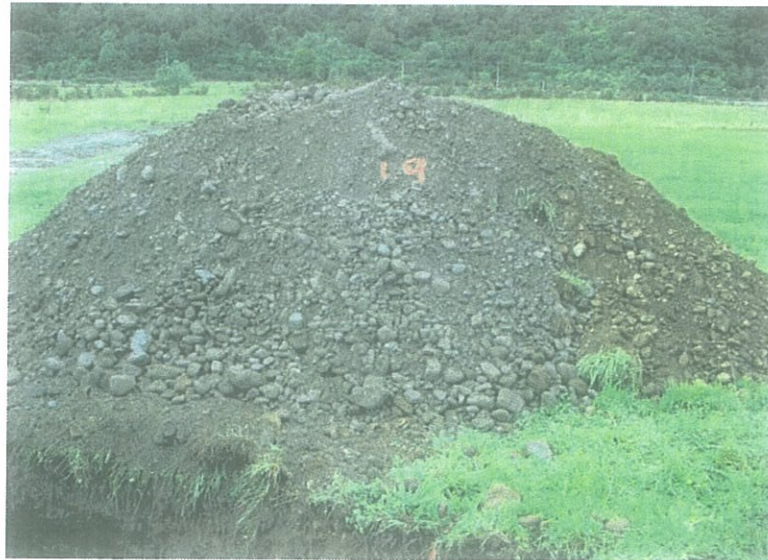
TITLE		Test Pit (GA 07) and Spoil Pile Photographs for Lot 9a	
PROJECT		Geotechnical Assessment, Proposed Subdivision, Lake Porerua, Westland	
CLIENT		Grant Marshall	FIGURE B7
DRAWN	JM/RB	DATE	23/03/2006
CHECKED	LRC	DATE	24/09/2007
		PROJECT No.	06812016
		SCALE	na
			A4

0.5															
			1.0															
			1.5															
			2.0															
			2.20				SW	SAND WITH SOME GRAVEL dark grey medium SAND with some gravel - medium dense, moist, well graded, subrounded greywacke gravel clasts (ALLUVIUM)

2.5															
			3.0				GW	COARSE SANDY GRAVEL dark grey coarse sandy GRAVEL - loose-medium dense, moist, rounded-subrounded graywacke clasts - pit walls collapsing from 3.5m depth to the surface (ALLUVIUM)

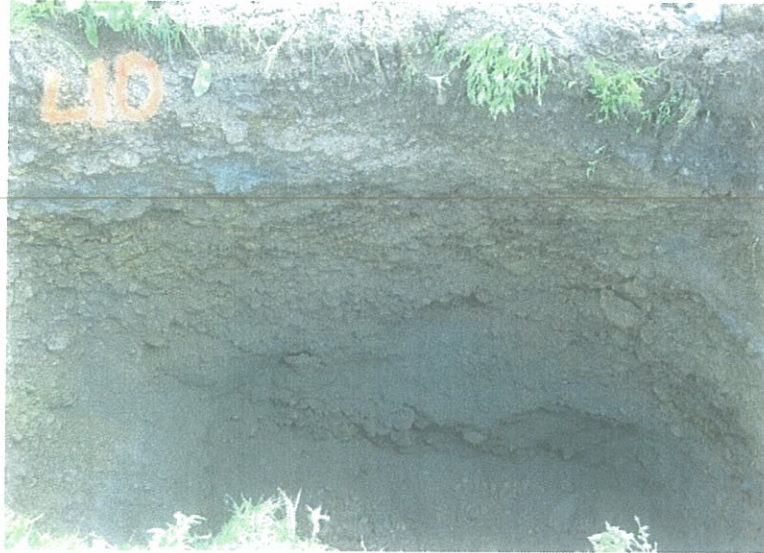
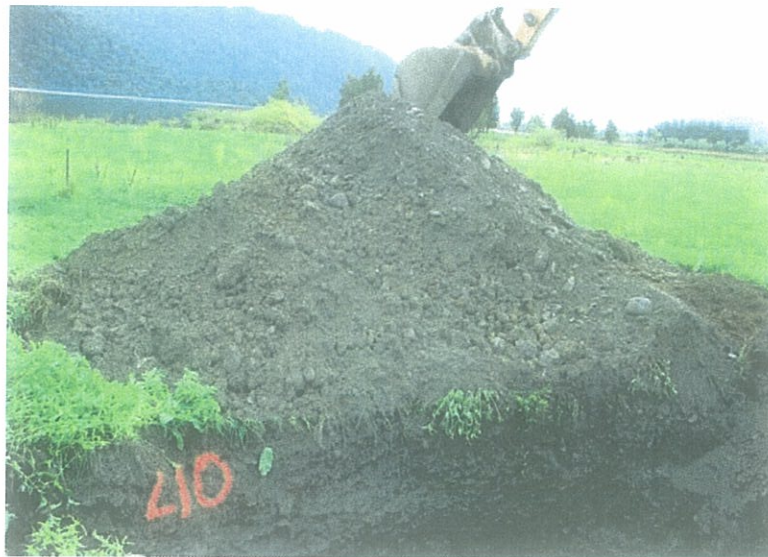
TITLE Test Pit (GA 08) and Spoil Pile Photographs for Lot 10a			
	PROJECT Geotechnical Assessment, Proposed Subdivision, Lake Porerua, Westland			
	CLIENT Grant Marshall		FIGURE B8	
	DRAWN JM/RB	DATE 23/03/2006	PROJECT No. 06812016	
	CHECKED LRC	DATE 24/09/2007	SCALE na	A4
Comments

Excavation				Sampling			Field Material Description										
METHOD	EXCAVATION RESISTANCE	WATER	DEPTH (metres)	SAMPLE OR FIELD TEST	RECOVERED GRAPHIC LOG	USC Symbol	SOIL / ROCK MATERIAL DESCRIPTION	WEATHERING	MOISTURE	CONSISTENCY	DCP TEST (AS1289.6.3.2) Blows per 100 mm				STRATIGRAPHIC UNIT		
			DEPTH RL								0	5	10	15	20	5	
EX	M	water pooling in base of pit	0.0			GW	SANDY GRAVEL dark grey coarse sandy GRAVEL - loose to very loose, moist, well graded, subangular clasts of schist up to 0.1m diameter. - at 1.4m becoming dark brown with increased large clast content (ALLUVIUM)	M	VL-L						5

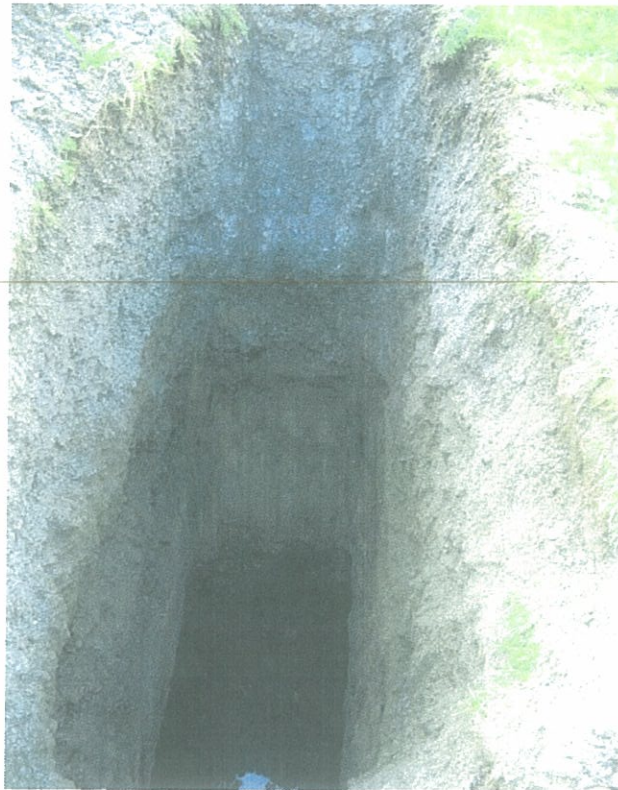
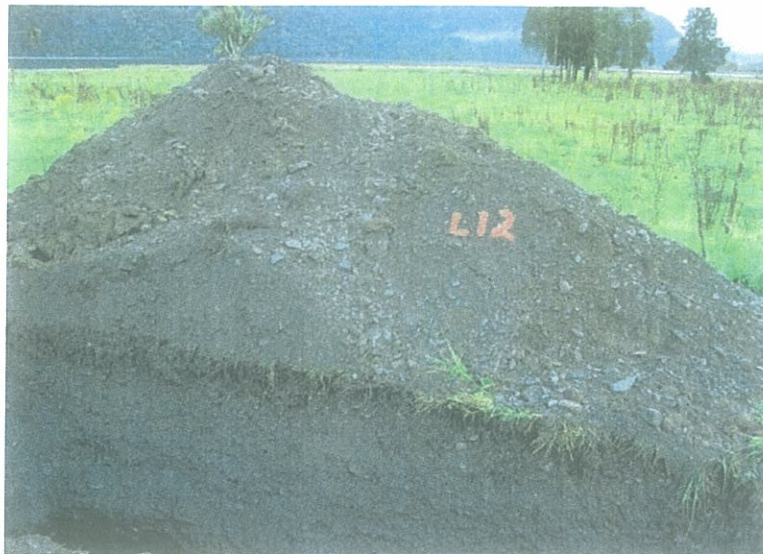
TITLE Test Pit (GA 09) and Spoil Pile Photographs for Lot 12			
	PROJECT Geotechnical Assessment, Proposed Subdivision, Lake Porerua, Westland			
Comments	CLIENT Grant Marshall		FIGURE B9	
	DRAWN JM/RB	DATE 23/03/2006	PROJECT No. 06812016	
	CHECKED LRC	DATE 24/09/2007	SCALE na	A4

Excavation			Sampling		Field Material Description															
METHOD	EXCAVATION RESISTANCE	WATER	DEPTH (metres)	DEPTH RL	SAMPLE OR FIELD TEST	RECOVERED GRAPHIC LOG	USC Symbol	SOIL / ROCK MATERIAL DESCRIPTION	WEATHERING	MOISTURE	CONSISTENCY	DCP TEST (AS1289.6.3.2) Blows per 100 mm					STRATIGRAPHIC UNIT			
												0	5	10	15	20				
EX	L	not encountered	0.0		Shear Vane Test FV=79/20kPa at 0.2m			ML	GRAVELLY SILT yellowish brown gravelly SILT - firm, moist, uniformly graded, rounded, coarse greywacke gravel (ALLUVIUM)	M									F

0.5	0.60				SM	SILTY SAND light grey silty SAND - medium dense, moist (ALLUVIUM)											MD
			0.80					GW	SANDY GRAVEL brownish grey sandy GRAVEL - loose, moist, fine-medium sand, well graded, subrounded greywacke gravel - sand becoming coarse below 1.1m - discontinuous iron pan at 1.4m - 0.3m thick no fines coarse gravel layer, continuous across pit (ALLUVIUM)											L

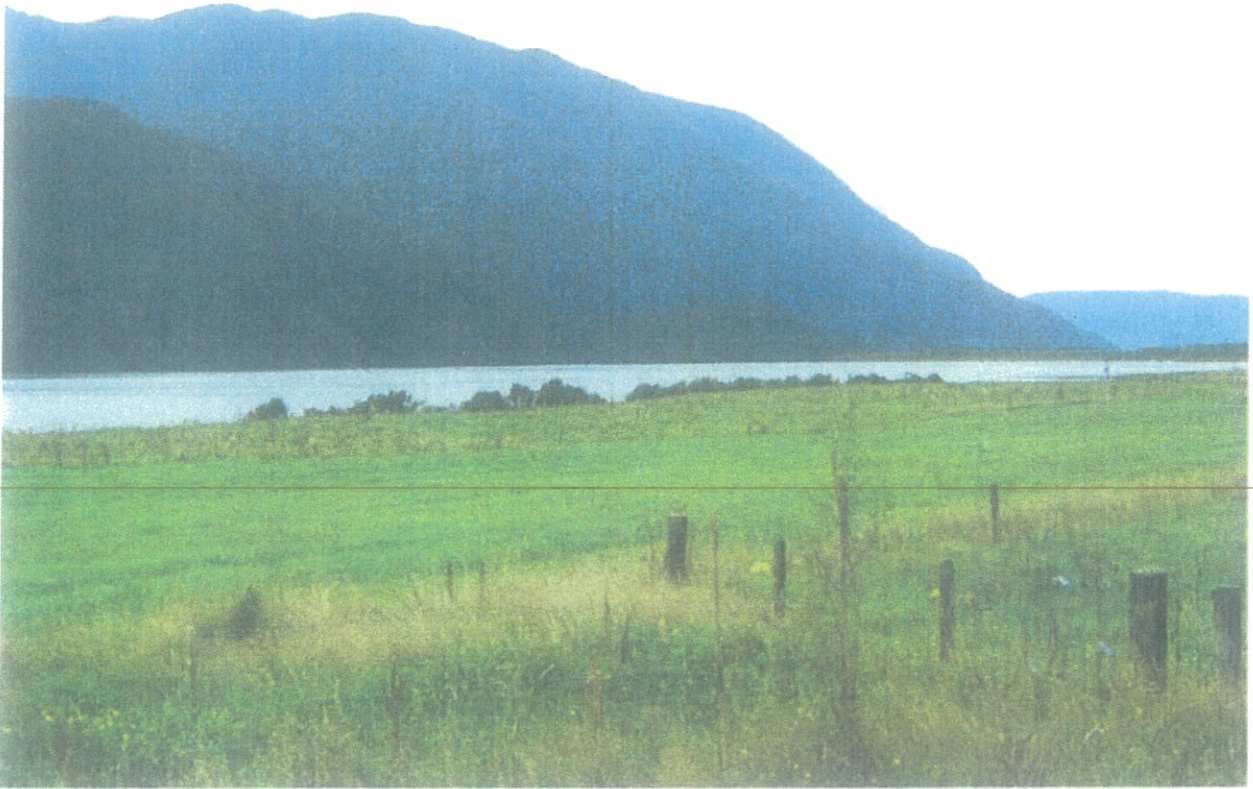
Figure A1: General view to north towards Lake Poerua and Mt Te Kinga, showing airstrip. Test Pits 11 to 13 excavated on western side of clear grassed area beyond first fence.

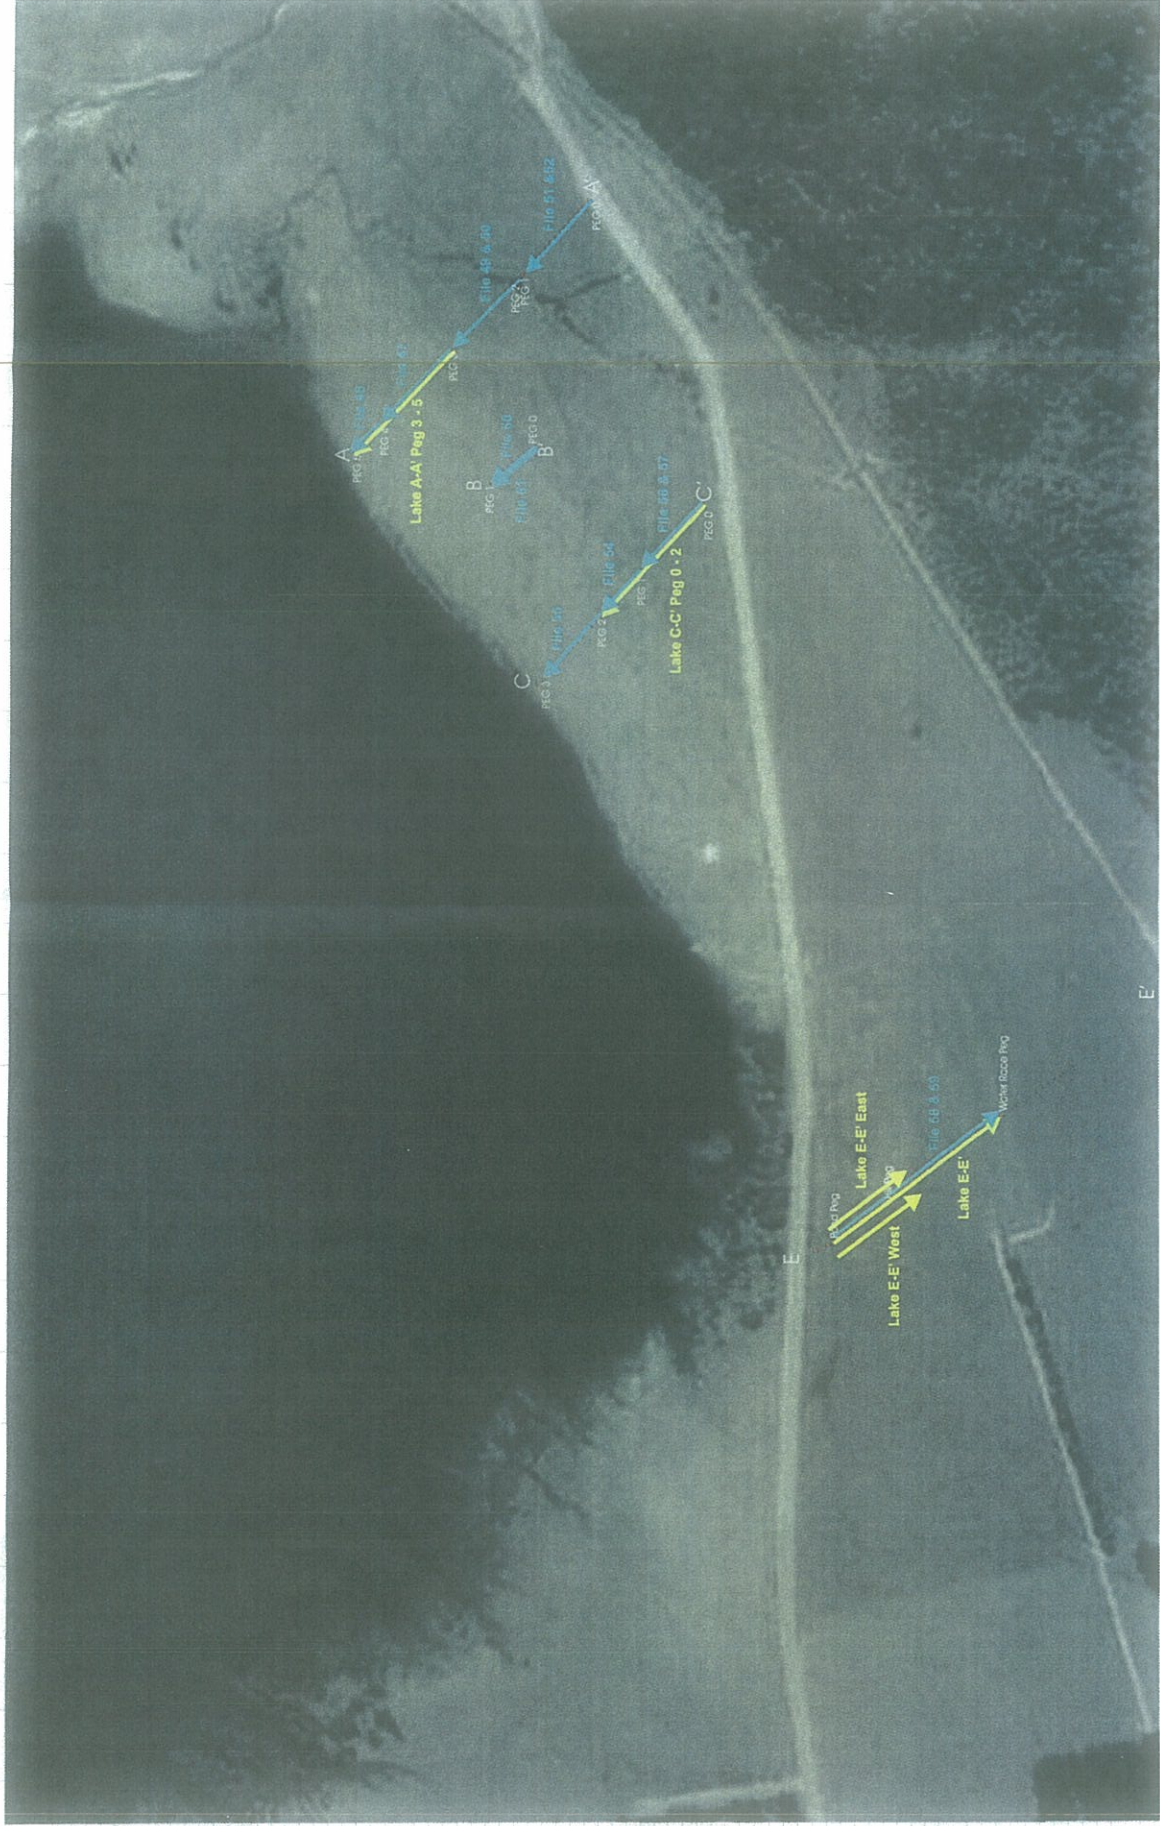
Figure 1: Map showing the location of the Lake Poerua GPR profiles. GPR profiles collected using the Pulse EKKO 100 MHz system are shown in yellow. GPR profiles collected using the GSSI 200 MHz system are shown in blue. Easting and Northing are in NZ Map grid 1949

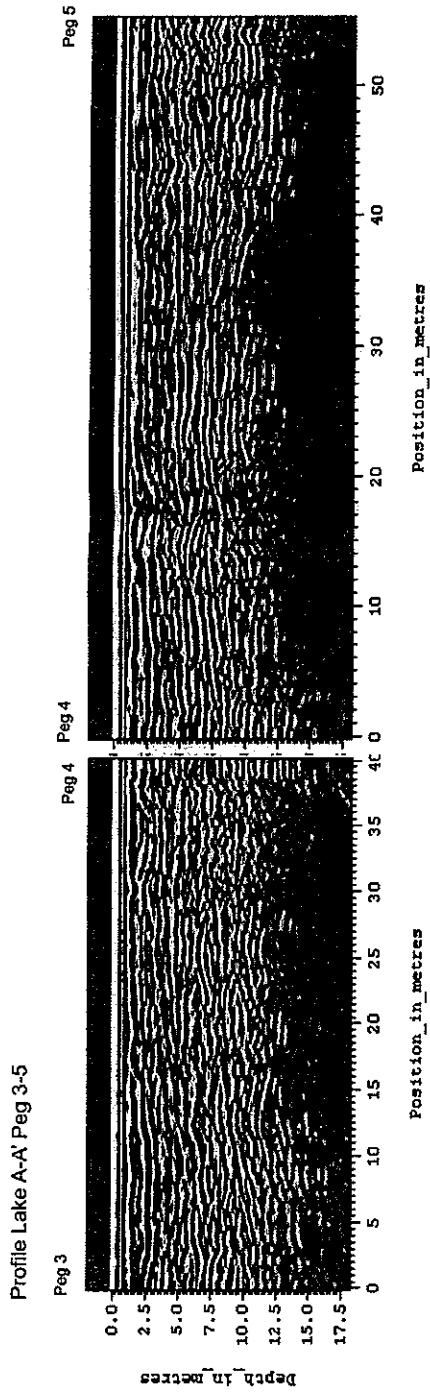
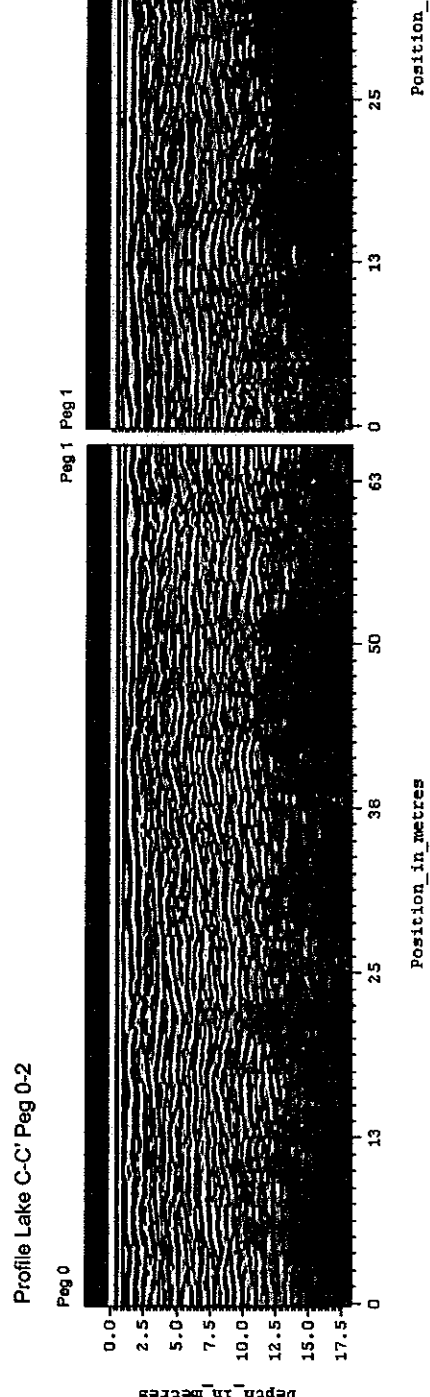
Figure 2: GPR Profiles Lake A-A' and Lake C-C' Pulse Ekko GPR system 100 MHz antenna

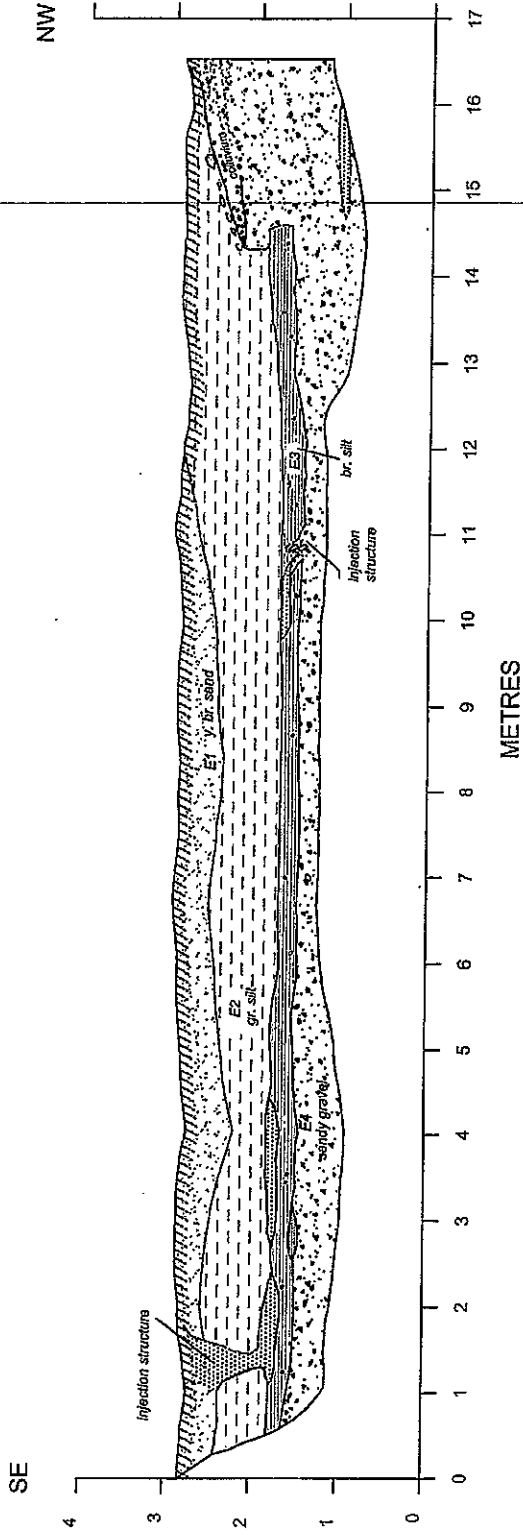
TRENCH E

- E1 yellow-brown, silty medium sand
- E2 grey, sandy silt, soft and moist
- E3 cream grey-brown, clayey silt with scattered rounded small clasts and lenses of loose sand
- E4 grey-brown, loose, sandy coarse gravel with subangular greywacke clasts

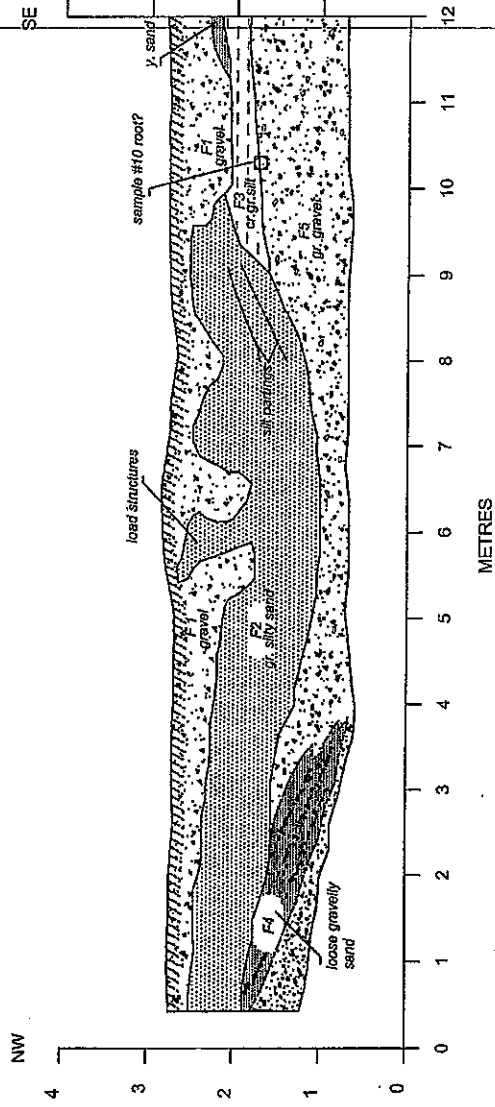
TRENCH F

- F1 brown-grey oxidised gravel capped by modern soil
 - F2 grey, loose, medium sand with thin cm. silt interbeds
 - F3 cream-grey, clayey silt
 - F4 brown-grey, loose, bedded, sandy gravel
 - F5 grey, subangular, greywacke gravel
- LITHOLOGY**
- modern soil
 - silt
 - wood
 - sand
 - coarse sandy gravel

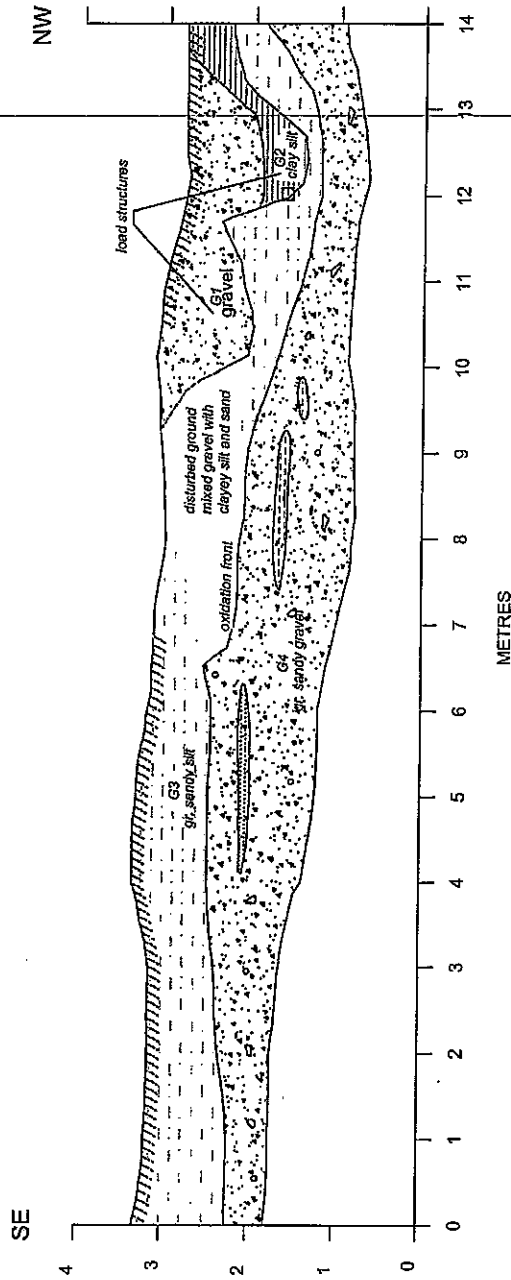
TRENCH G

- *"No evidence of shearing or fault displacement was found" (p1)*
- *"...the stratigraphy (in Trench G) indicates that the fluidisation event post-dates both deposition of the grey silts and overlying gravel...." (p2)*
- *"The site, lying east of the projected rupture trace of the last two events, would have been lifted relative to lake level at the time of the last earthquake (c. 1715 AD)....." (p3)*
- *"Despite proximity of the projected fault trace no evidence of secondary faulting or intense deformation of the sequence was observed...." (p3)*
- *".... there is no evidence of the introduction of any locally derived material..., such as schist landslide or debris flow deposits, associated with this shaking event (ie the 1715 earthquake)....." (p3)*

LITHOLOGY	
G1 grey-brown, unsorted, subangular sandy greywacke clast gravel		modern soil
G2 grey-brown, clayey silt		clayey silt
G3 medium grey, clayey silt with sandy laminae becoming gravelly near the base		sandy silt
G4 grey, coarse sandy gravel with subangular clasts of greywacke		coarse sandy gravel
		wood
