**GEOTECHNICAL SITE SUITABILITY
ASSESSMENT**

PROPOSED SUBDIVISION

**LAKE POERUA
WESTLAND**

R06812016-02-V2

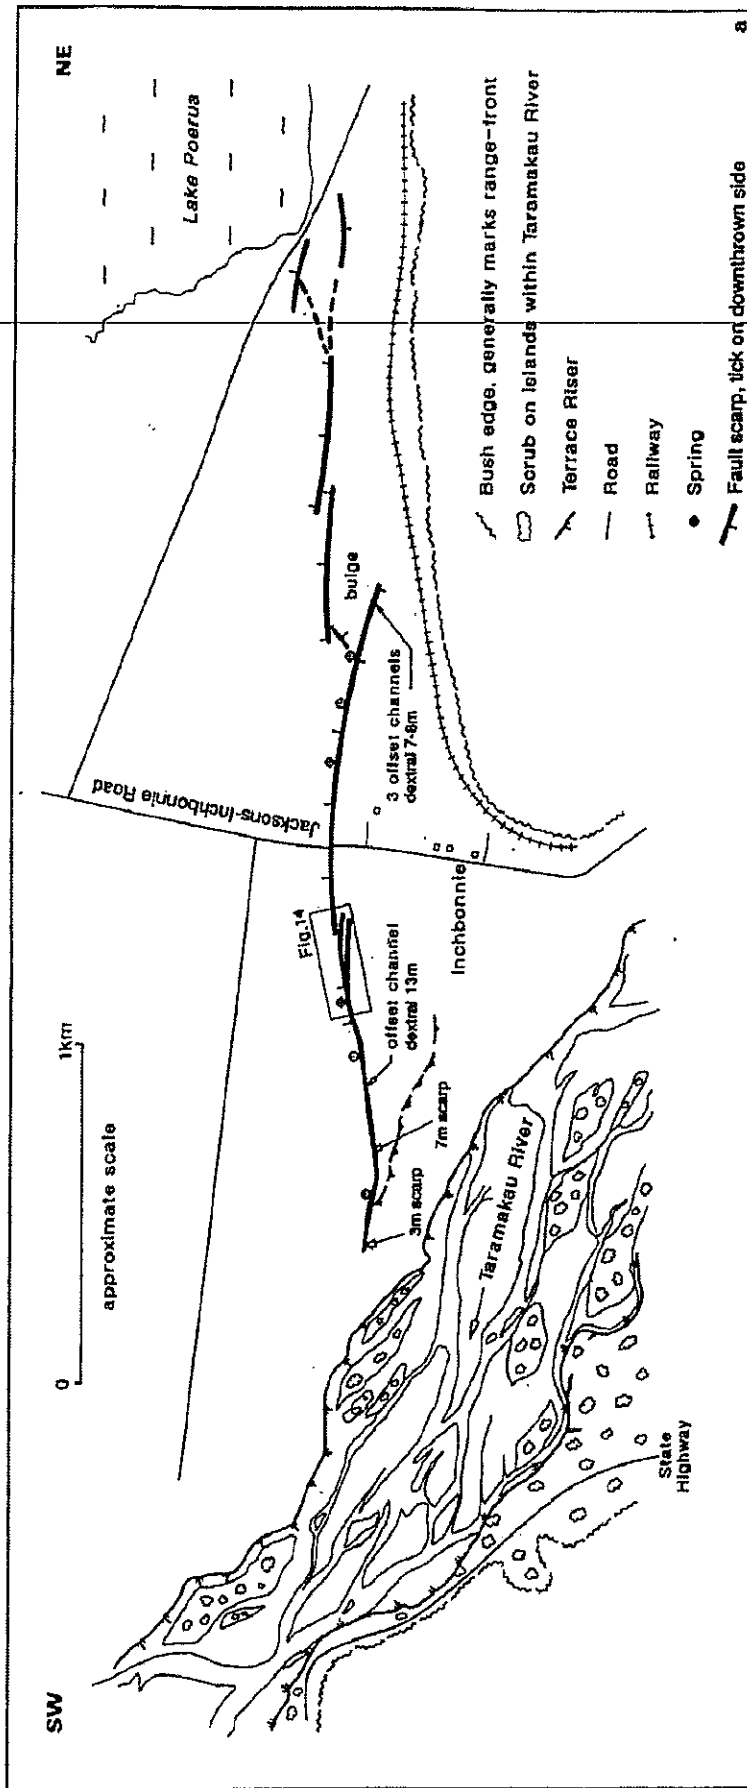
Fig. 13a - Late Holocene fault traces in the vicinity of Incheonie. Note the left-stepping en-echelon pattern with bulges between fault strands.

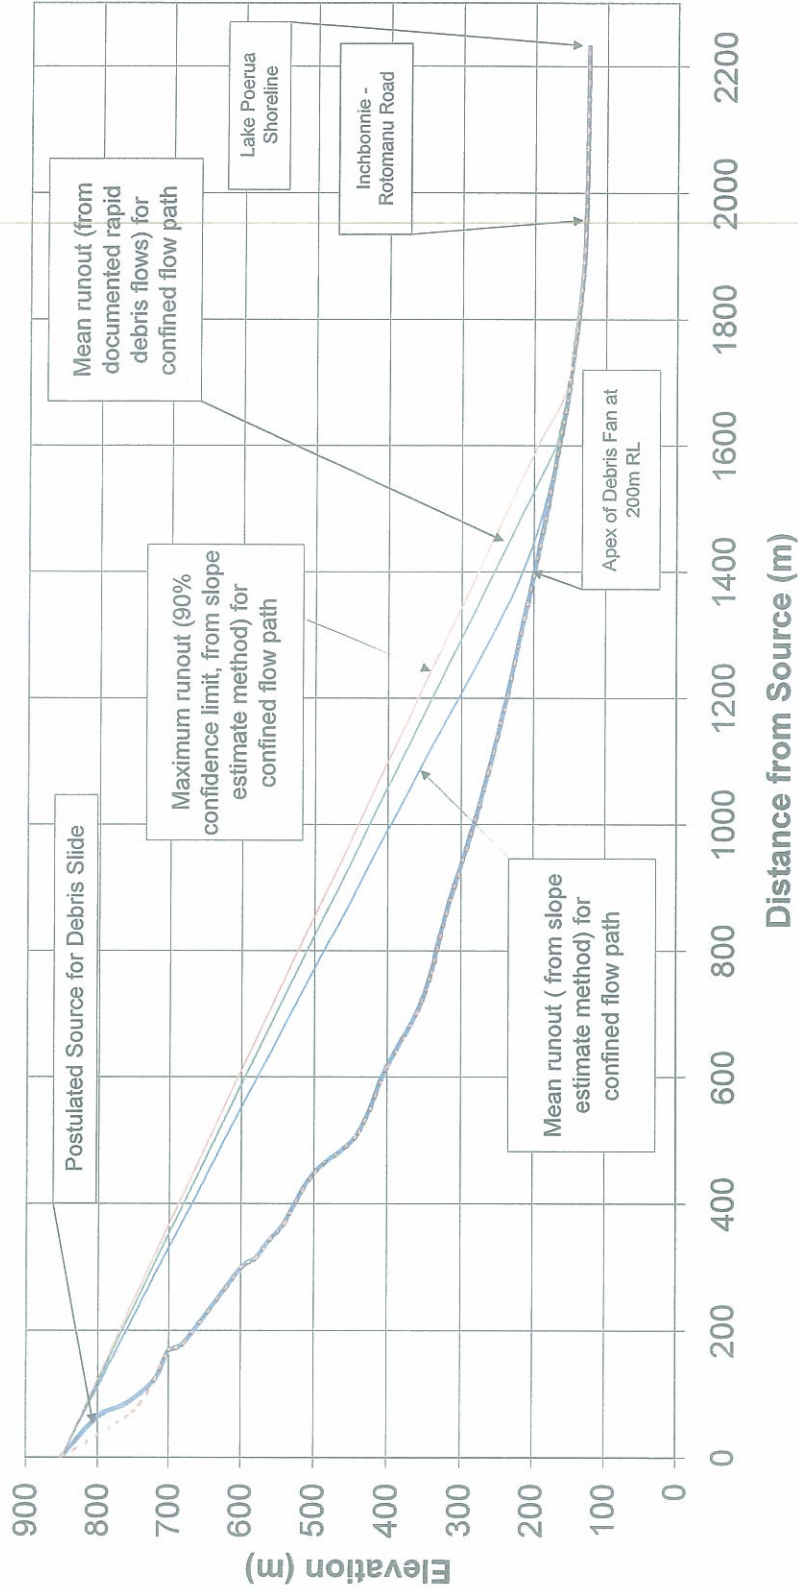
Mine Creek Profile (Hunter & Fell Method)

Hunter & Fell Estimation			
Pathway	Equation	Calculated H/L	
		S. Error	Mean
Confined	$H/L = 0.54^x (\tan a_2) + 0.147$	0.027	0.410
			0.454
			0.499
			29.6
			From Source
			Calculated Angle α_2

Table 3 Estimated H/L			
SD	Low	Mid	
		-45%	+45%
0.11	0.22	0.245	0.608
		0.426	0.67
			High

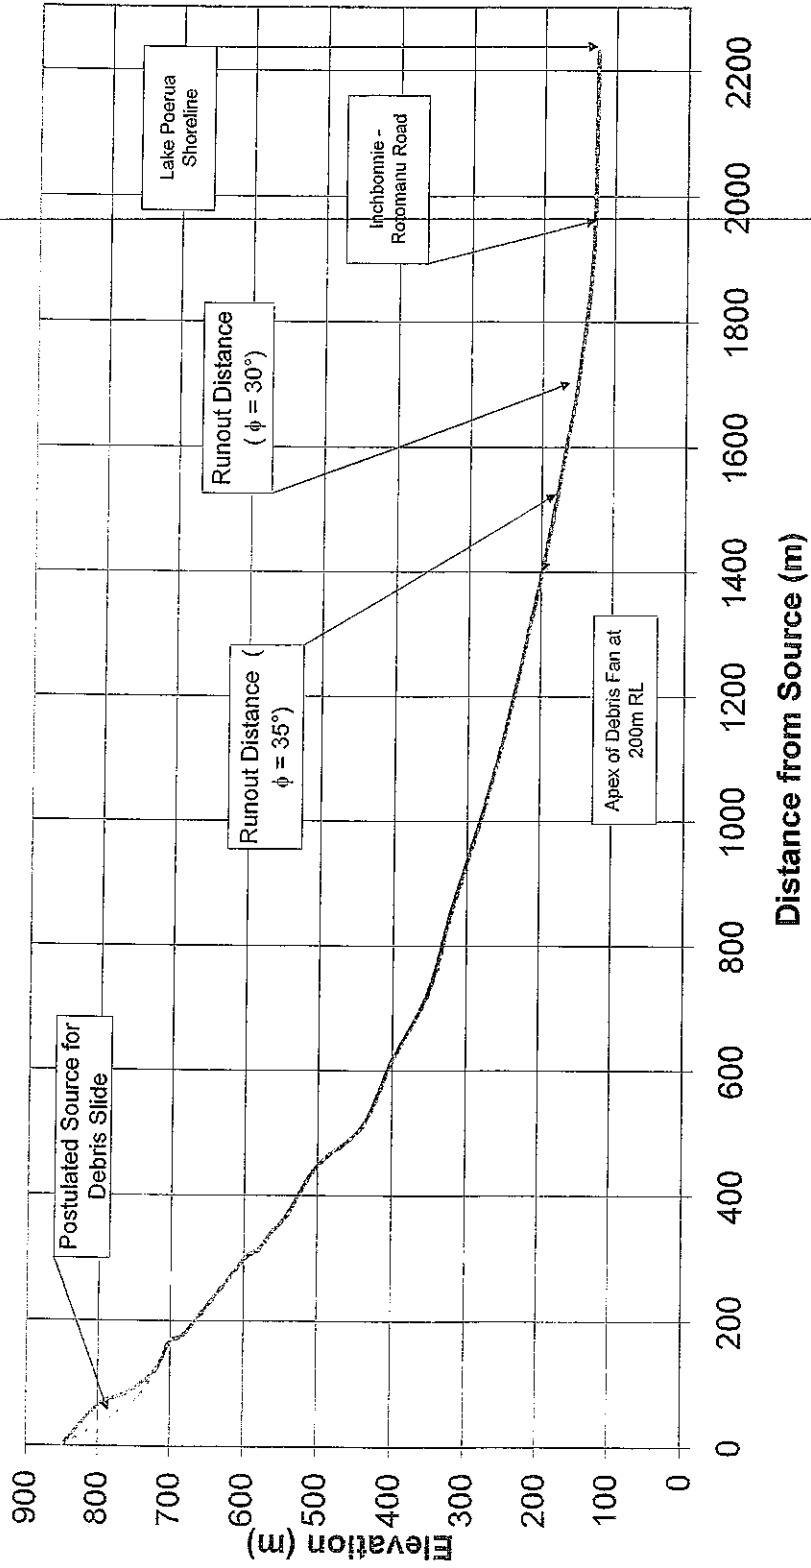
Mine Creek Profile (Dynamic Analysis Method)

Slope	Volume (m ³)	Angle of Internal Friction (°)		Runout Distance (m)	Endpoint
		30	35		
Mine Creek	117000	30	35	1527	In top of fan
	116000			1905	In middle of fan

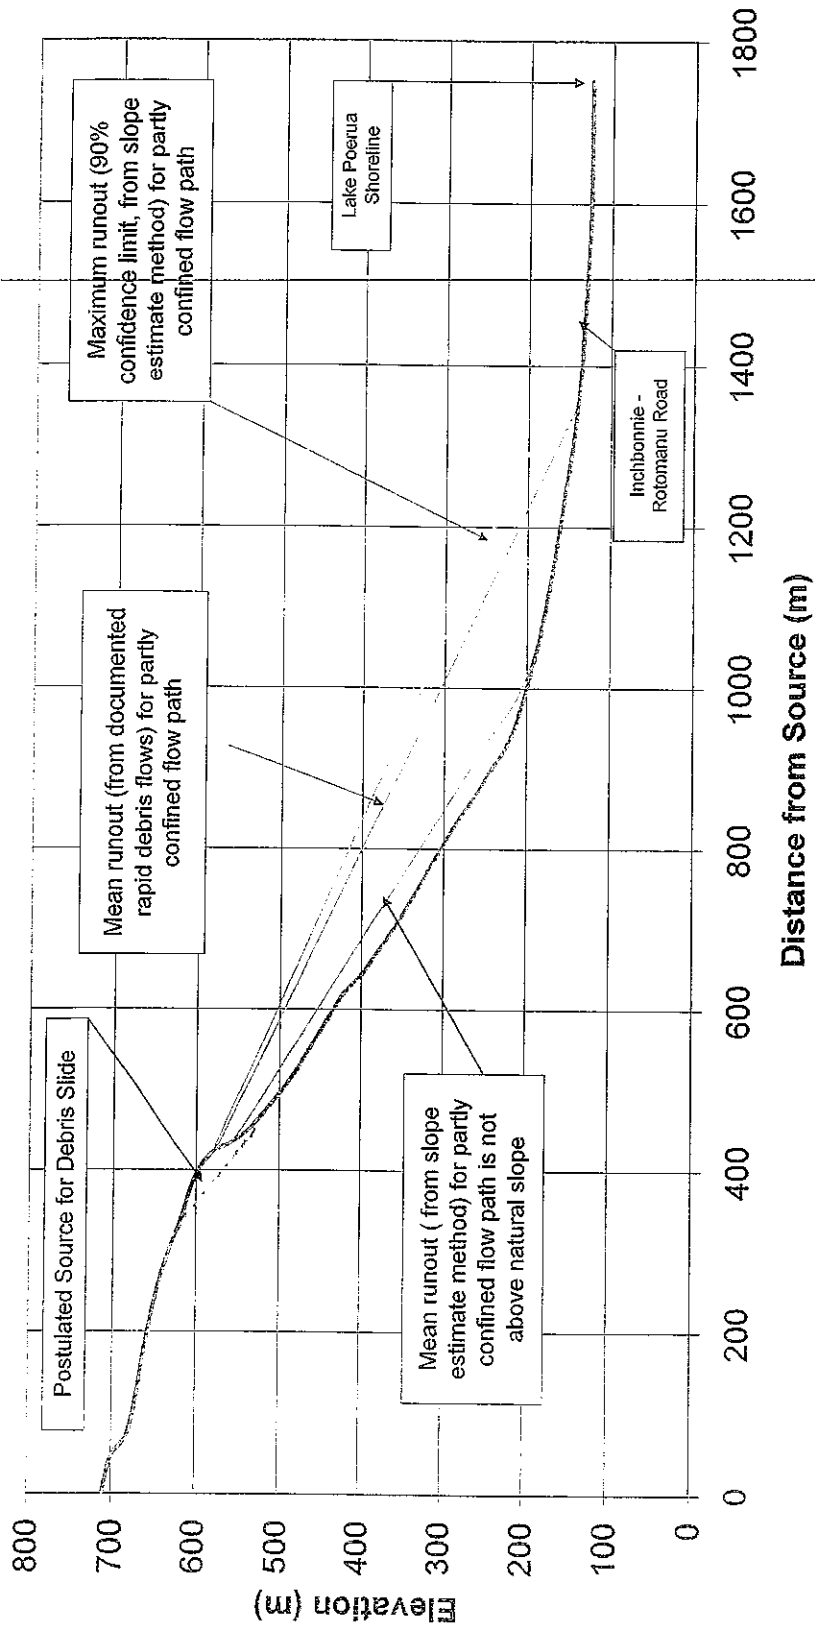
Alexandra Range Profile (Hunter & Fell Method)

Hunter & Fell Estimation			
Pathway	Equation	Calculated Angle α_s	Calculated H/L
Partly	$H/L = 0.69 \cdot (\tan \alpha_s)^2 + 0.056$	From Source	-45% Mean +45%
		37.6	0.617 0.798
		S.Error	0.11 0.435

Table 3: Estimator H/L			
SD	Low	Mid	High
0.174	0.280	0.282	0.470 0.658 0.820

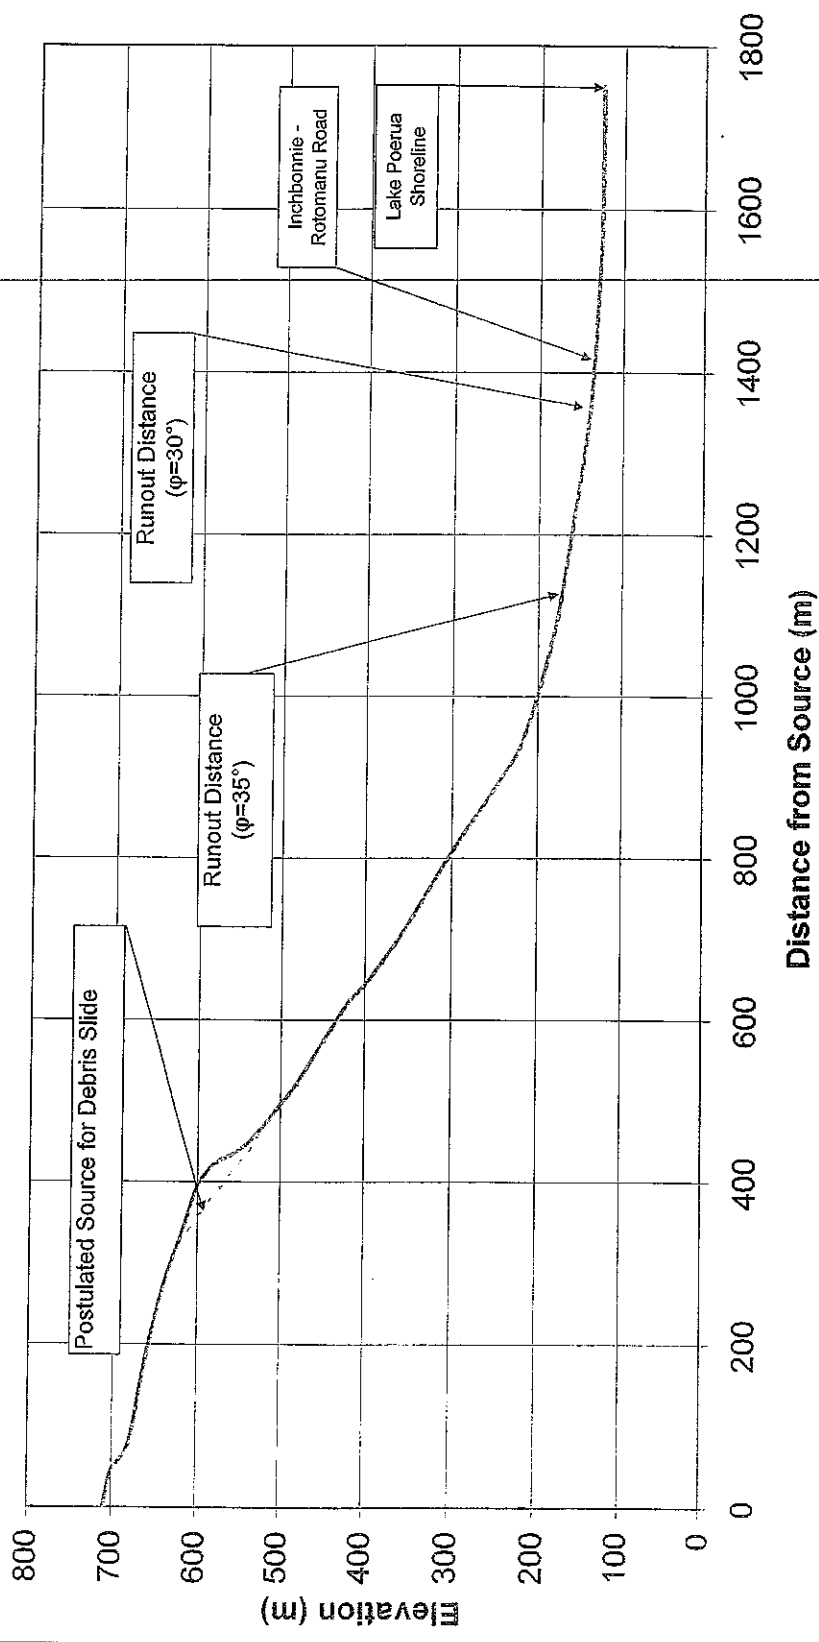
Alexander Range Profile (Dynamic Analysis Method)

Slope	Volume (m ³)	Angle of Internal Friction (°)	Runout Distance (m)	Endpoint
Alexander Range	124000	30	1374	Welf uphill of Inchbonnie - Rotomanu Road
	124000	35	1140	Just above Inchbonnie - Rotomanu Road
