In the matter of a hearing on submissions on the proposed Te Tai Poutini Plan

Tauranga Bay Holdings Limited

Evidence of Philippe Dumont – Environmental Engineer

Preliminary Site Investigation (PSI)

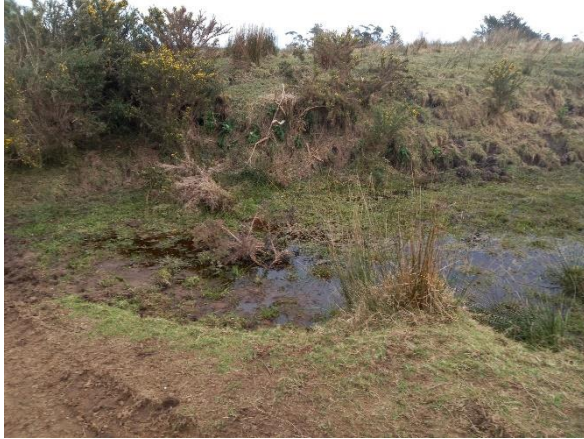
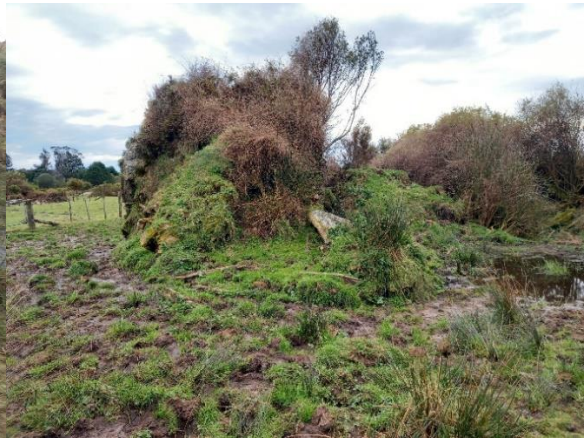
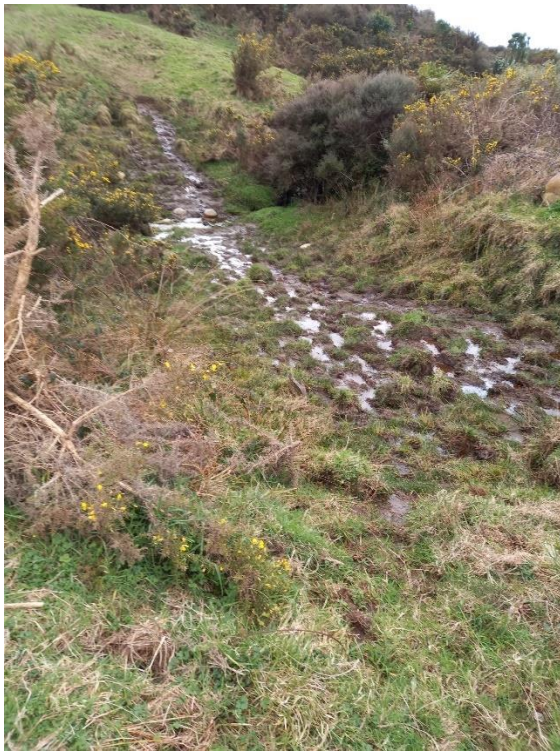
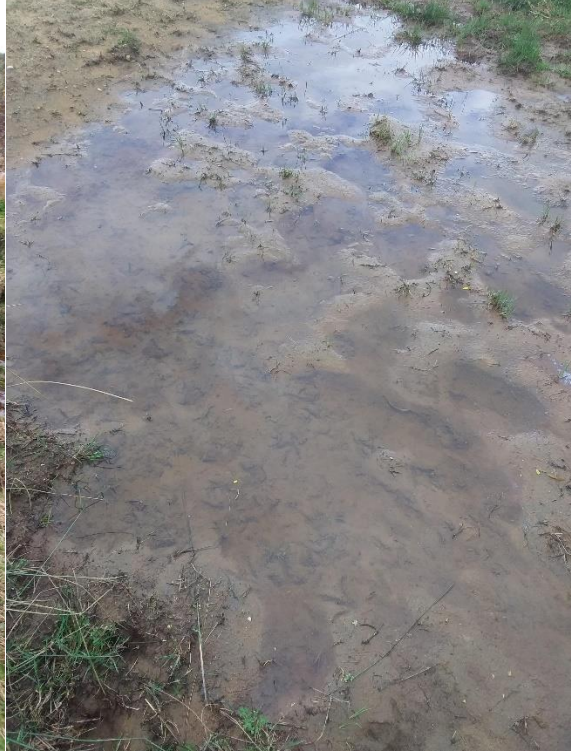
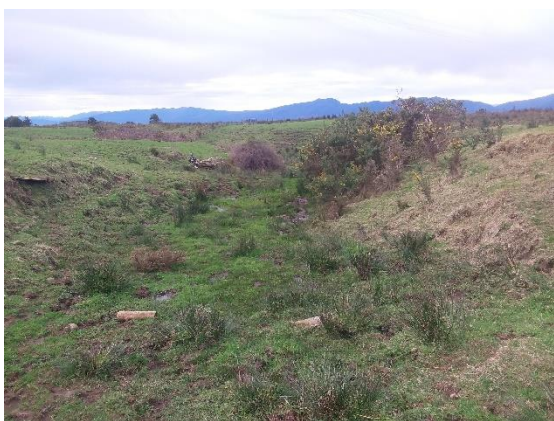
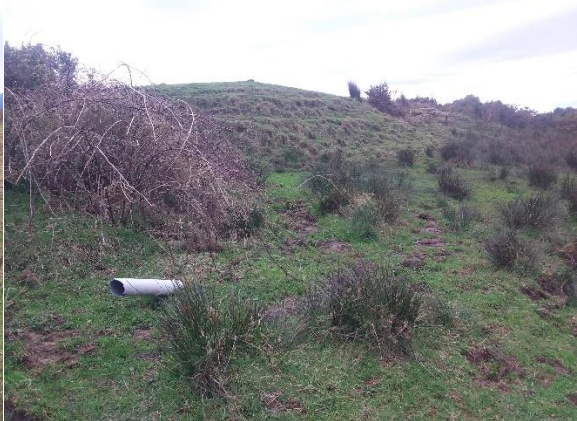
Appendix C. Site Photographs

- Several stockpiles noted to the east of the residential dwelling. These appear to be cleared vegetation.
- A small amount of scrap metal was found in one of the vegetation piles.

- A small burn pad was present just outside of the separate house lot. It is unclear if the burn pad is located on the property in question or within the title of the neighbouring house. It is located in an area fenced off from the property in question and appears to be maintained by the neighbouring property owner.

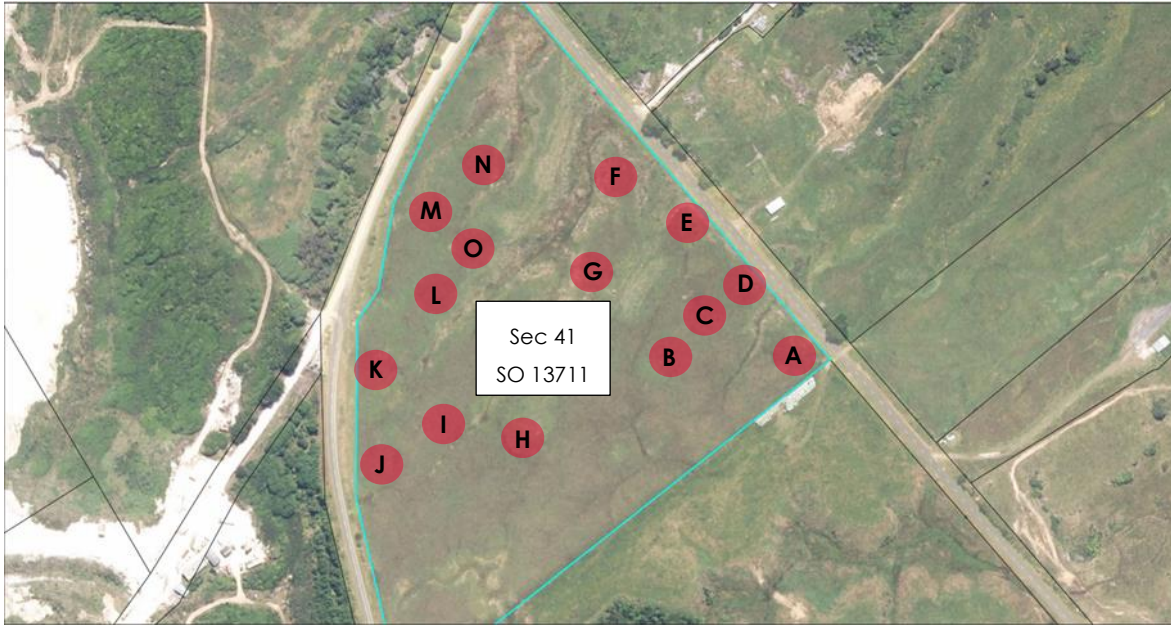
Figure 5. Aerial of the site indicating the areas investigated (Eliot Sinclair, 2022).

On the 3rd May 2022 we undertook our geotechnical site investigation which consisted of a site walkover, sixteen scala penetrometer tests, and the inspection of twelve machine dug test pits. The full Site Investigation Records can be found in Appendix B. Our testing was undertaken in fifteen locations, labelled A – O and illustrated in Figure 5, and through Figures 6 - 9.

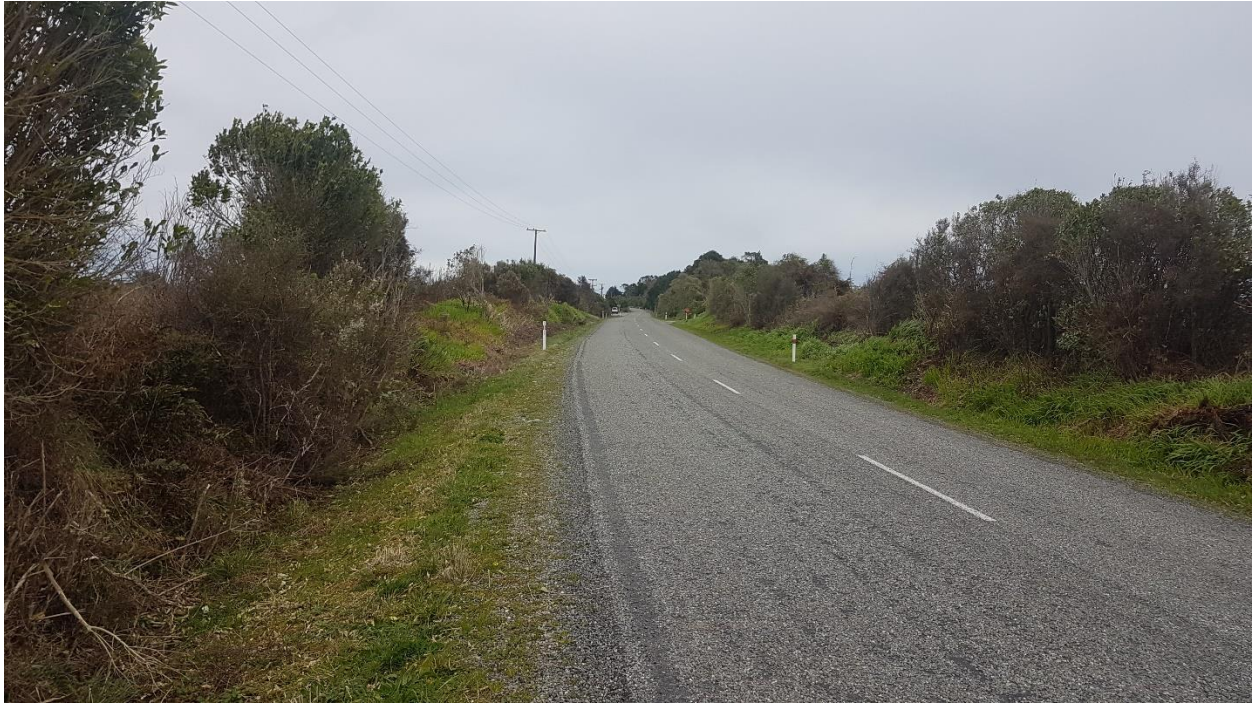
Figure 1. Photo showing sight distance looking SW from likely access location to northern site off Tauranga Bay Road
