Online submission

Plan section	Provision	Support/oppose	Reasons	Deci
Natural Hazards	Earthquake Hazard Overlays - All	Amend	Map 65 relates to Lake Poerua and surrounds. This area of Lake Poerua at 2382 Lake Brunner Road ,Inchbonnie has been extensively researched with a consent granted for a 12 section subdivision by the commissioner of the NZ Environmental Court in November 2011. Section 221 for this development was issued by the GDC on 9th August 2018.At time of writing two dwellings have been completed with another undergoing a build and two more consented buildings planned. We are concerned with inaccuracies of the Faultline in Map 65. As part of the approval process for the subdivision, consultation was made between GNS on behalf of the Grey District council, Golders and Canterprise to determine the location of the fault line and the final hazard setback plan drawn by GNS was used to change the subdivision layout to ensure all building sites were outside the setbacks. This map shows the Faultline going straight across the subdivision footprint. The set back/fault avoidance line consists of the land between the lake edge and the front fence which runs along the front of all th

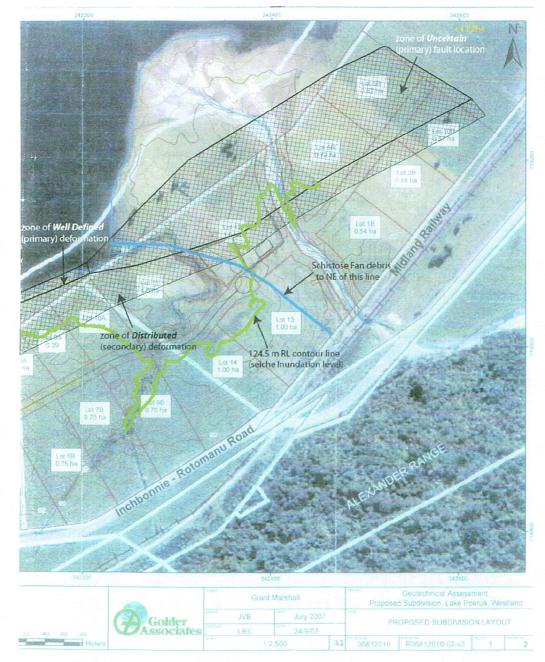
Figure A. Map showing suggested Fault Rupture and Deformation Avoidance Zones in the NE part of the Lake Poerua subdivision. The green line shows the expected seiche inundation level (from the lake) across this area. The blue line demarks the area covered by schistose fan debris.

level of uncertainty based on projecting the fault from places where the location is better known. In this regard the pink primary rupture zone increased in width to accommodate that uncertainty. The fault setback shown on Golders' Figure 5 across the Mine Creek area (blue) is not adequate in this regard. The width of uncertainty probably equates to approx. ± 50 m in this case. This is shown on Figure A of this letter. For those areas shown inside the hachures the MfE Guidelines suggest a *Discretionary* and *Non-Complying* resource consent activity status for BIC 2a and 2b structures, respectively.

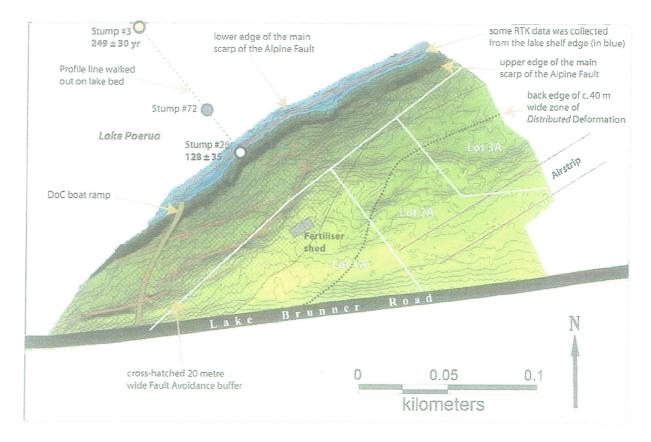
Figure 1. Interpreted GPS-RTK micro-topographic map of the SW corner of the Lake Poerua subdivision site and Dept. of Conservation lot. The main purpose of the map was to extend the features seen in the DoC Carpark across the SW end of the subdivision only. Red lines are interpreted fault locations from the topographic map. Note: They may or may not be faults, but they appear to be. The red line in the lake (blue) shows the location of the <u>base</u> of the main fault trace. The <u>fault zone</u> or rupture zone should be considered as the entire steep face between the top and bottom edges of the fault scarp along the lake front. I have applied a 20 metre Fault Avoidance buffer to the top edge of these mapped fault traces.

Approximate Lot boundaries have been placed on here (I understand these are going to change). My concerns about Lot 1A are reflected in the potential fault traces shown near Lot 1A. An arcuate scallop-shaped feature exits across Lots 2A and 3A. It is not mapped and its origin is unknown (slump scar?).

In the Lake Poerua example, where some trenching has been done across the upthrown block, we have agreed that there was no documented evidence of primary deformation (large displacements). However, it remains prudent along the Alpine Fault, to maintain a 20 m Fault Avoidance zone from the top edge of the fault scarp as shown in Figure 1. This was generally agreed by all parties

- the amendment of the boundary between Lots 1A and 2A is reasonable to avoid possible fault traces at the SW corner of the subdivision and to allow more flexibility for siting house lots outside of designated hazard zones (see Figure 1 of this letter).

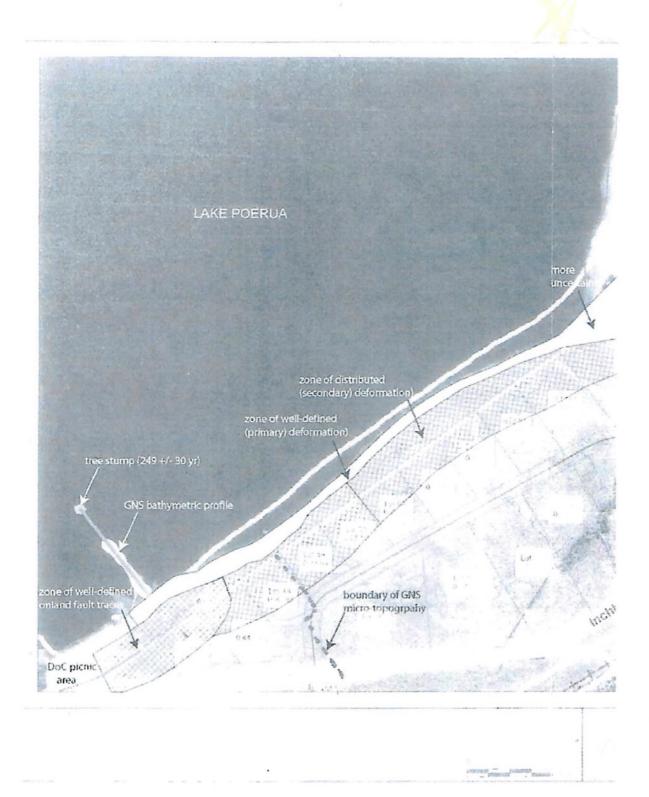
Figure 3 Active Fault Deformation Zonation map for the Lake Poerua lakefront adjacent to the proposed subdivision. The pink coloured zone and hachured zone about the red fault line are considered zones of primary rupture, while the broad hachured area is a zone of secondary (distributed) deformation. The pink zone broadens near Mine Creek where the fault location is poorly expressed. The green line shows the location of the bathymetric profile, which was anchored at a drowned stump, the outside of which was dated.

Lot 1A is largely encompassed by a zone surrounding a recognised active fault trace. The MfE Guidelines suggest it should have a *Non-Complying* resource consent activity status for BIC 2a and 2b structures. The hazard zone we show on Figure 3 of Langridge & McSaveney (2008) could be reduced in dimension by undertaking further geological studies, e.g. a trench, to determine the nature of the feature there and the width of deformation (see Fig. 6.1 in *Kerr et al. 2003*).

The scan presented as Figure 3 in Langridge & McSaveney (2007) did not extend to the NE end of the proposed site as I was unaware that the area of Mine Creek was still being considered for subdivision in the current scheme. A number of hazards have already been identified in relation to these lots: fault rupture; fault deformation; inundation from seiche wave; and inundation/debris flow from Mine Creek. These will be discussed further below.

- Can you also clarify the situation in respect of Lots 11 (the extent of the secondary formation is not fully shown on your Figure 3) 12, 13 and 14-all are proposed to be built upon. In the Conclusions and Recommendations 5. and 6. doubt is cast on the suitability of lots 11 and 12 at least.
