o Poutini Plan

Topic: Rural Zone

Cape Foulwind Staple 2 Limited

PLANNING EVIDENCE OF JANE BAYLEY

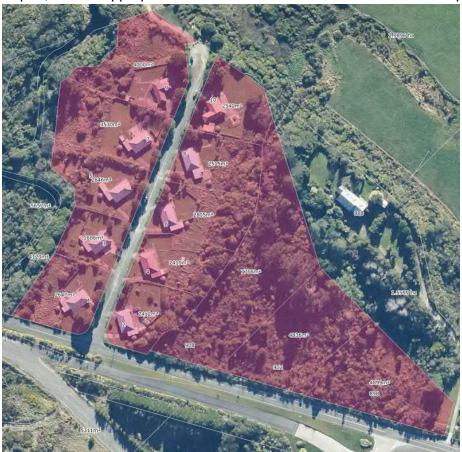
3.9 Since issue of the submission, CFS2 have completed two subdivisions as shown on the Map below. The Larsen Street parcels range from 1,686m² to 4,000m², while the three sections adjacent are 4,836m² to 7,766m². As the clustered parcels are below the threshold of the General Rural Zone, and have been developed, or have been consented to be built upon, it is not appropriate to retain the General Rural Zone on these parcels.

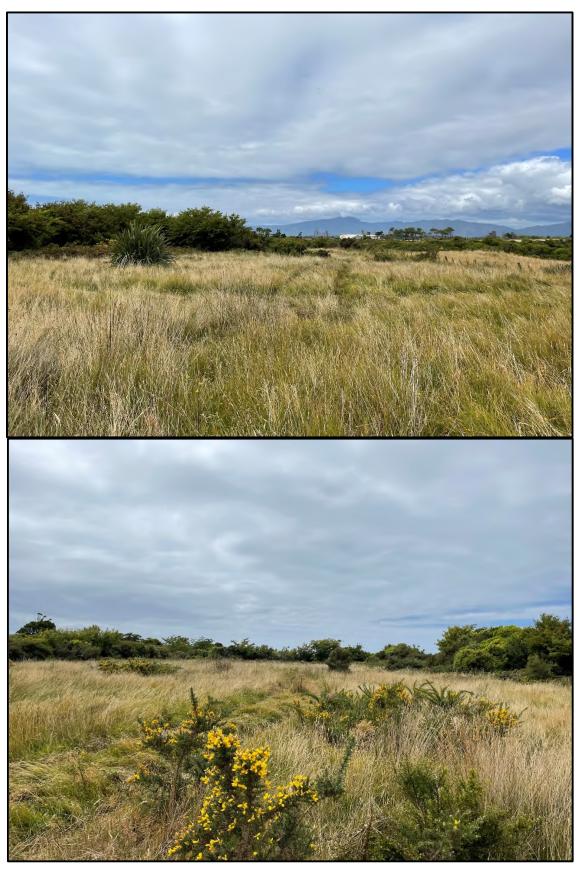
Figure 1: Photographs of the site taken near test pit TP10's location looking east (top) and west (bottom). In the photograph on top, the dense tree vegetation in the left of the photograph marks the approximate crest of the gully. Photographs taken by Davis Ogilvie, 14 February 2024.

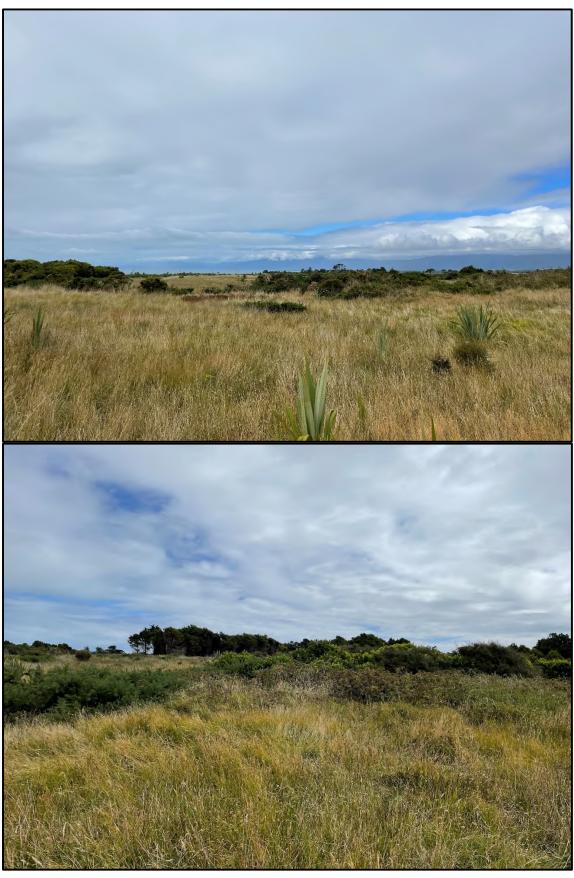
Figure 2: Photographs taken near test pit TP7's location looking southeast (top) and west (bottom).

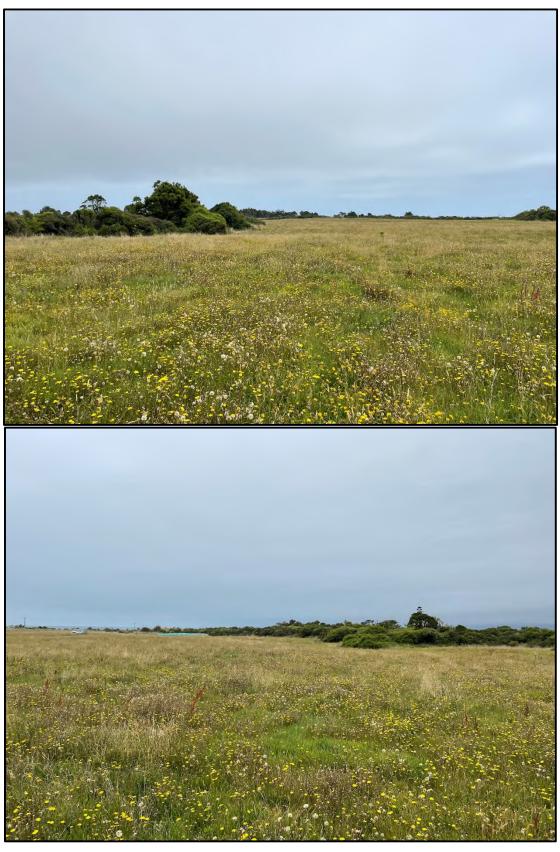
Figure 3: Photographs taken near test pit TP3's location looking west (top) and east (bottom).

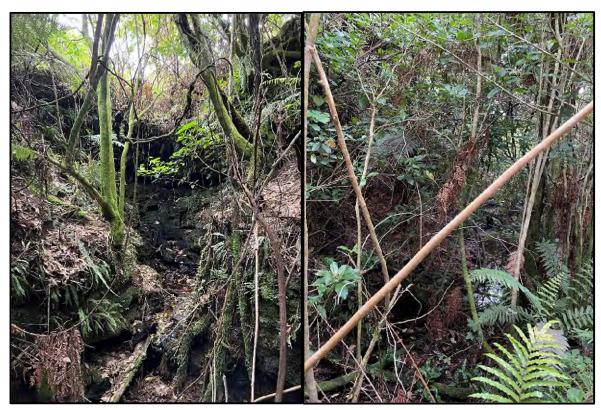
Figure 4: Photographs taken from the bottom of the gully, at its western-most extent. The photograph on the left is looking west towards a steep gully slope characterised by moss-covered dense sand. It is estimated that from the bottom of the gully to the crest is approximately 5.0 – 6.0 m elevation difference. The photograph on the right is looking east from the same location, showing standing water and dense vegetation characteristic of much of the accessible parts of the gully. Photographs taken by Davis Ogilvie, 16 February 2024.

The accessible parts of the gully bottom are approximately 5.0-6.0 m lower than the crest and characterised by bog conditions with gently-flowing water in places, areas of standing water, and ground cover characterised by silt, sand and decaying organic debris. At the western-most extent of the gully, some groundwater seepage was observed near the bottom. At this location, the gully slope consisted of stable, near-vertical, dense sandy soils (with iron-oxide staining).
