**Before the Proposed Te Tai o Poutini Plan - A Combined District Plan for the West Coast, Hearings Panel**

In the matter of the Proposed Te Tai o Poutini Plan: A Combined District Plan for the West Coast – Hearing Topic 3

And **Transpower New Zealand Limited**  
Submitter 229 and Further Submitter FS110

**Statement of Evidence in Chief of Jordan Brett-Allen  
Shortland-Witehira**

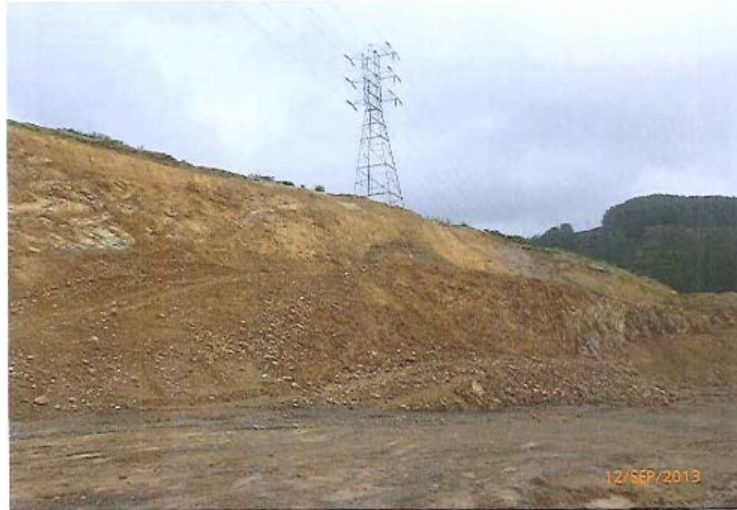
19. Figure 1 shows earthworks that occurred around a tower as part of development for an urban subdivision in Whitby, Porirua. The earthworks were well within 12 metres of the support structure and reduced the structural capacity of the tower. While NZECP34 provides a dispensation pathway for earthworks within 12 metres of a support structure, Transpower would not have given dispensation for these earthworks as proposed without mitigation being designed and put in place to ensure the structural capacity of the tower was maintained, and the potential erosion issues were addressed.

Figure 1. Earthworks in Porirua

20. As well as possibly undermining the stability of the tower structure, the earthworks in the photograph have also restricted vehicular access to the tower and the area where Transpower can place vehicles and machinery required to maintain the tower. This compromises Transpower's ability to maintain the existing transmission line. Typical maintenance activities include insulator replacement, climbing assessments, steel replacement and tower painting.

21. In this instance, Transpower worked with the developer retrospectively to ensure that the constraints on the line introduced by the developer were mitigated, and the long-term stability of the towers would be retained. This required the installation of a shotcrete surface on the cut batter and the strengthening of the grillage foundation.

22. Such works are an example of how earthworks conducted close to the Grid can undermine Transpower's ability to operate and maintain the network effectively and efficiently. Ultimately, the manner in which Transpower carries out maintenance at this tower needed to change to address the effects.

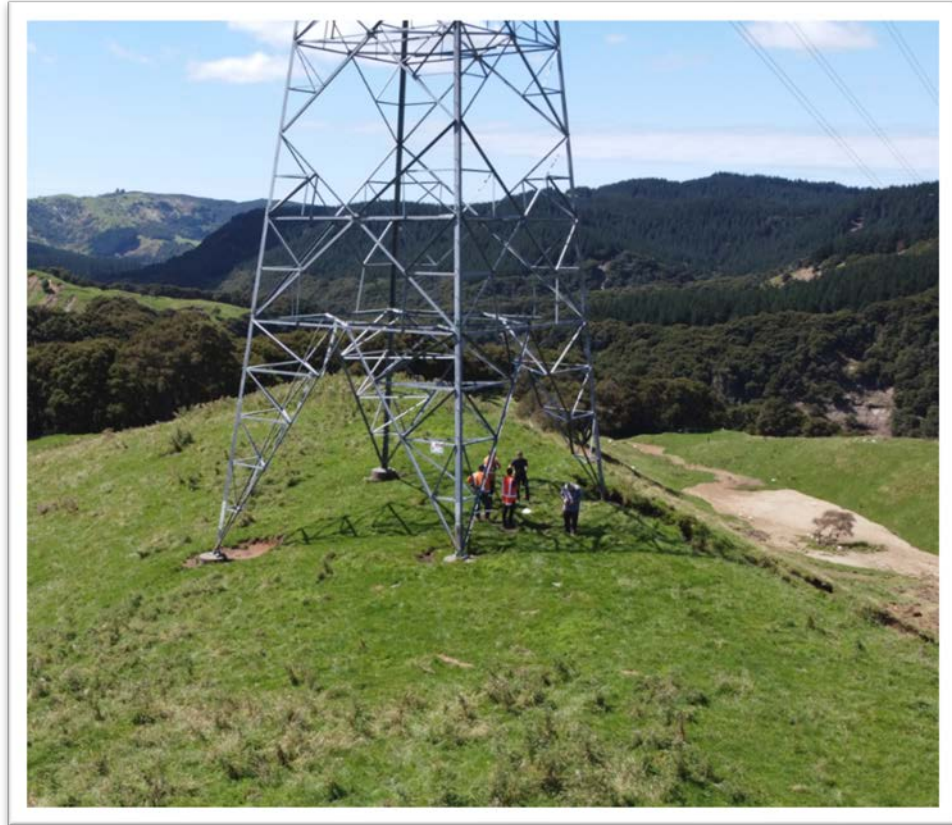
23. Another example of the impact of excavations near tower foundations is the relatively recent construction of the Transmission Gully highway. During the design and construction of this highway the builder approached Transpower to obtain approval to excavate within the NZECP34 distances. Given the national significance of this project, agreement was reached to monitor the stability of the slope, and if instability was found then the builder would be liable for the costs of

rectifying that instability. During construction, monitoring found that the slope did in fact begin to move and the builder was required to pay the extensive rectification work costs.

*Figure 2. Earthworks at Transmission Gully*

24. The rectification of the instability of the slope resulted in a delay of the project. In addition, new foundations needed to be installed to support the tower, to address the new terrain conditions.
25. In the above case it was possible to set responsibilities and liabilities before the work commenced. Transpower has experienced other situations such as in Figure 2 above where retrospective mitigation has been required. The period between identifying this non-compliance and being able to design and construct mitigation placed the security of the National Grid at risk.

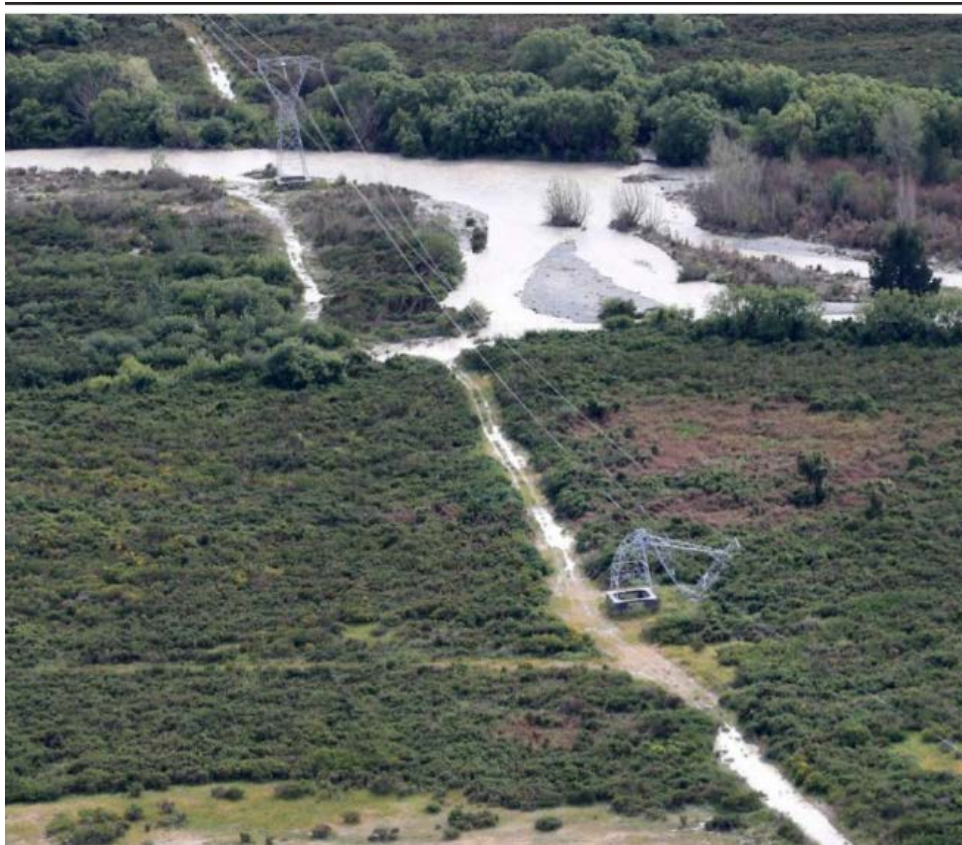
*Figure 3. Rangitata incident in 2019*

29. The example above depicts the end of a cascade failure, where the structures leading up to these in the photo in Figure 3 had collapsed. The Rangitata incident in 2019 caused nine towers to fail (under weather conditions.)

30. Structure or cascade failure can take between weeks and months to repair depending on the damage extent, location, access, grid criticality, construction resources and material resources. These are all relevant factors to consider for the West Coast. These effects on the Grid can equally occur due to inappropriate earthworks activities near the support structures.
31. In comparison to the rest of New Zealand and the National Grid, the West Coast does not have many high voltage transmission lines in the region. This means there are limited options for electricity supply to be transferred to alternative lines if a fault or failure occurs, and therefore the ongoing operation of the existing assets is crucial.

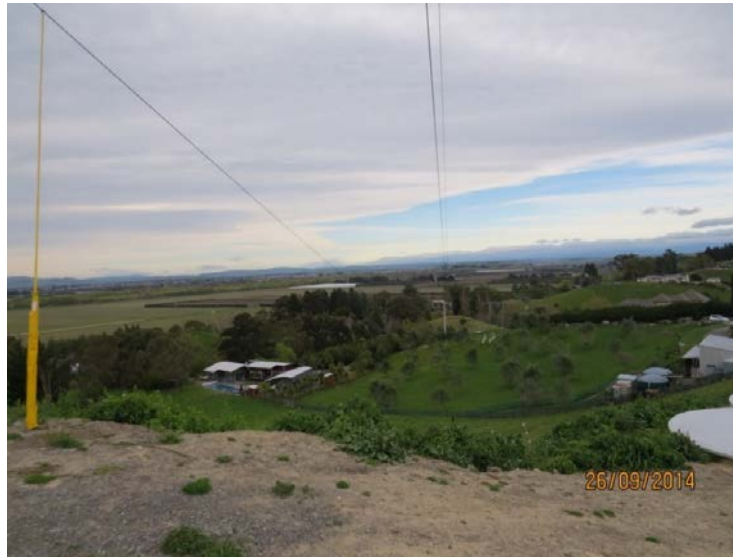
32. Another example of earthworks adversely impacting the operation of existing National Grid assets is earthworks undertaken in Hastings (Figure 4 and Figure 5 below). Transpower investigated the clearances from the conductor to ground for two Hastings properties and found the minimum clearance was only 5.3m from the ground to conductor at everyday conditions (instead of 6.5m at maximum operating conditions required under NZECP34). In this case there was a significant risk of electrical flashover to vehicles passing underneath and people moving tall objects.

*Figure 4. Hastings ground clearance violations*

33. Transpower needed to arrange temporary fencing of the two earthworks sites to prevent any further access under the conductors until rectification works were completed. Mitigation included installing a new set of cross arms on the poles. The top and bottom crossarms were changed to shorter steel crossarms with new Horizontal Line Posts (HLPs) attached. This lifts the conductor into a clamp on the end of the HLPs on the same pole by approximately 1200mm and prevented the need to replace the poles. Transpower then carried out ground works to cut the edge of the bench/track back to ensure the regulation 6.5m ground clearance at maximum operating temperature was complied with i.e., remediating the site back to original ground level and achieving compliance with NZECP34.

34. Transpower is not able to grant a dispensation under NZECP34 for earthworks that exceed the clearance distances. Electrical clearance distances are set by NZECP34 to ensure that any person traversing under the conductors can do so safely. Any earthworks that create a conductor clearance violation put that person at risk, so the earthworks need to be either reversed, relocated or mitigated to

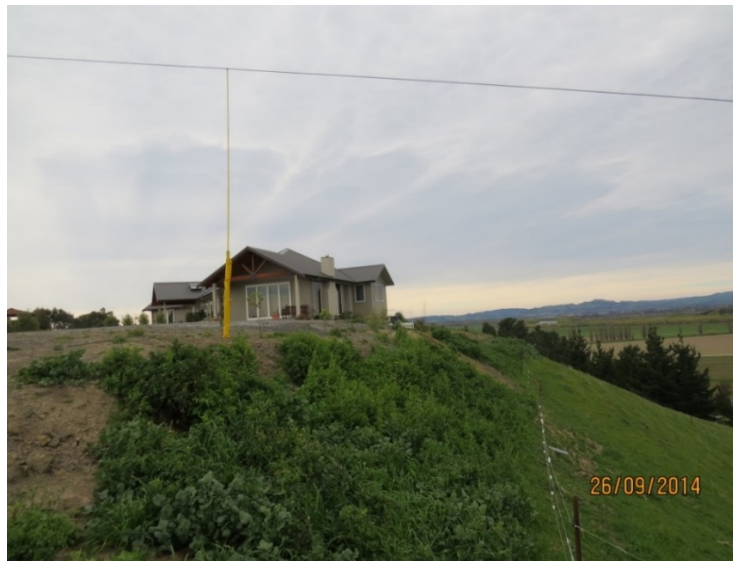
*Figure 5. Hastings ground clearance violations*
