In the matter of a hearing on submissions on the proposed Te Tai o Poutini Plan

Topic: Rural Zone

Supplementary Evidence of Katharine Jones

- 6 This supplementary evidence provides an update to my primary evidence, dated 18 March 2024, following a site visit to the ANZCO Kokiri Site (**the Site**) which I undertook on 17 May 2024.
- 7 This supplementary evidence should be read in conjunction with my primary evidence.

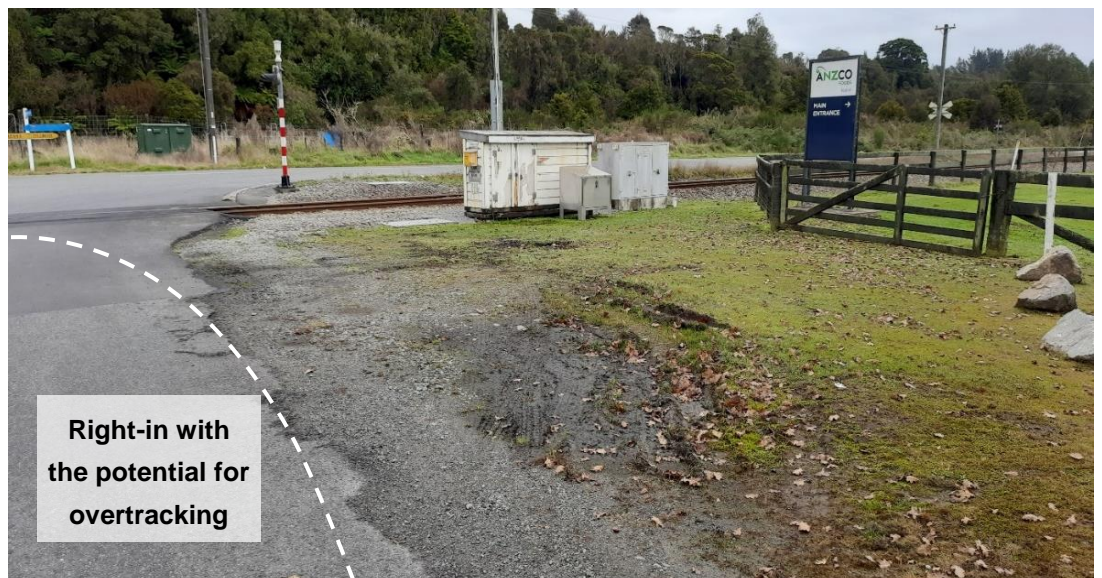
- 10 During the on-site portion of the visit, plant staff noted that, on multiple occasions, larger passenger vehicles and campervans have parked on the grassed area on the shoulder of Blair Road, as shown in Figure 1 below. In some instances, these vehicles remained parked overnight or for an extended period of time. The tyre tracks observed on site, as shown in Figure 1, appeared similar in size to the tyre tracks expected from these types of vehicles (i.e. smaller vehicles than a truck and trailer).
- 11 The plant staff also advised of previous observations of the existing rail tracks moving while trains passed along the tracks in the vicinity of the intersection. It was noted that on a few occasions, KiwiRail light vehicles have parked on the same grassed area referenced above and in Figure 1, to make observations while trains pass through.

Figure 1: Grassed shoulder on Blair Road near the intersection of Arnold Valley Road showing several tyre tracks from vehicles manoeuvring and/or parking on the shoulder. Photo taken on 17 May 2024.

- 14 It appeared both on site and on later review of the video recording that the truck and trailer units were able to safely perform both the right-turning and left-turning manoeuvres without leaving the sealed portion of the carriageway. I consider that based on these observations, the tyre tracks observed on the grassed shoulder of Blair Road were likely not caused by a heavy vehicle, similar to these truck and trailer units, undertaking these turning movements.
- 15 After both visiting the Site and having conversations with various plant staff, I consider no changes are required with regard to movements associated with the use of the Site.

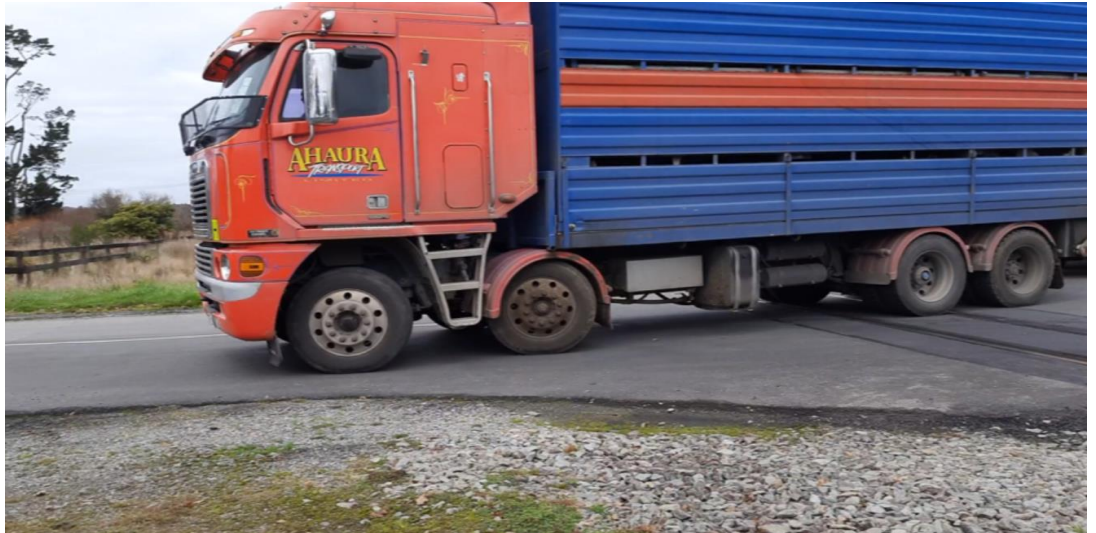
- 12 A truck and trailer unit was observed turning right onto Blair Road from the northern approach of Arnold Valley Road. This indicates that the primary route for heavy vehicles travelling to and from the Site on plant business and as such the left-out and right-in would be the primary vehicle manoeuvres that are performed. The right-in manoeuvre was recorded with regard to assessing the potential for overtracking, and snapshots of the video recording are provided in Figures 2 and 3 below.

Figure 2: Screenshot from on-site video of truck and trailer manoeuvre remaining on sealed carriageway. Video recorded on 17 May 2024.

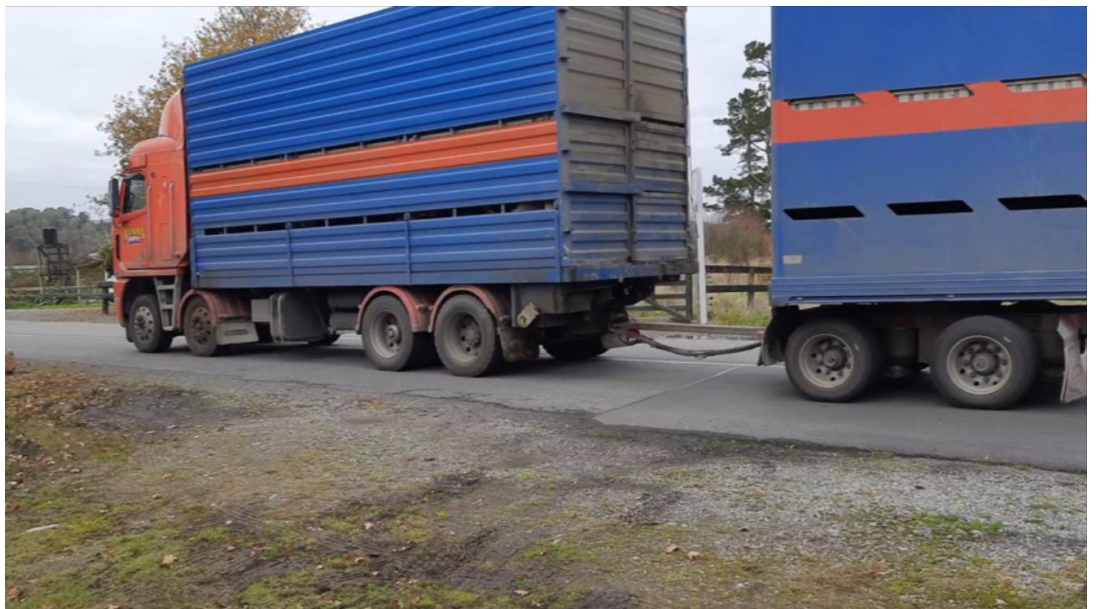
Figure 3: Screenshot from on-site video of truck and trailer manoeuvre remaining on sealed carriageway. Video recorded on 17 May 2024.

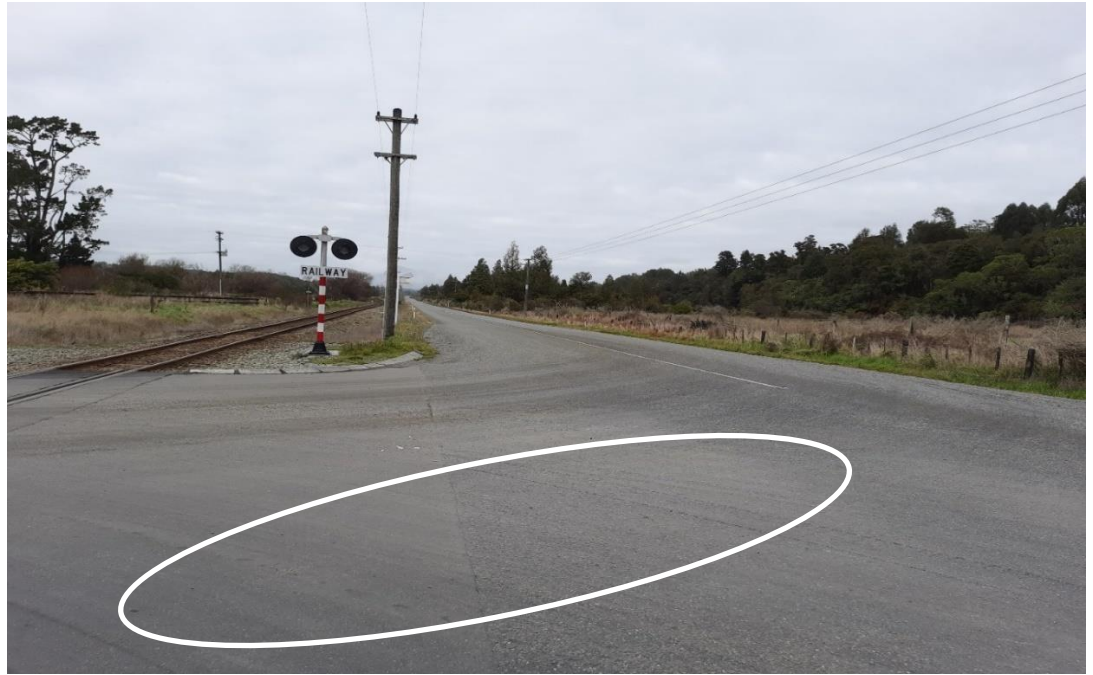
- 13 Multiple vehicles, including truck and trailer units, were also observed turning left onto Arnold Valley Road from Blair Road. Visible tyre tracks from these vehicles were photographed on site and are shown in Figure 4.

Figure 4: View of Arnold Valley Road facing southbound. Visible sets of left-turning tyre tracks are shown circled in white. Photo taken on 17 May 2024.
